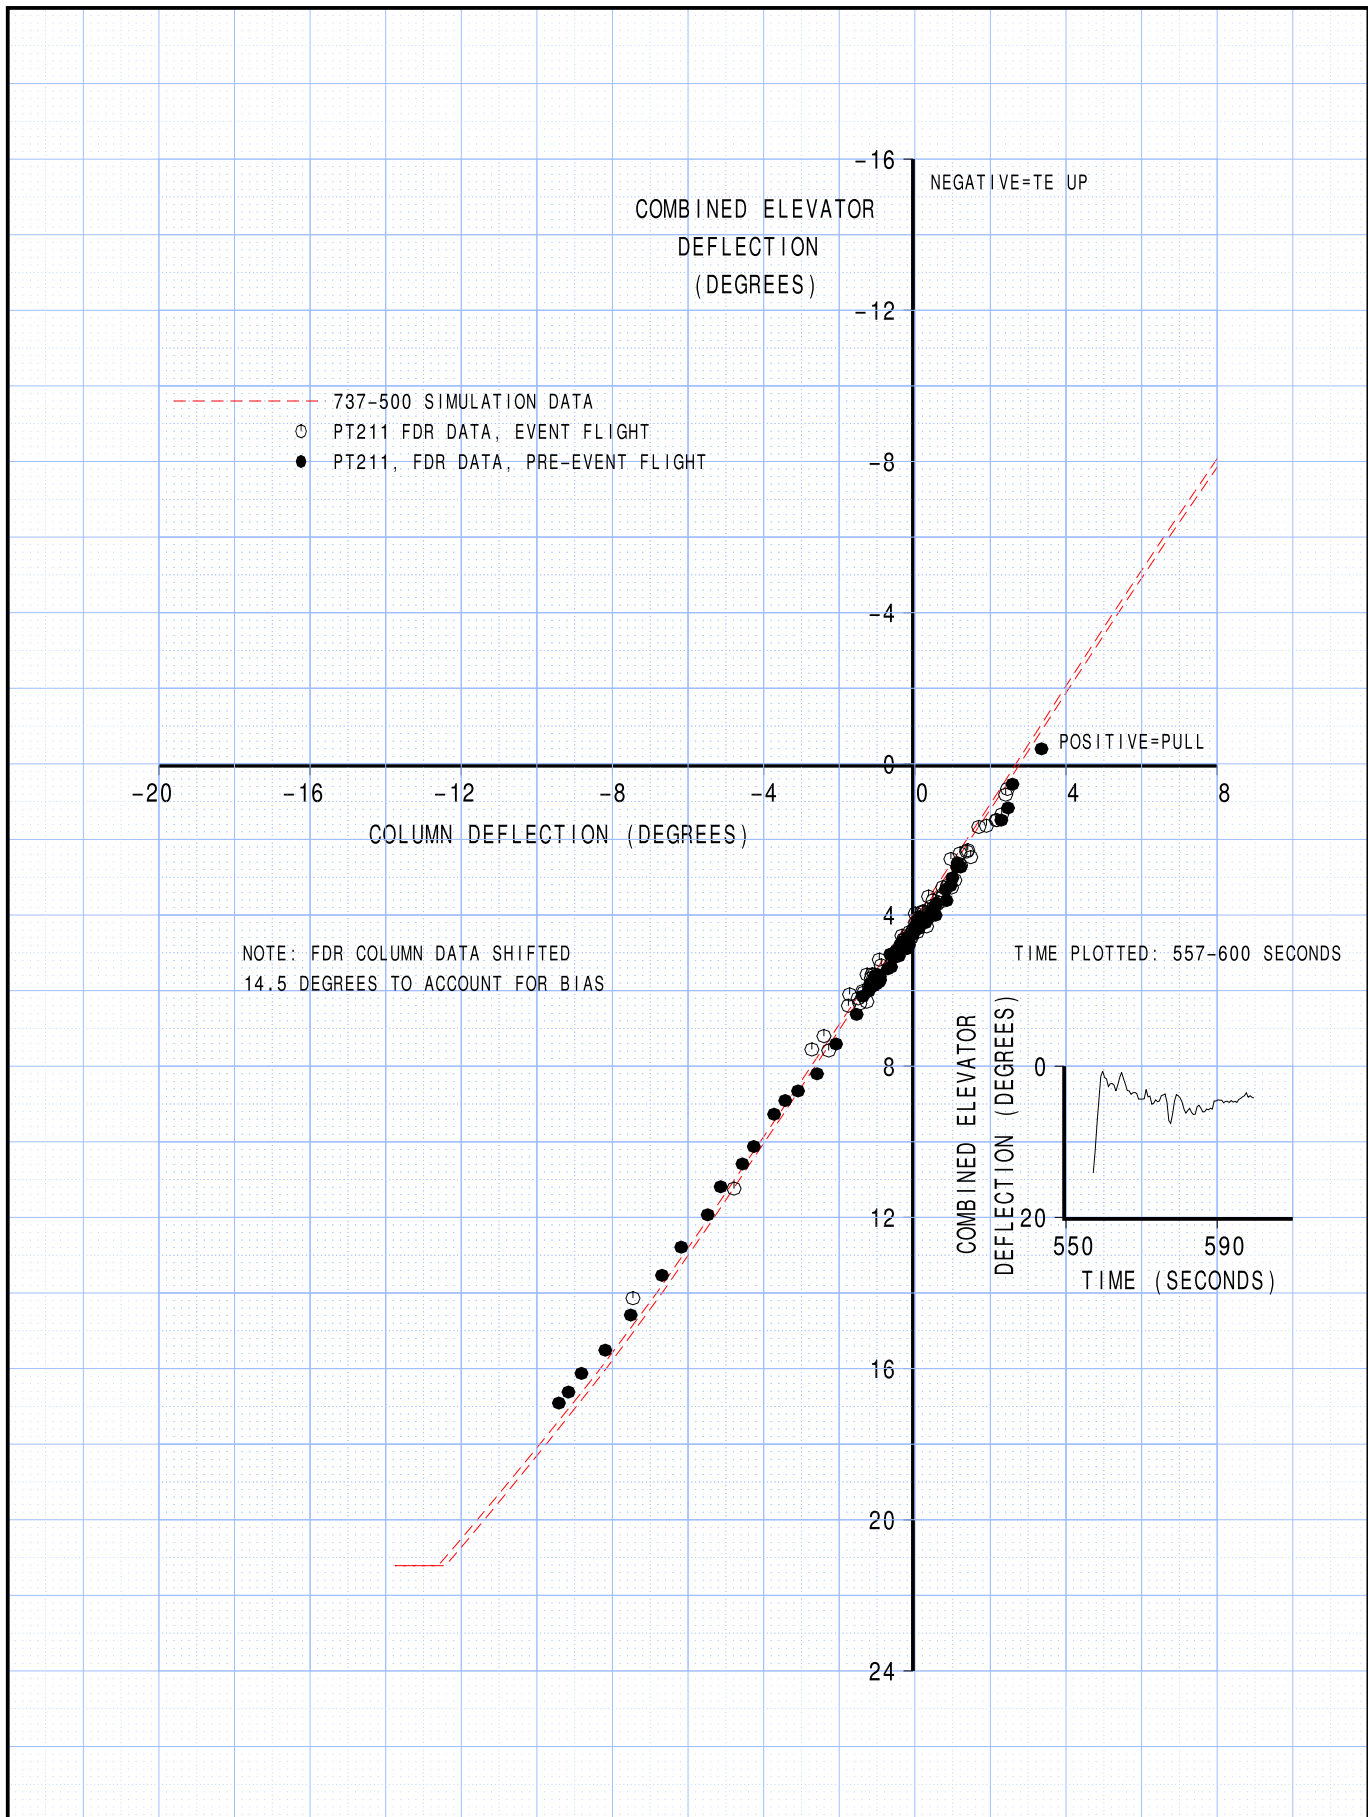
CALC	AERODYNAMICS	9Dec15	REVISED	DATE	TTQ 737-500 GO-AROUND ACCIDENT 17NOV13--TIME-ALIGNED FDR DATA EVENT VS. PRE-EVENT FLIGHT, ELEV X-PLOT(TKO)	PT211/VQ-BBN
CHECK				FIGURE 1		
APPD.				PAGE		
APPD.

Response: The previous flight’s FDR data were provided for analysis. The analysis shows that no go-around was performed in the previous flight; however, other portions of the flight were reviewed and analyzed. The data show the elevator deflected linearly with column, as expected, for the takeoff (Figure 1) and landing (Figure 2) of the flight before the accident flight. Furthermore, the elevators deflected as expected during takeoff of the accident flight (Figure 1).
