Technical report IN-005/2005

Serious incident of aircraft
Tupolev 154M, registration
RA-85644, operated by
Aeroflot, at Barcelona Airport
(Spain), on 27 February 2005

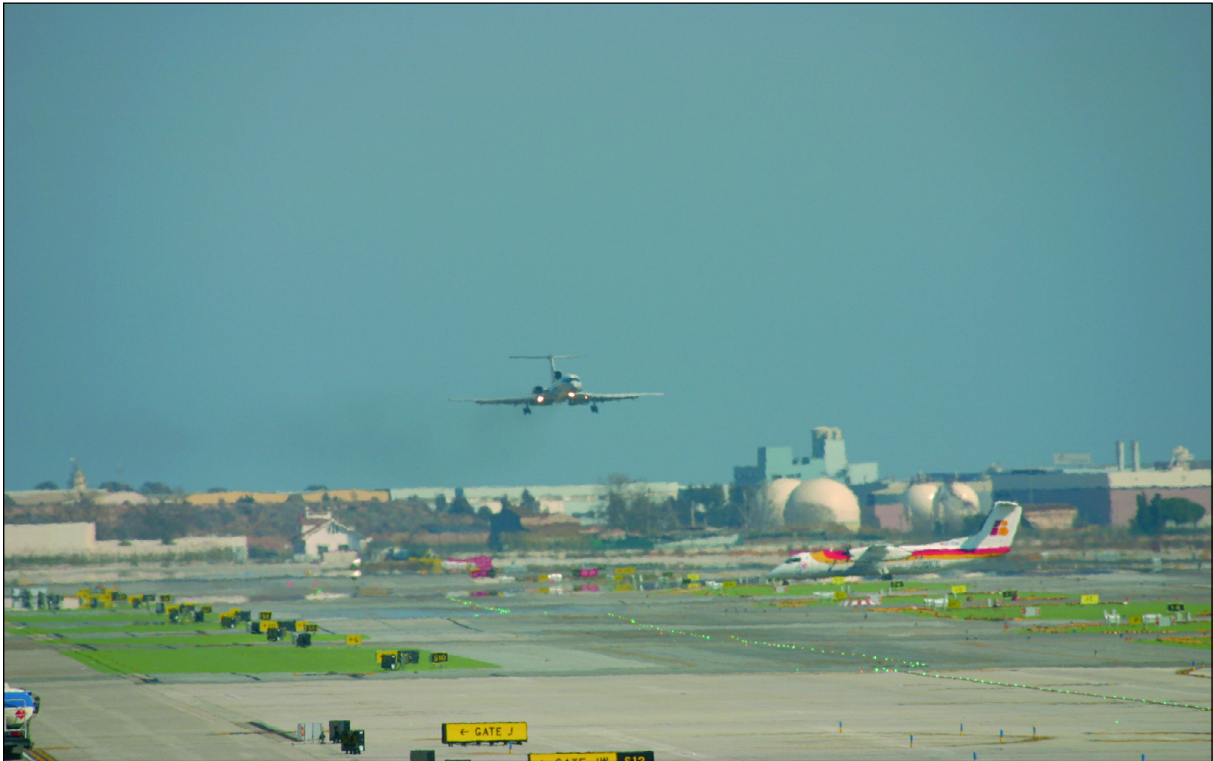
Photo 1. Aircraft approaching to taxiway T at the time a Dash-8 is leaving the taxiway T (photo by a private observer outside the airport premises)

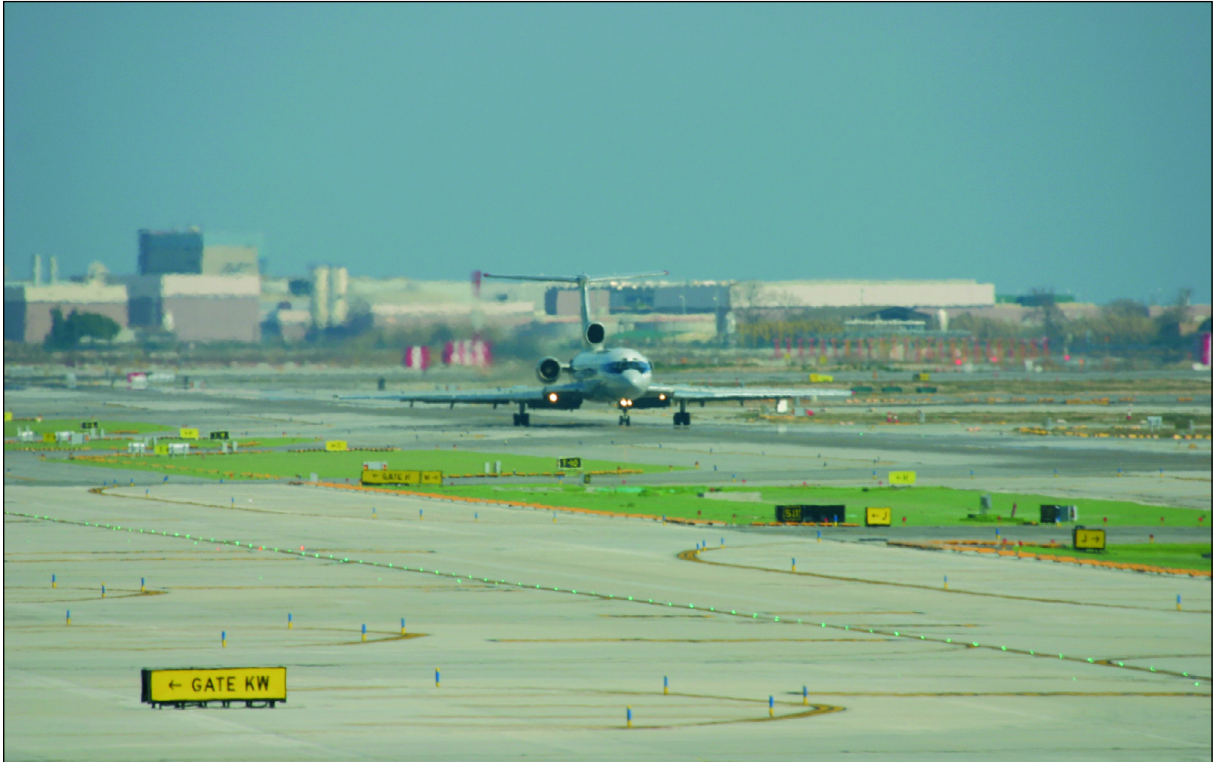
At 12:45:04 the aircraft was cleared again to land on runway 25R. At 12:46:30 the aircraft was informed it had landed on taxiway «T». There were no aircraft on taxiway «T». Taxiway «T» is parallel and on the right of runway 25R.

Photo 2. Aircraft landing on taxiway T (photo by a private observer outside the airport premises)

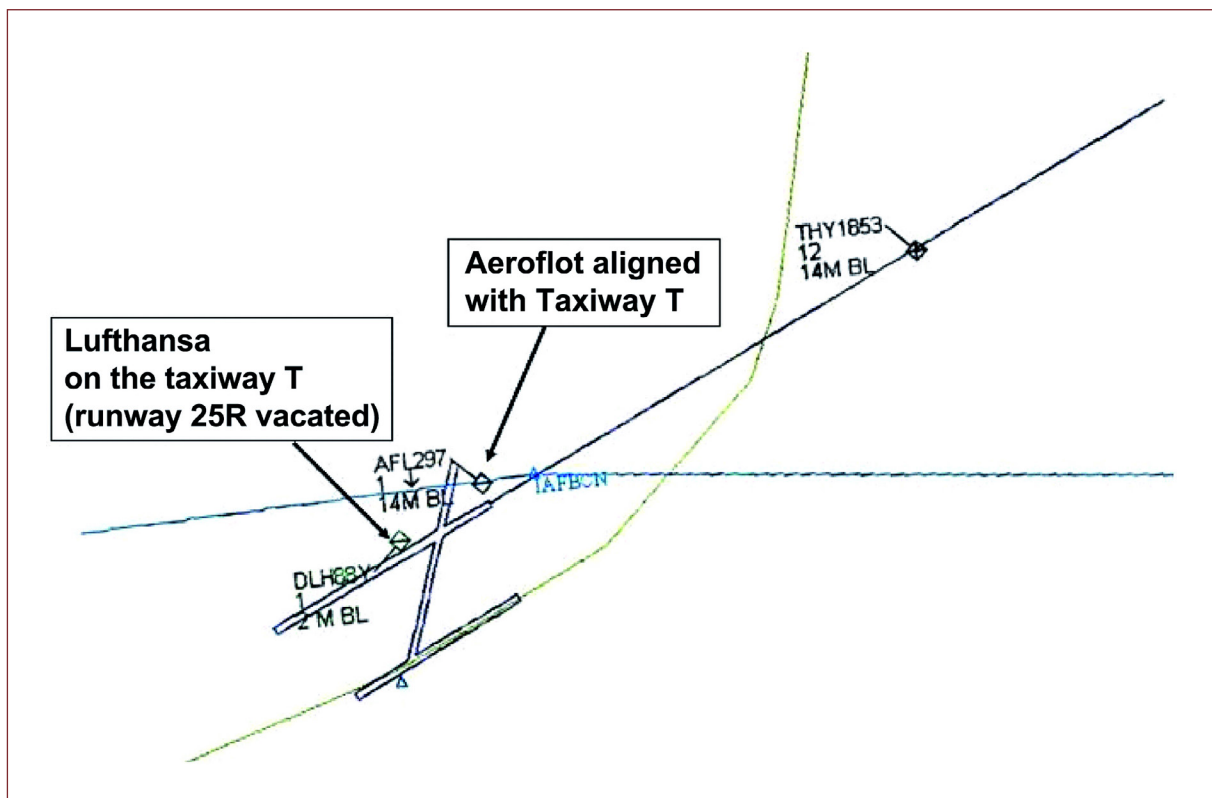
According to radar information provided by the ACC the runway was vacated by the Lufthansa aircraft just when the Tupolev 154 was initiating the go around.

Photo 3. Radar information at 12:31:43 when the Aeroflot was initiating the go around

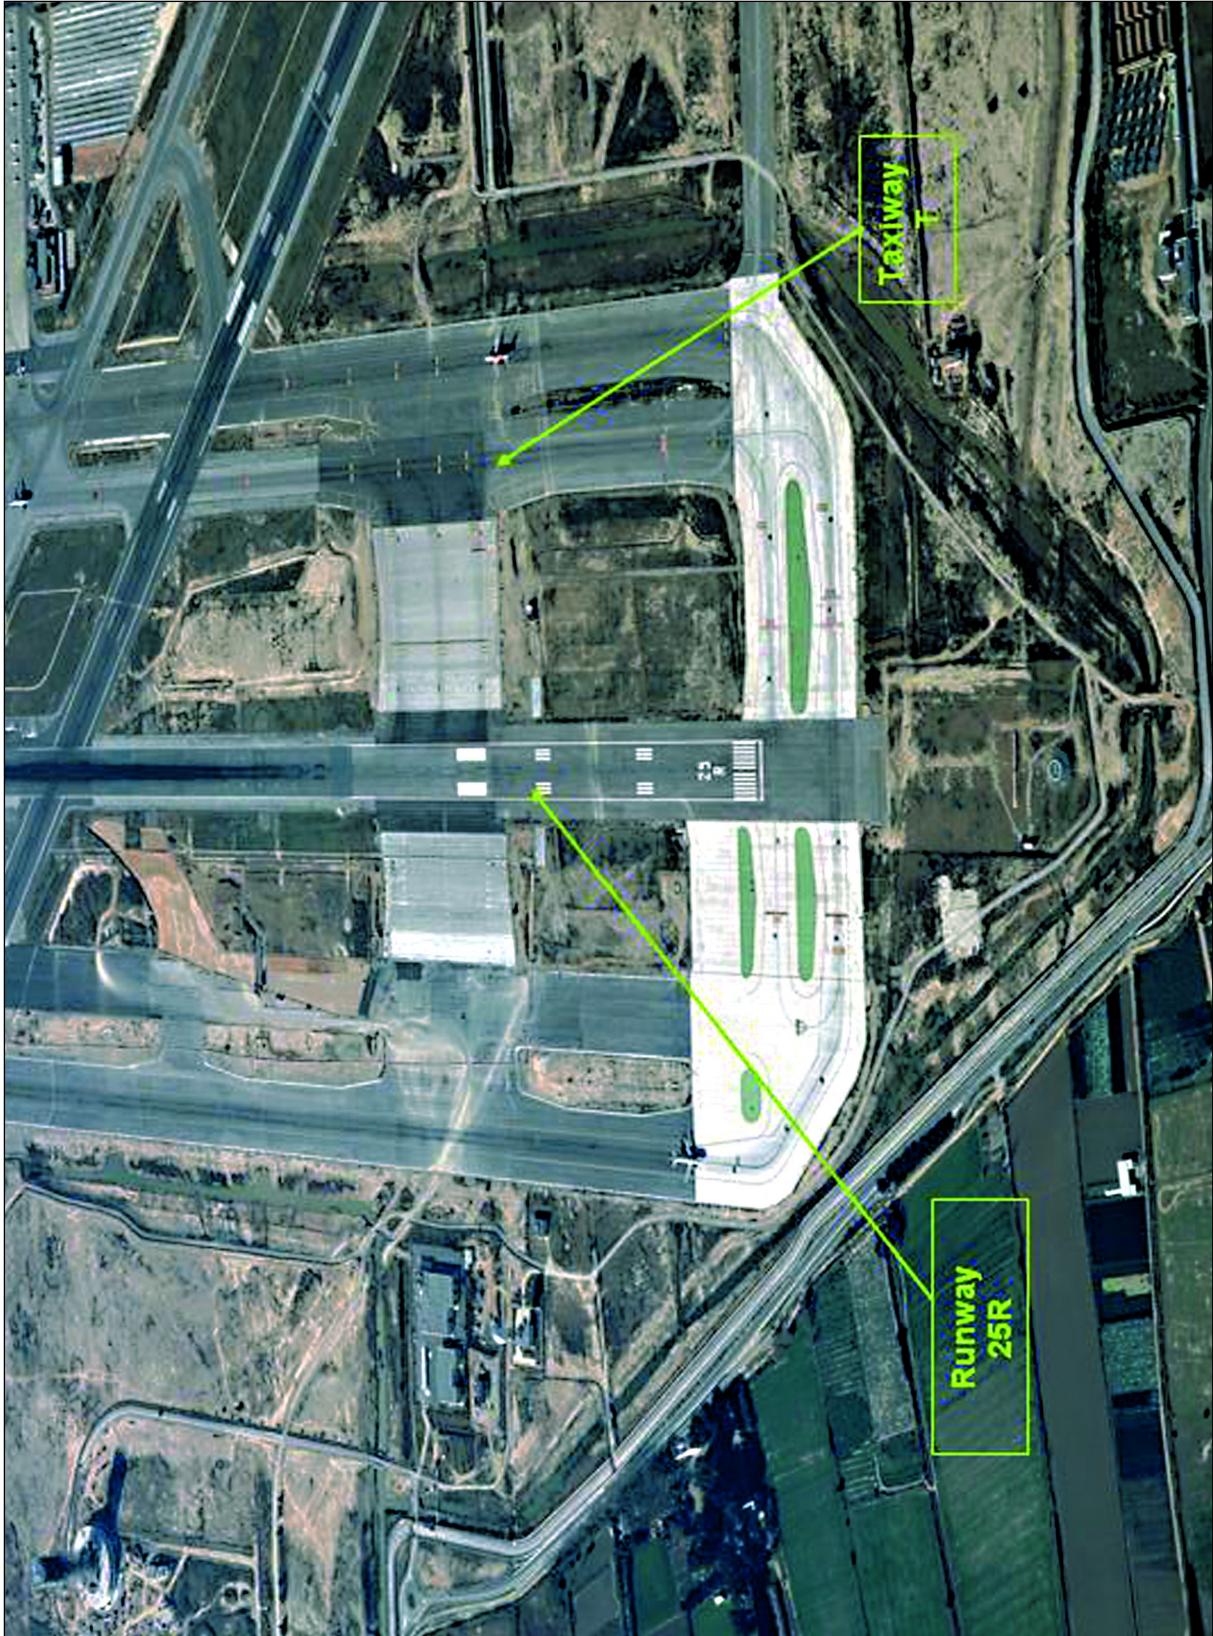
- Designation or number markings.
- Threshold marking.
- Center line marking (as can be seen in the picture n° 3 these markings are not easily appreciated).
- Aiming point marking.
- Touch-down zone marking.
- Side stripe marking.

The distance between the taxiway and runway centrelines is 250 meters. Photo 4 (taken in March 2005) shows the appearance of runway 25R and taxiway T.

Photo 4. Runway 25R and taxiway T
