FINAL REPORT

**ACCIDENT
INVOLVING ATR 72 AIRCRAFT
REGISTRATION MARKS TS-LBB
ditching off the coast of Capo Gallo (Palermo - Sicily)
August 6th, 2005**

AGENZIA NAZIONALE
PER LA SICUREZZA DEL VOLO

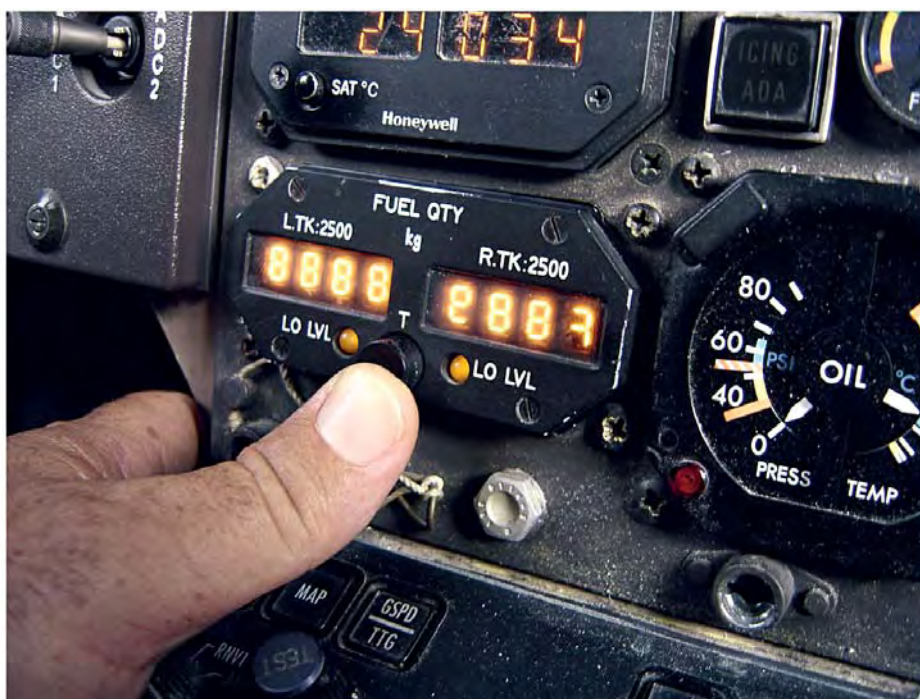
During the first route, Tunis-Catania, the flight captain had become aware of the inefficiency of the fuel quantity indicator (FQI); in particular, the value shown by the FQI for the right-hand tank was not normal: some LEDs of the display were not working, which meant that the fuel quantity was not correctly displayed. In photo 1 it's in fact possible to see the lights of the right display that were not working correctly: the one for the thousands, and the one for the units. The FQI provides the crew with the value of the fuel quantity, in kg or in pounds, depending on the aircraft model, inside the wing fuel tanks. Further details on how this instrument works are outlined in the following paragraph 1.6.5.2.

Photo 1: The FQI installed on TS-LBB before replacement.

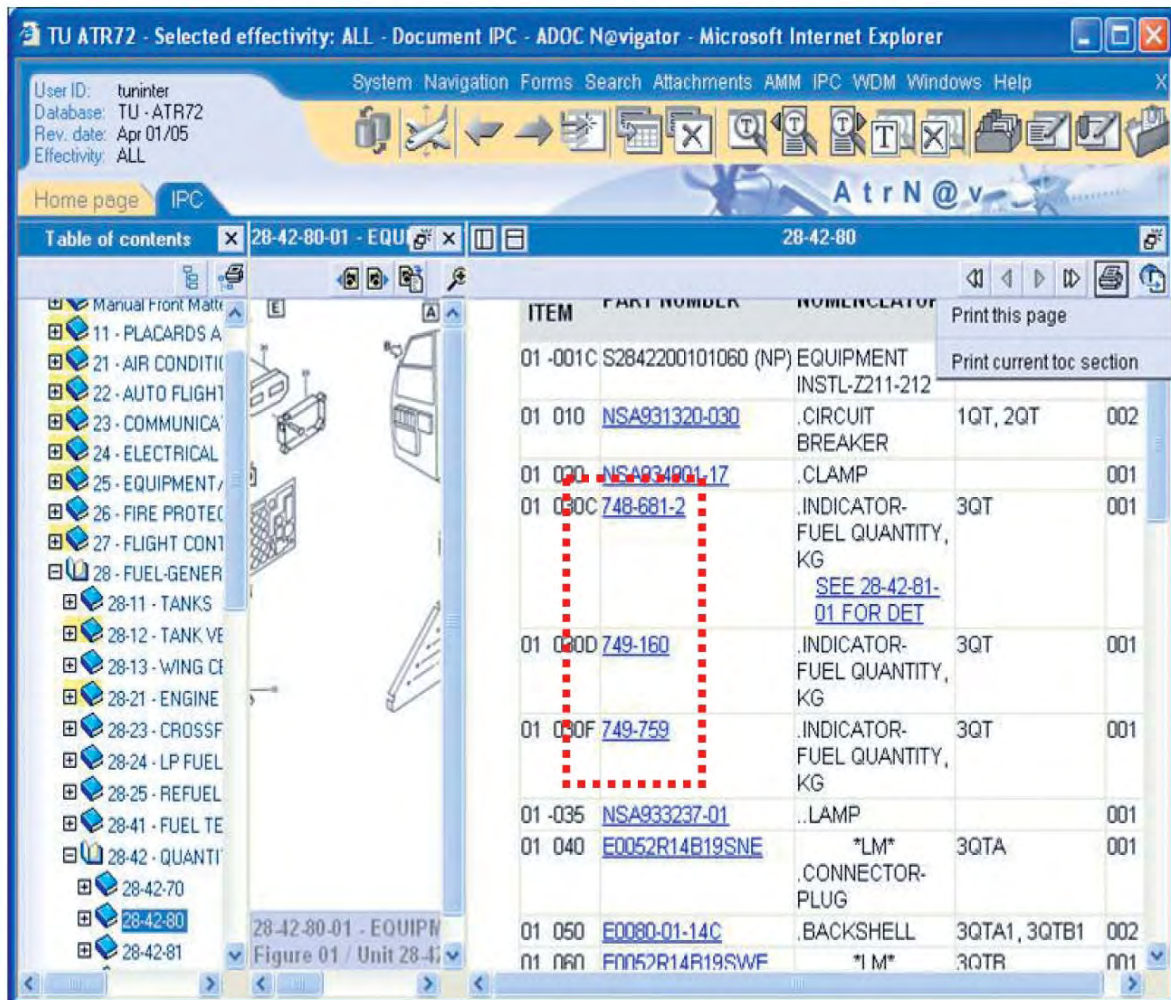
He therefore checked using a video terminal the electronic Illustrated Parts Catalogue (IPC - which is the only reference document for the operators), supplied by the aircraft manufacturer, and identified three Part Numbers (P/N) corresponding to the FQI to be replaced, all suitable to be fitted on ATR 72 aircraft:

Figure 4: IPC video screen.

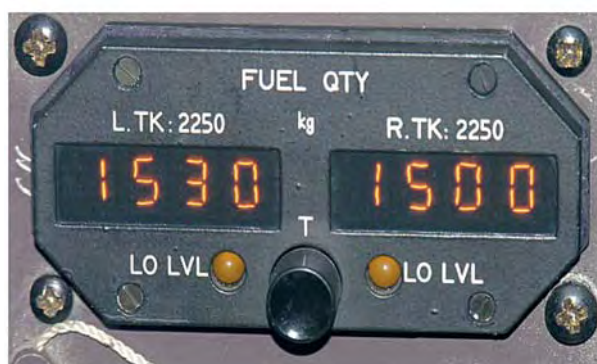
The ATR 42 and ATR 72 type FQIs are identical in their dimension and installation procedure. Therefore an ATR 42 type FQI could be installed by mistake on an ATR 72 aircraft and vice versa. The only difference between the two FQIs, when installed on the aircraft, is white lettering indicating the maximum fuel quantity for each wing fuel tank. This can be found on the front of the instrument and is “2500” for the ATR 72 type FQI and “2250” for the ATR 42 type.

Photo 7: FQI ATR 42.

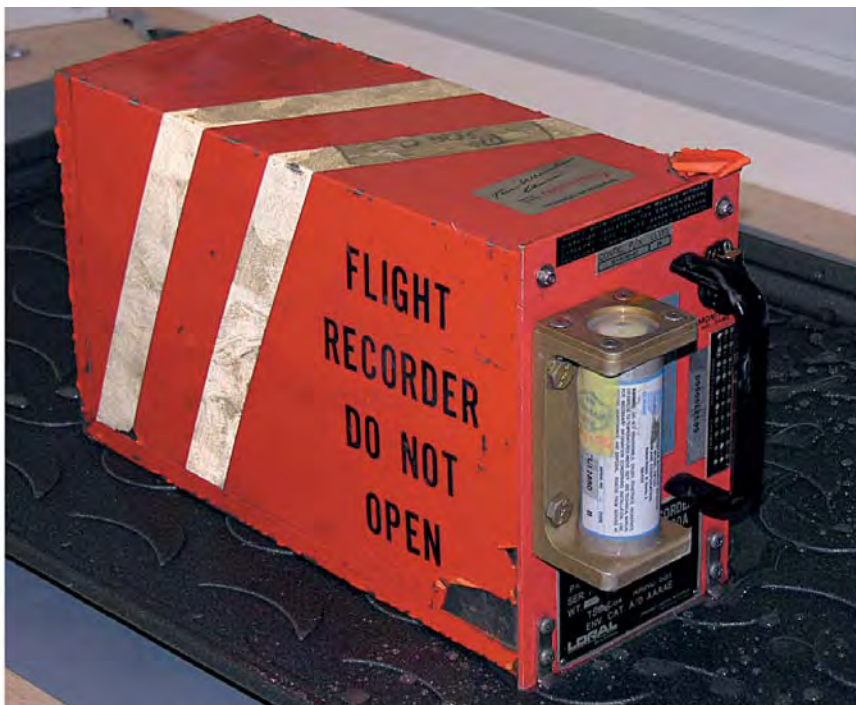
Both units were in reasonable general condition, without evidence of impact or fire damage.

Photo 18: CVR, external condition. ULB in foreground.

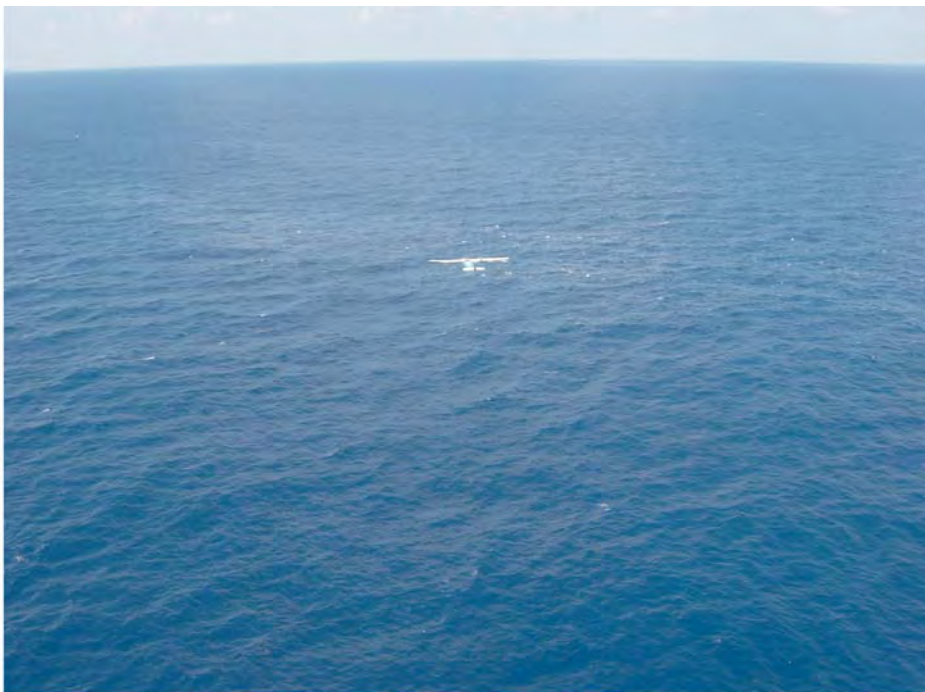
This was also confirmed by the B737 aircraft flight captain, who flew over the area where the event took place, giving Palermo control tower the position of the wreckage. Photo 19, taken by the first helicopter arriving on the scene, clearly shows the rear of the aircraft on the sea surface, together with the LH and RH wings. The nose of the wreckage is oriented at 040°/050°.

Photo 19: View of the wreckage upon arrival of the first rescue helicopter.

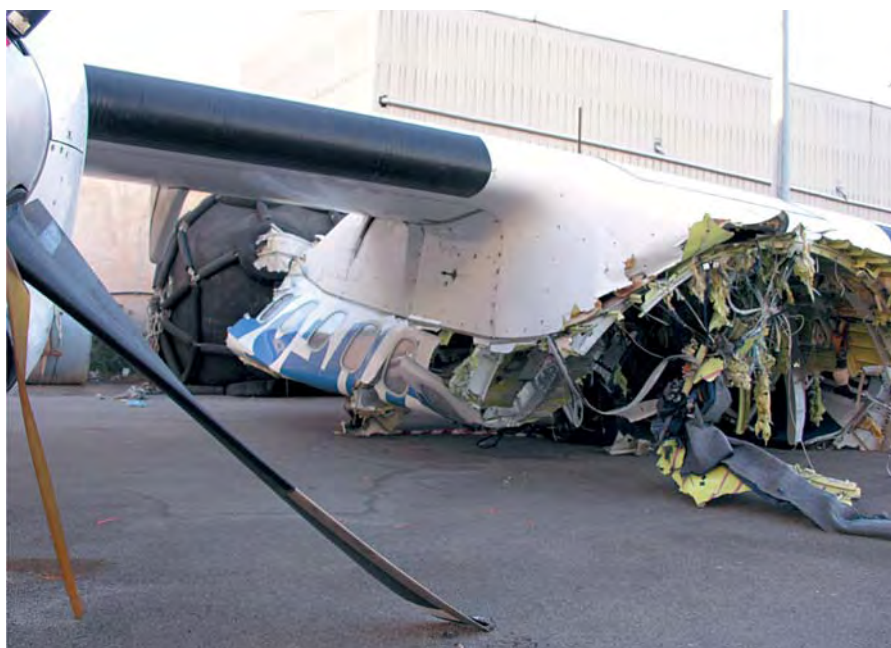
- Both the inner and outer dripsticks (magnetic graduated rod used to check the quantity of fuel inside the wing fuel tanks) appeared in good condition.
- Gravity refuelling point in good conditions: no corrosion and filter in good condition.
- Panel opening area for access to the Feeder Tank: no contamination detected, presence of water and fuel (or at least of two fluids with different densities) inside the tank. No visible damage to the internal pipes.
- Presence of water inside the wing fuel tank possibly penetrated from the NACA air vent (underside of the wing) during the period in the water after ditching.

Photo 20: Part of the central fuselage with LH and RH wings.

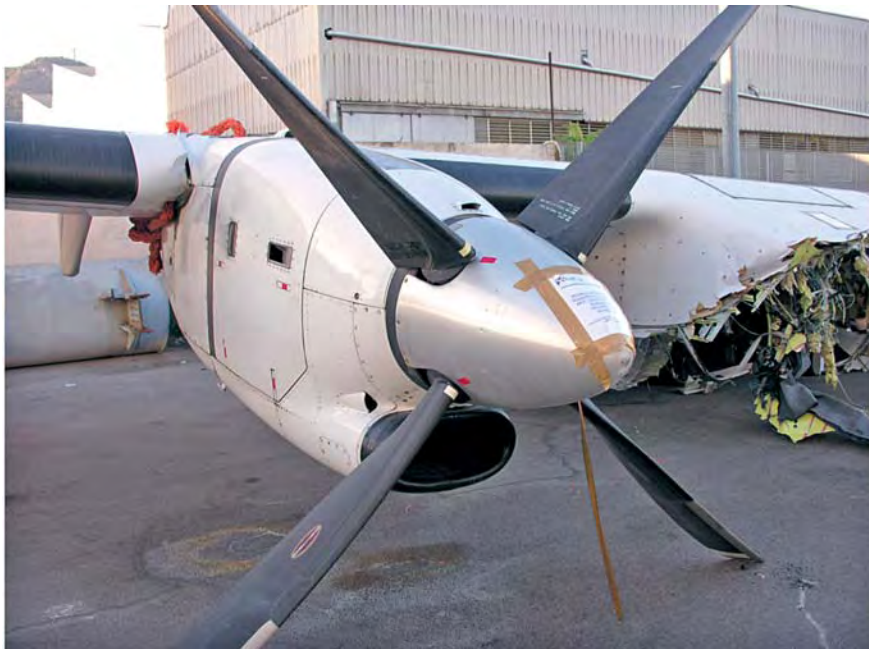
- Considerable presence of corrosion on various components, caused by the action of the seawater they came into contact with. The engines were immediately treated with fresh water to limit any further corrosion to the components.
- Some of the propeller blades, resting on the ground, were clearly bent.
- MFCU Fuel Control in the shut-off position.
- No visible loss of fluids from components and accessories.
- No clear breaks in the fuel feed line.
- Low pressure filter removed to check its condition. No external contamination was detected.

Photo 21: Right engine – note the propellers in the fully feathered position (red line).

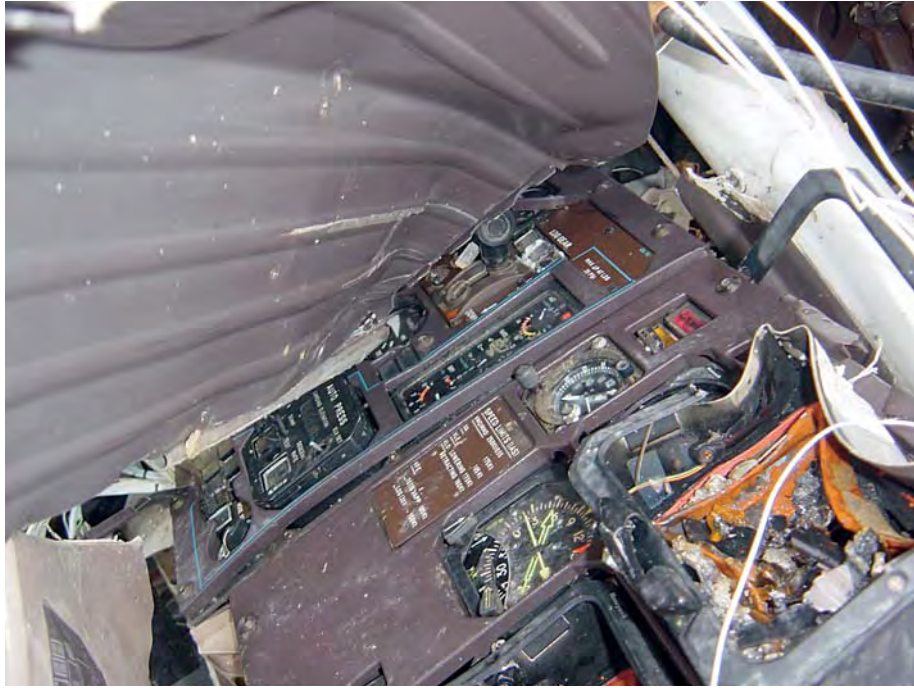
Photo 28, taken immediately after positioning the wreckage on the deck of the ship, shows in fact that the lever of the landing gear was in the UP position. It was also found after removal that the flaps position analogue indicator was showing 30° .

Photo 28: part of the TS-LBB instrument panel after recovery
(note the landing gear lever in the “UP” position at the centre of the photo).

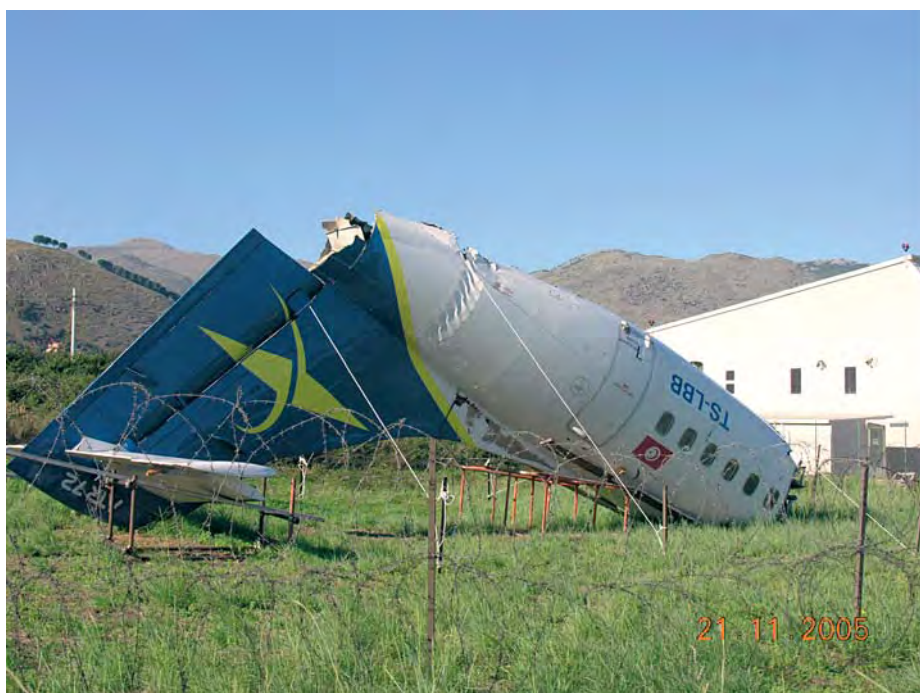
Photo 32: Rear section of the wreckage at Bocca di Falco airport – left-hand view.

The rear of this section showed a great amount of damage and deformation, resulting in the breaking of the pressure bulkhead between the pressurised and the non pressurised zone. This indicates that the impact of the aircraft against the sea surface was very strong. The rear had in fact completely collapsed, while the seating area was virtually intact.

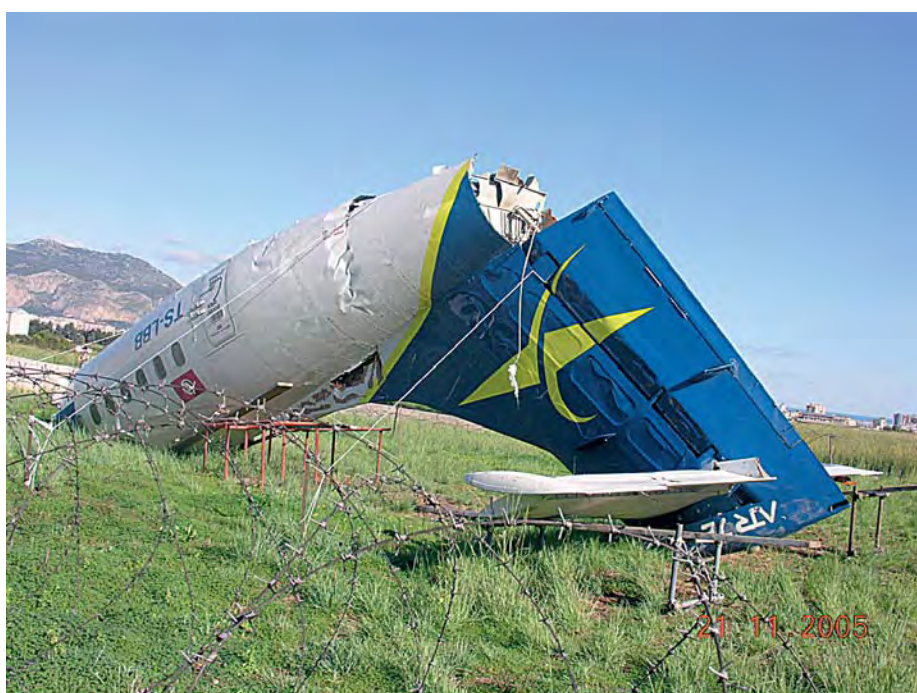
Photo 33: Rear of the wreckage at Bocca di Falco airport, right-hand view.

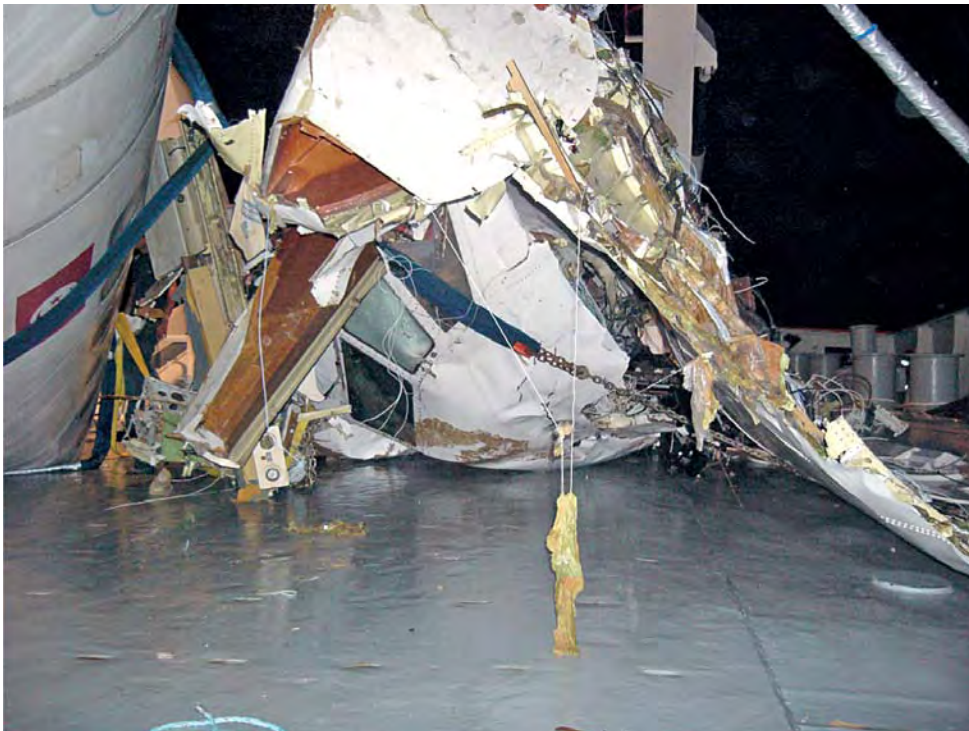
This section was divided into two parts. One part included the cockpit and the left-hand structure, while the other included the right-hand structure and the top part of the cabin. Also in this section no evidence of breaks due to fatigue and/or corrosion were found. All breakage points showed in fact a morphology typical of breaks caused by overload. No signs of fire were detected either. The section of the cockpit showed serious and extensive damage. It is very likely such damage was caused not only by the impact with the sea surface, but also by the subsequent impact with the seabed.

Photo 37: Part of the cockpit immediately after recovery.

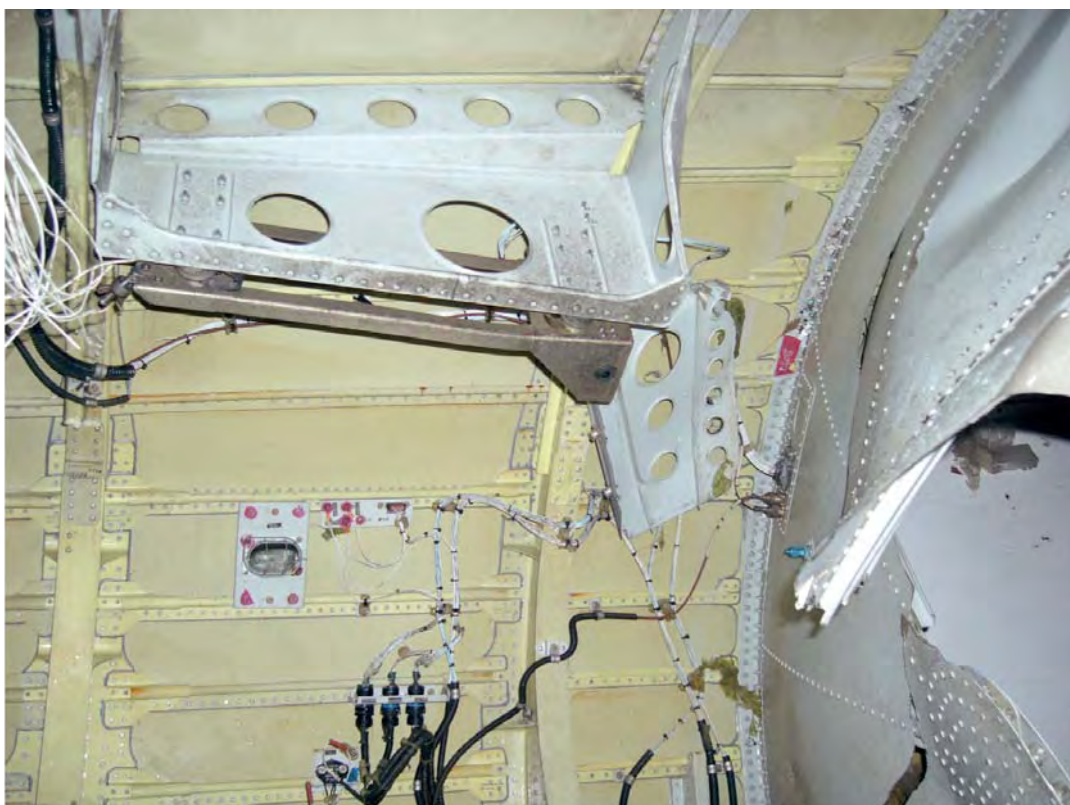
Considerable structural damage was found on the inside. The pressure bulkhead between the cabin pressurized zone and the tail had a large diagonal gash (see photo 34 and 61). The tail assemblies did not show any significant deformation. The CVR was removed from its housing. It was removed, immediately washed with fresh water and then placed in a container full of distilled water. The supports of the FDR housing appeared damaged and the device itself was missing (photo 61).

Photo 61: The damaged FDR housing (note the deformation of the pressure bulkhead, demonstrating the strong impact sustained by the rear section of the aircraft).

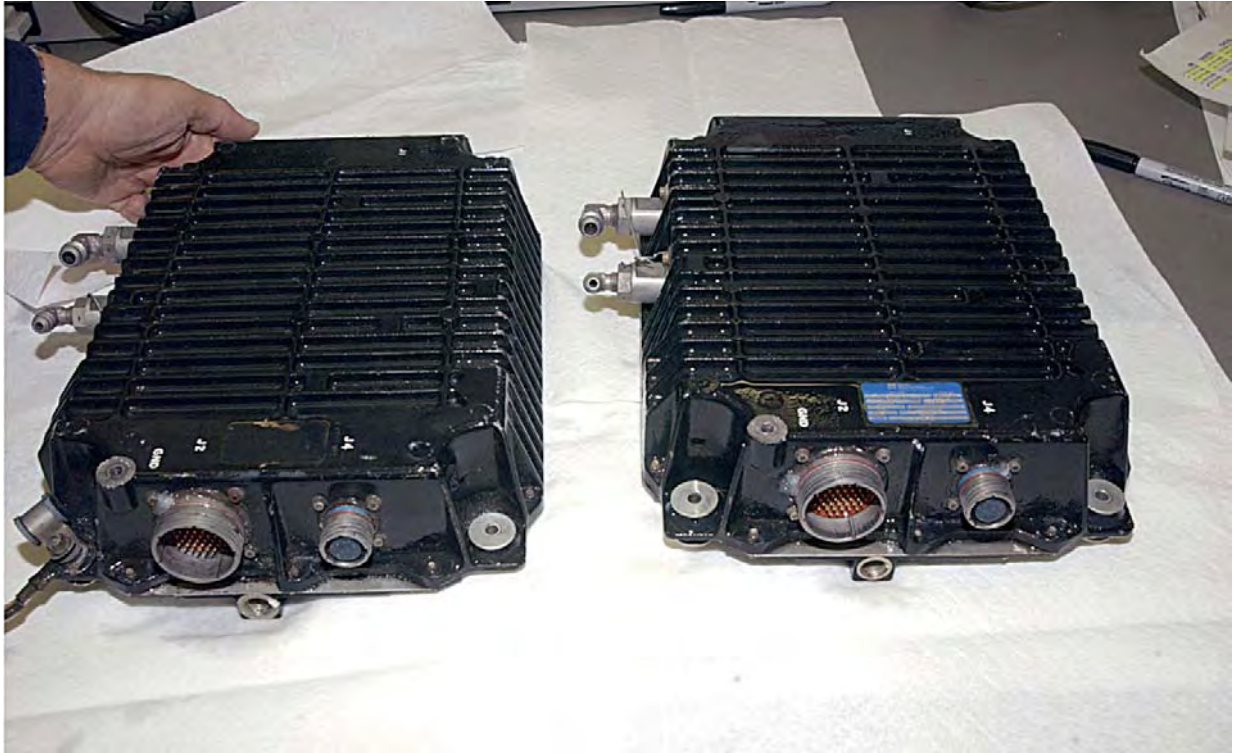
Photo 74: Engine EECs. Note the one on the left, for the right engine, without identification plate.

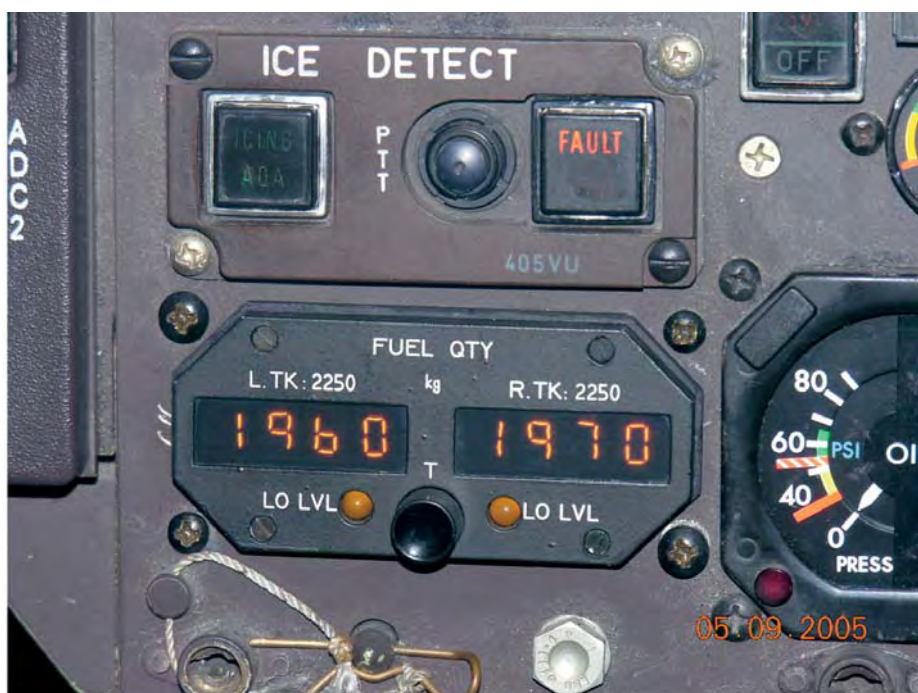
Photo 78: Indication given by an ATR 42 FQI fitted on an ATR 72 with a quantity of 3800 kg of fuel selected.

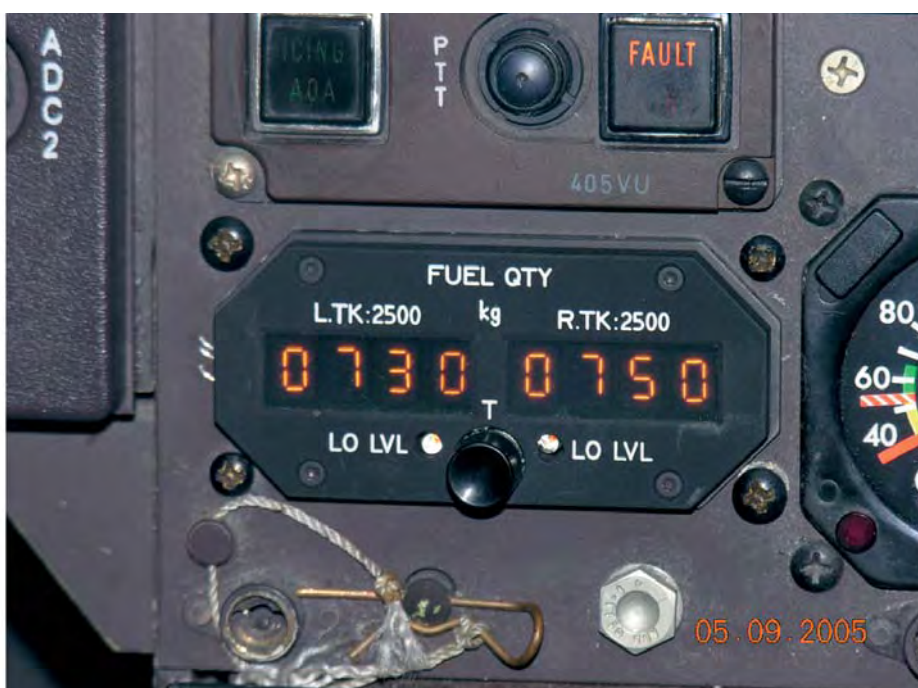
Photo 79: Indication given by the FQI ATR 72 on an ATR 72 with approximately 3800 kg selected (total actually present equals to approximately 1500 kg).

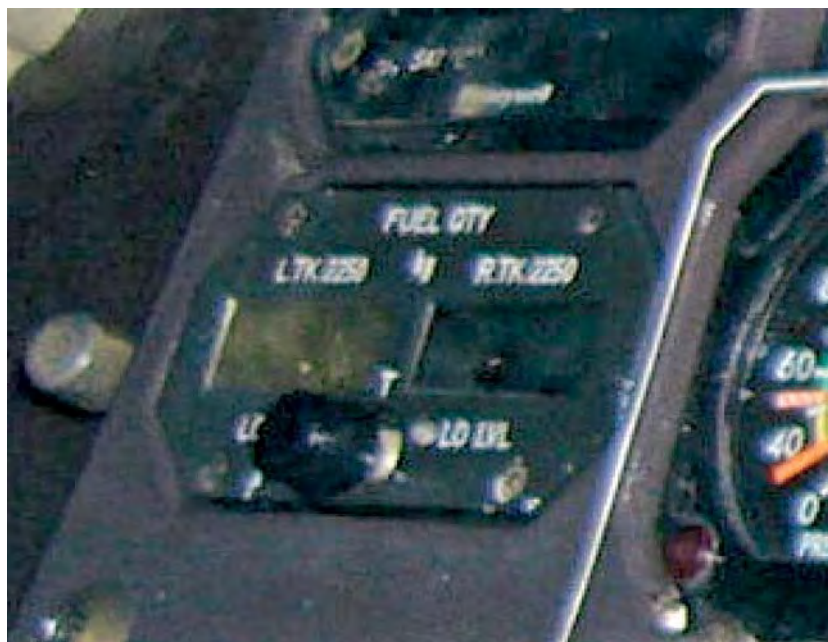
Photo 87: FQI installed onboard TS-LBB, taken immediately after wreckage recovery.
