FINAL
KNKT.12.05.09.04

Aircraft Accident Investigation Report

**Sukhoi Civil Aircraft Company
Sukhoi RRJ-95B; 97004
Mount Salak, West Java
Republic of Indonesia
9 May 2012**

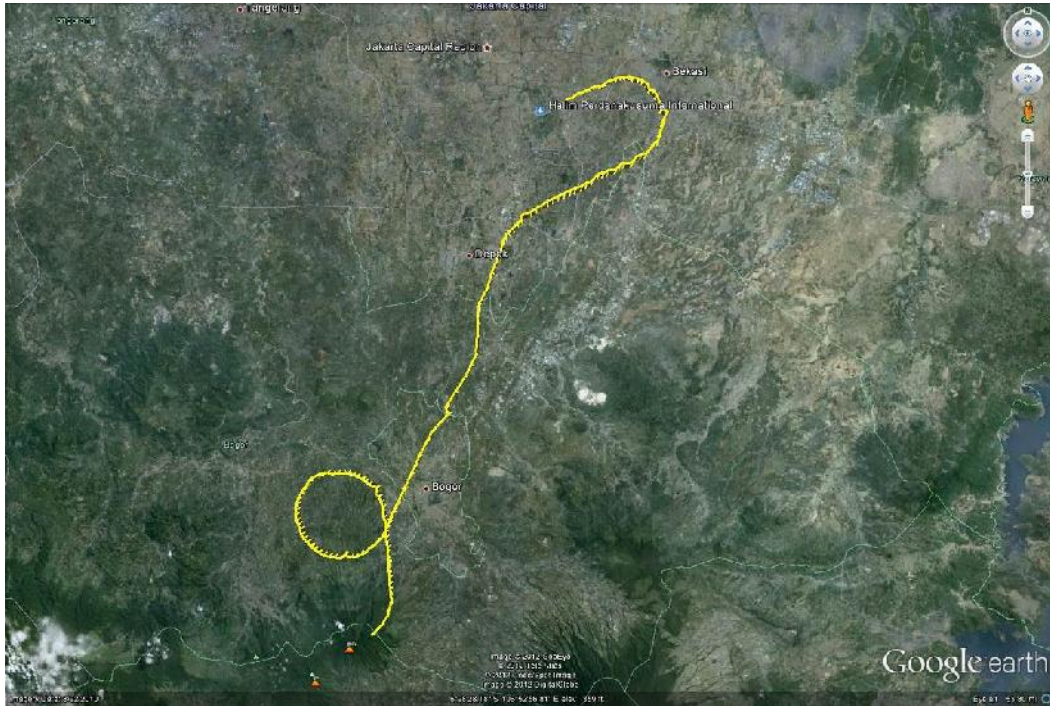
Figure 7: Plot from the radar replay

The following plot was captured from radar replay of the Jakarta Approach which was then superimposed onto Google-earth.

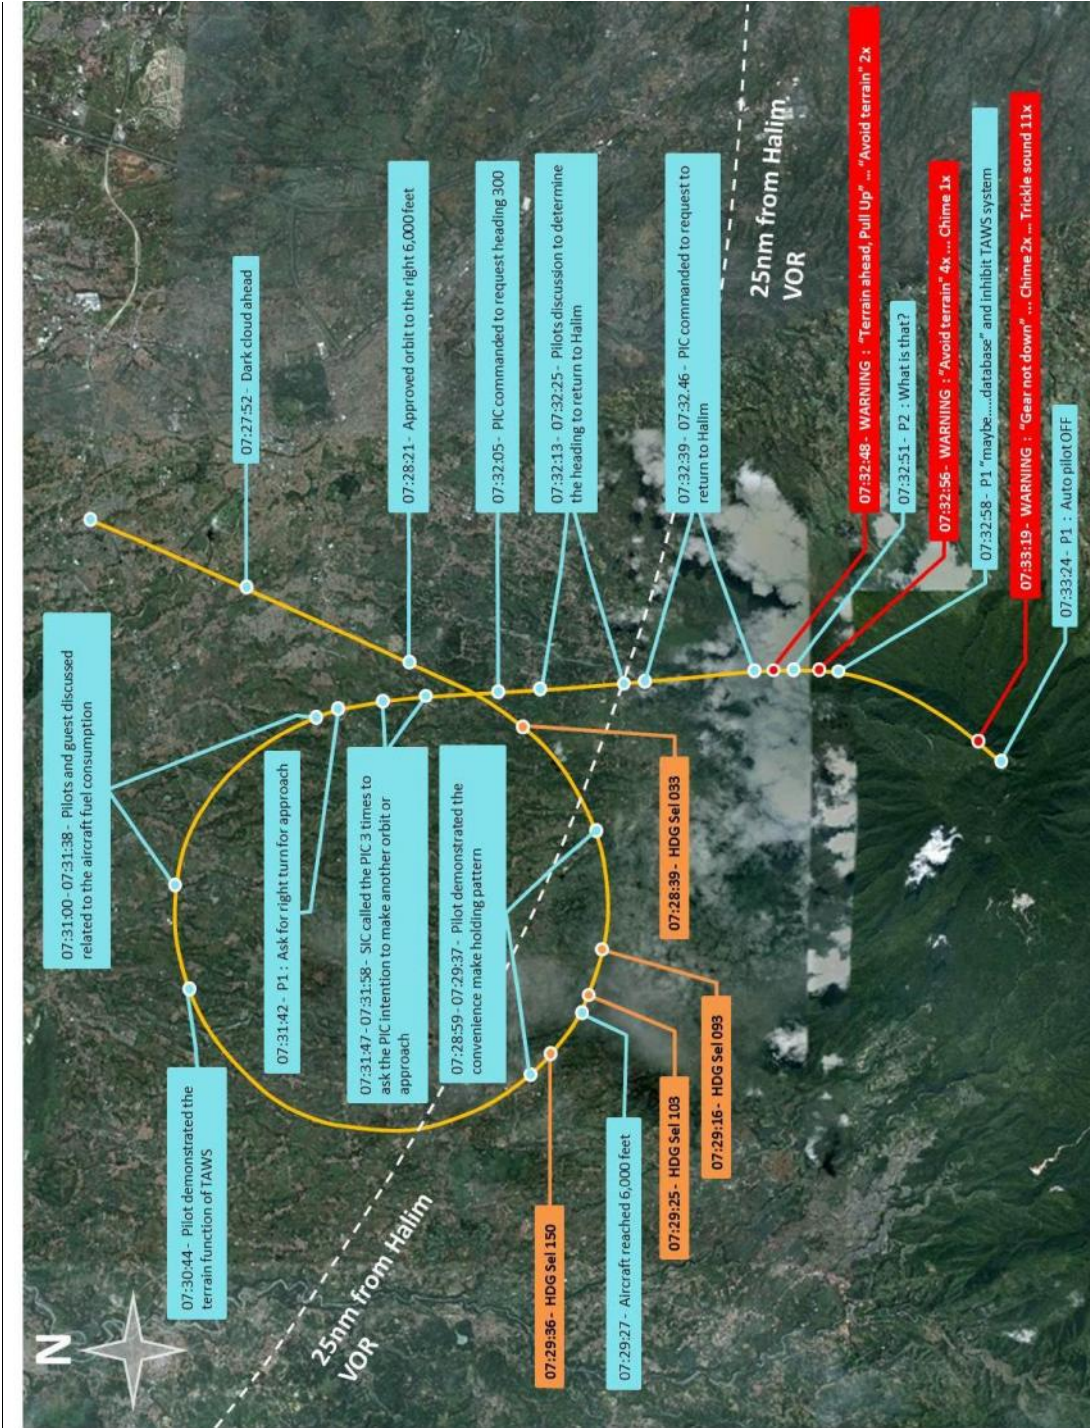
Figure 17: Event link of the final segment of the flight

At the final segment of the recording approximately 38 seconds before the end of recording, there were several alerts and warnings from the TAWS and from the aircraft warning system.

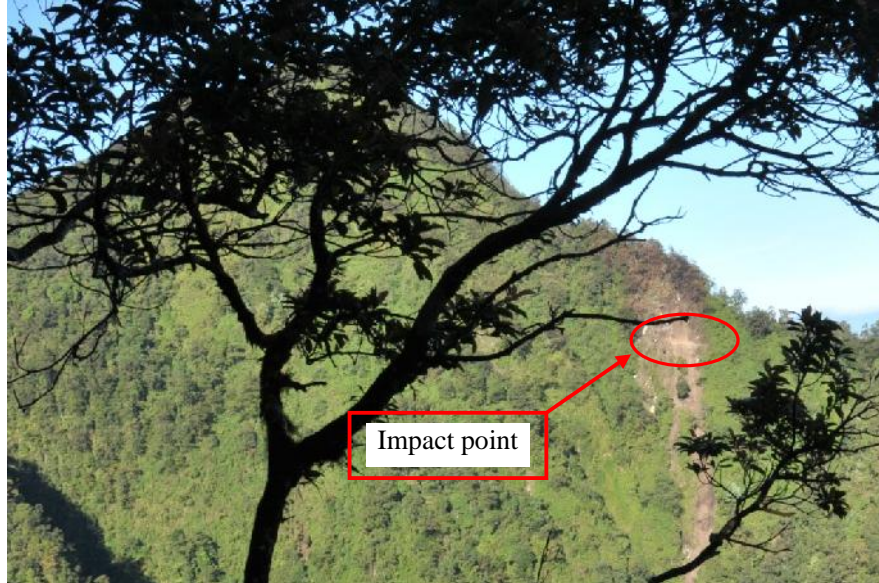
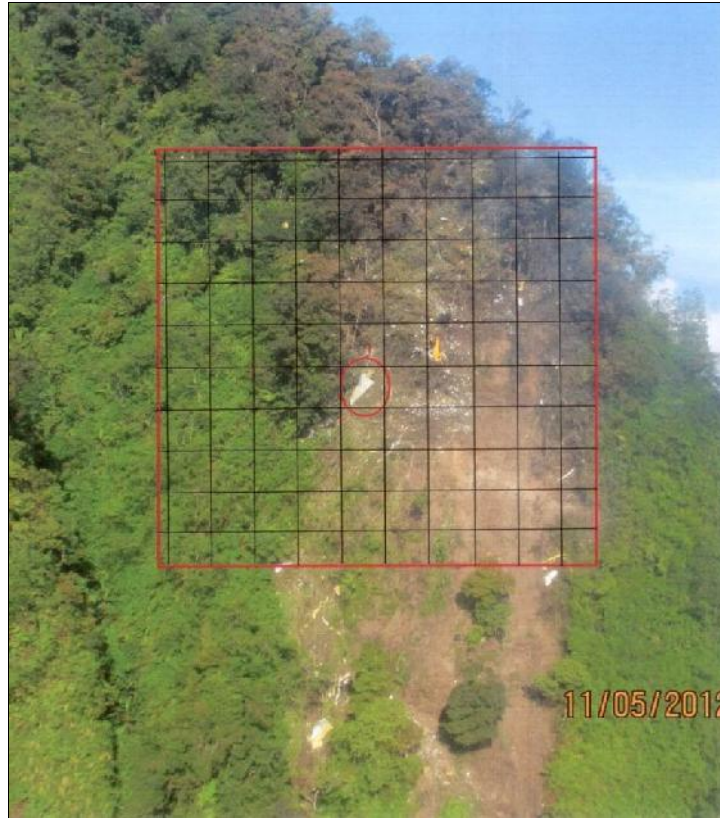
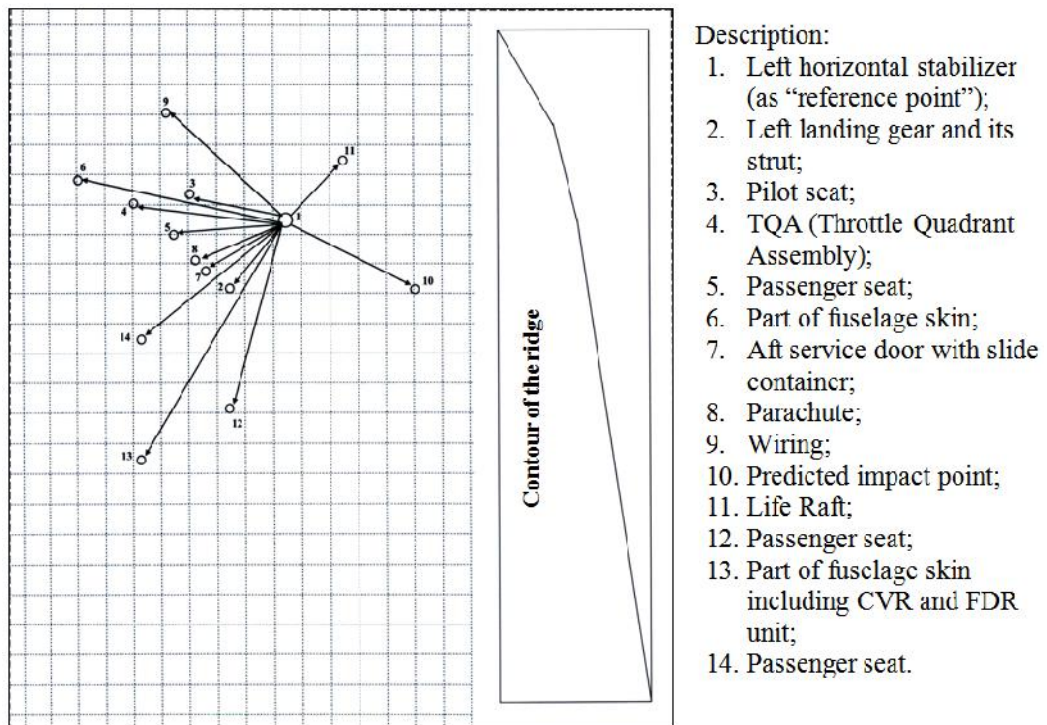
The aircraft impacted terrain at 6,000 feet ASL on an approximately 85 degree slope ridge. The wreckage was spread over a wide area. Most of the wreckage such as landing gear, engines and vertical stabilizer were found at the bottom of the valley at approximately 500 meters below the impact point.

The area surrounding the impact point was burnt. Some wreckage in that area was found partially burnt.

The aircraft was destroyed by impact forces and post-impact fire.

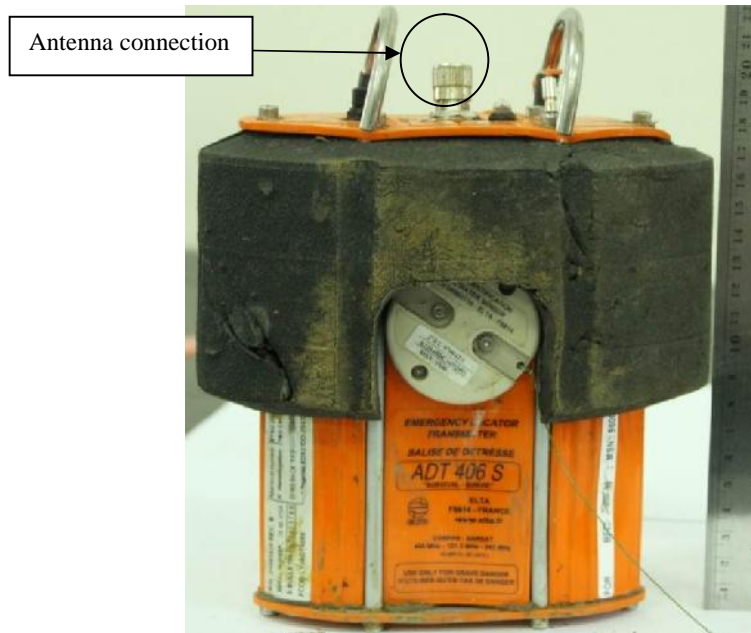
Figure 21: Emergency Locator Transmitter with antenna detached

The ELT was found with the antenna detached due to the high magnitude of impact force. The separation of the antenna from the ELT unit explained the reason why no distress signal was transmitted.

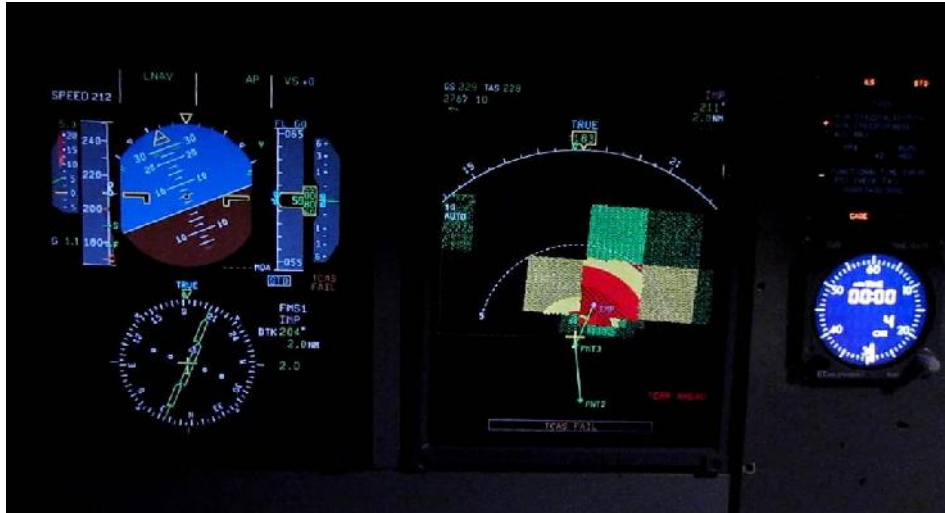
Figure 22: The cockpit instrument displayed in the simulation of the last segment of the flight

The collision with the terrain could be avoided if the crew performed the appropriate actions in responding the TAWS warning within 24 seconds after the first TAWS warning activated.
