#### 1.14.2 Cockpit voice recorder

Chart 5. Flight KE 007 from Anchorage to Shoot-down  
 Graphique 5. Vol KE 007 - D'Anchorage au point d'attaque  
 Carta 5. El vuelo KE 007 desde Anchorage hasta el derribo  
 Карта 5. Полет KE 007 от Анкориджа до пункта, в котором воздушное судно было сбито  
 الخارطة (٥) مسار طيران الطائرة KE 007 من انكوريدج حتى اسقاطها

#### 1.14.3 **Digital flight data recorder**

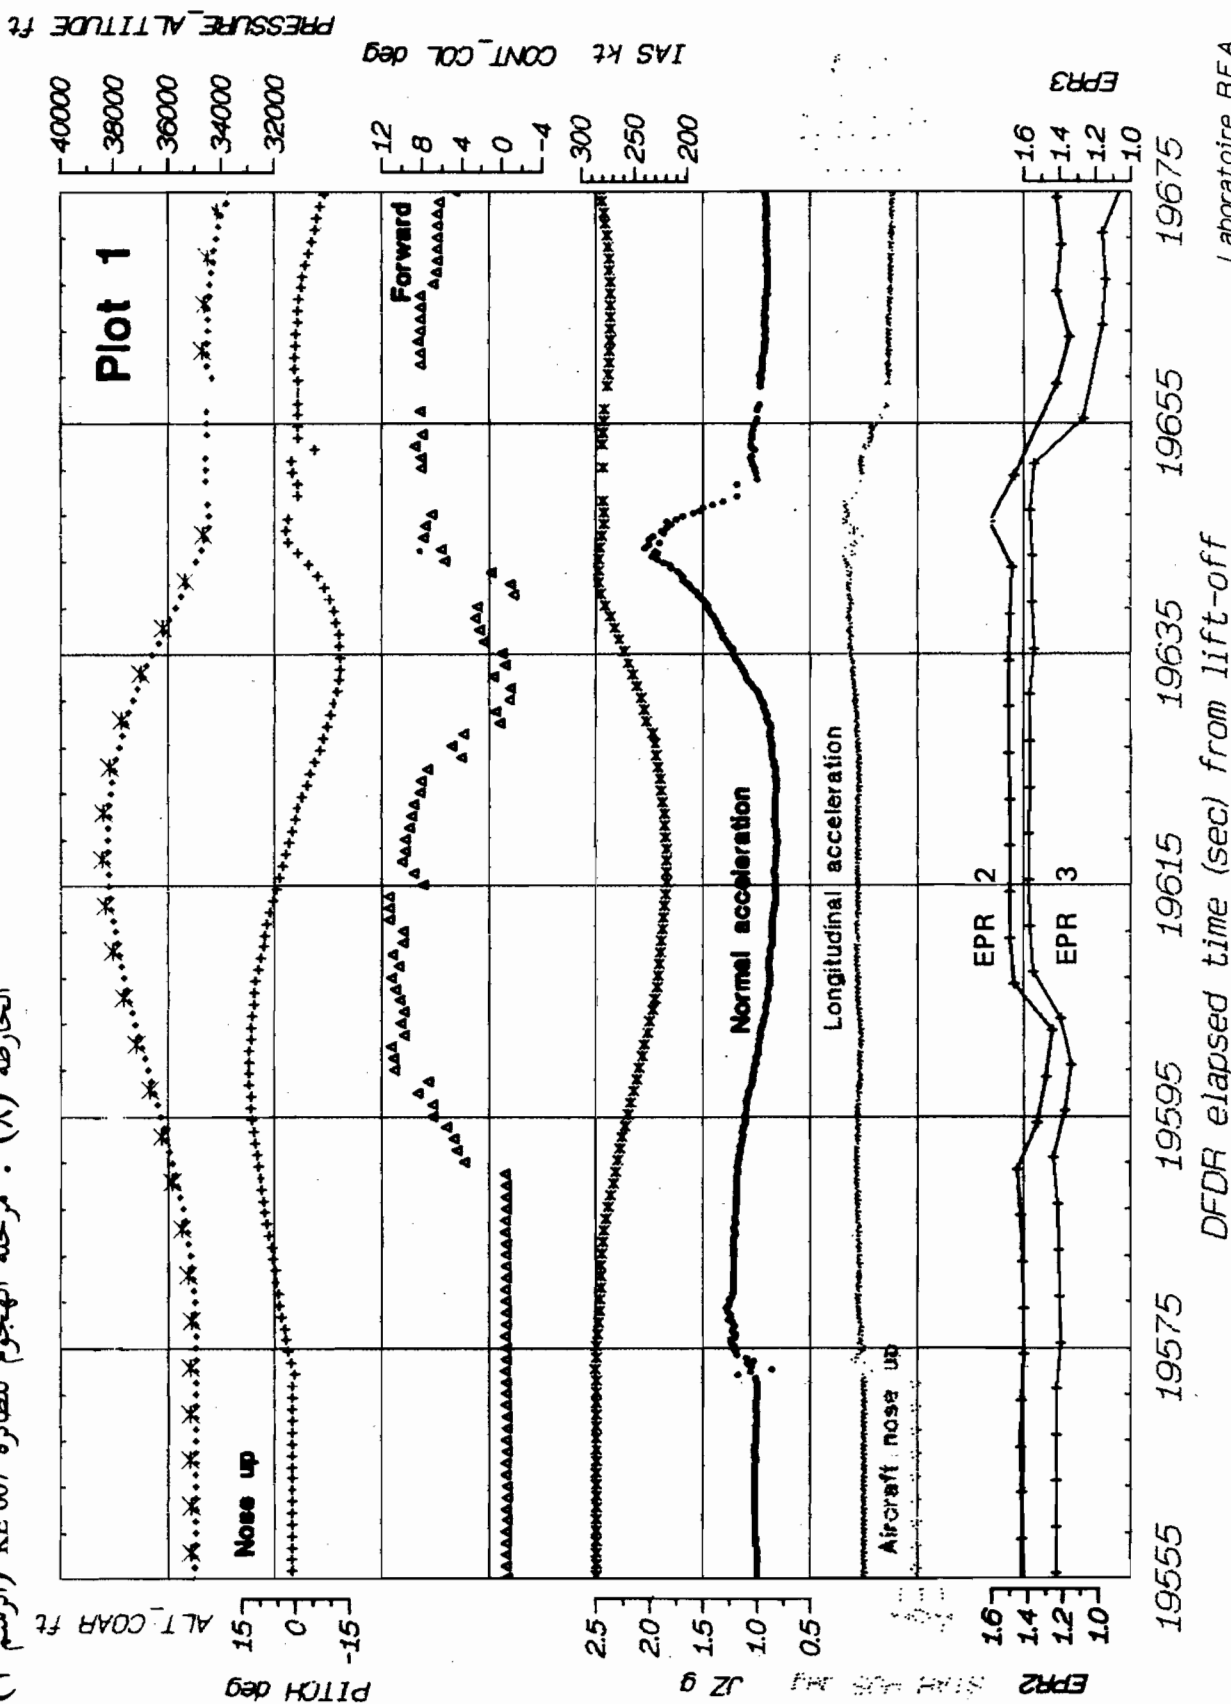
Chart 8. Flight KE 007 Attack Phase (Plot 1)  
 Graphique 8. Vol KE 007 - Phase d'attaque (graphie 1)  
 Carta 8. Fase de ataque al vuelo KE 007 (Trazado 1)  
 Карта 8. Этап атаки рейса KE 007 (график 1)  
 الخارطة (أ) : مرحلة الهجوم للطائرة KE 007 (الرسم 1)

1.14.3.10.1 The first abnormality associated with the missile attack was a momentary reduction in the background noise level on the Flight Engineer's audio channel of the CVR. Its duration was of the order of 0.02 seconds. The first of several bursts of noise was detected by the CAM 0.22 seconds later. At the same time, a loss of one zero bit in the recovered serial digital signal from the DFDR occurred. This most likely resulted from a momentary shock to the DFDR that caused a small disturbance in the tape motion.

1.14.3.10.2 Almost immediately, a vertical acceleration of 1.17 g was found as compared with 1.00 g recorded 0.25 seconds earlier. Within a further 0.03 seconds, a reasonable value of lateral acceleration was recorded as compared with obviously incorrect values which had been recorded up to 0.25 seconds earlier. Both these observations suggested that the accelerometer was subjected to a sudden vibration.

1.14.3.10.3 A maximum deflection of the rudder pedal was recorded after the vertical acceleration sample of 1.17 g, and subsequent values stayed constant at the maximum. A near neutral value had been recorded before the attack commenced. Based on a performance analysis of the aircraft's manoeuvres during the attack phase, this was caused by a failure of one of the two cables or their attachments that transmit the rudder pedal motion to the hydraulic actuators at the rear of the aircraft. In this event, the feel centring mechanism would have held the rudder in neutral.

1.14.3.10.4 The first sample of horizontal stabilizer angle recorded after the attack was well outside the maximum range of movement. The previous value had been normal. This change indicated either a failure associated with the transducer installation or an electrical fault in its output.

1.14.3.10.5 The bursts of noise on the CAM recording lasted over a period of 0.87 seconds and the background noise level returned to its pre-attack level 0.23 seconds later. The CVR noises and the initial events recorded on the DFDR were synchronized to within one second by correlation of autopilot disconnect signals with the associated audio warnings, and HF 1 transmit signals with the audio messages.

1.14.3.10.6 Initially the aircraft pitched up and the vertical acceleration increased to approximately 1.2 g over 3 to 5 seconds. There was no indication of control column movement. During this period, the aircraft rolled slightly right wing down. Autopilot A remained in the Command mode.

1.14.3.10.7 Eleven seconds after the CAM recorded the first sounds of the attack, the sound of the cabin altitude warning was heard. The vertical acceleration remained at approximately 1.2 g for about 17 seconds with the aircraft entering a climb at 7 000 ft/min. At this time, the autopilot tripped or was selected to OFF and the sound of the autopilot disconnect warning occurred. The control column then moved forward significantly.

1.14.3.10.8 From 17 to 40 seconds after the attack the aircraft continued to climb, though at a gradually reducing rate, and the vertical acceleration reduced through the 1 g level to 0.82 g. At the same time there was a reduction in the engine power settings. The aircraft also started to roll left wing down. At that point, a crew member reported that the speed brakes were coming out. Neither the vertical nor the longitudinal accelerations showed any evidence that this actually occurred. The indications of speed brake application available to the crew were the spoiler lever position and an amber master caution warning light.

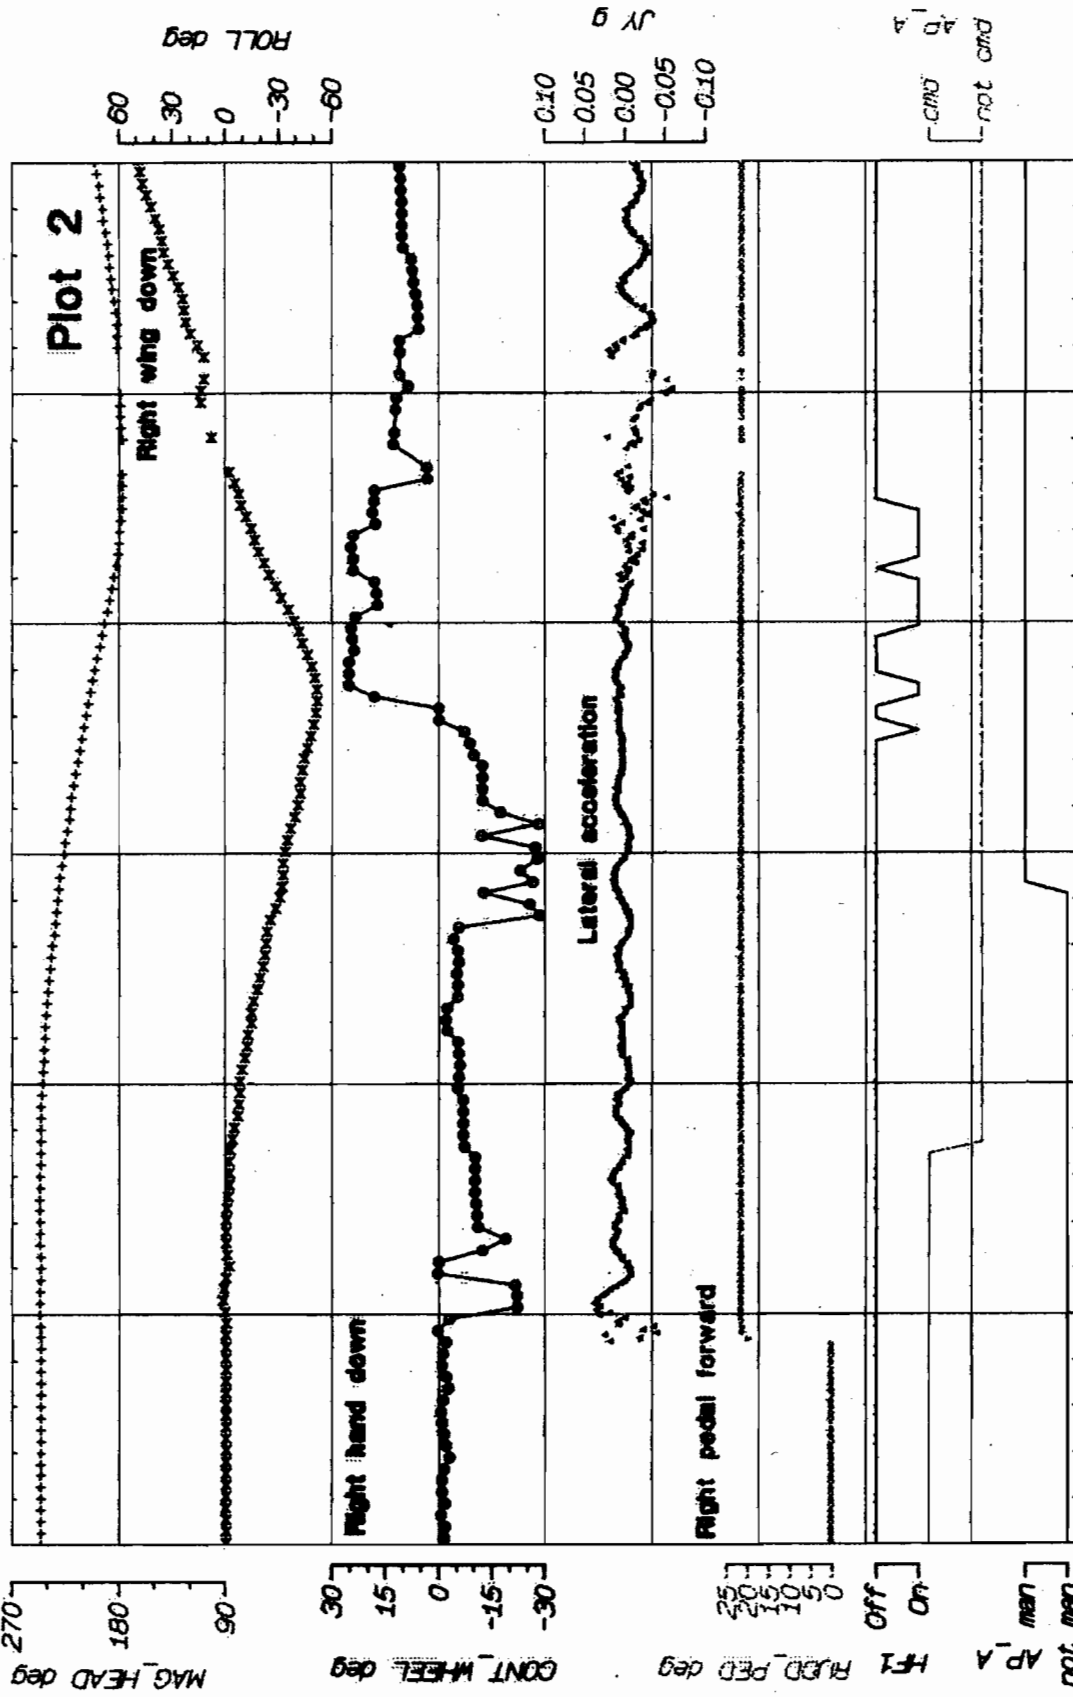
Chart 9. Flight KE 007 Attack Phase (Plot 2)

1.14.3.10.9 When the roll angle reached about 23°, larger erratic control wheel movements were recorded up to almost 30° left hand down, but there was no noticeable increase in the rate of roll to the left. The DFDR then indicated that autopilot A was selected to the Manual mode in which it remained for the rest of the recording. The DFDR may have recorded the position of the selector only. The selection was accompanied by the sound of a second autopilot disconnect warning.

1.14.3.10.10 The aircraft reached a maximum altitude of 38 250 ft with a reduction in calibrated airspeed from the initial 286 kt to 220 kt. As the aircraft started to descend, the control column first slowly and then more rapidly returned towards the neutral position; the vertical acceleration then increased significantly. For a short period, the rate of descent increased to over 12 000 ft/min and the speed increased to 284 kt. Simultaneously with the more rapid movements of the control column to neutral, the control wheel moved to 25° right hand down, the roll attitude reached 52° left wing down and then decreased.

1.14.3.10.12 The vertical acceleration increased to just over 2.0 g, at which level it started to fluctuate. With a forward movement of the control column, the aircraft recovered to level flight and rolled right wing down.

1.14.3.10.13 The recordings ceased simultaneously on both the DFDR and the CVR 104 seconds after the attack as the aircraft rolled through 49° right wing down on a magnetic heading of 200° at an altitude of 33 850 ft with a speed of 282 kt CAS and a rate of descent of about 5 000 ft/min.
