Safety Investigation Final Report

Serious Incident File No. 33-18

- TAKEOFF WITH WRONG WEIGHT PARAMETERS IN THE FMC -

Date	29.3.2018
Aircraft	B-787-9
Registration	4X-EDB
Location	Ben Gurion Airport

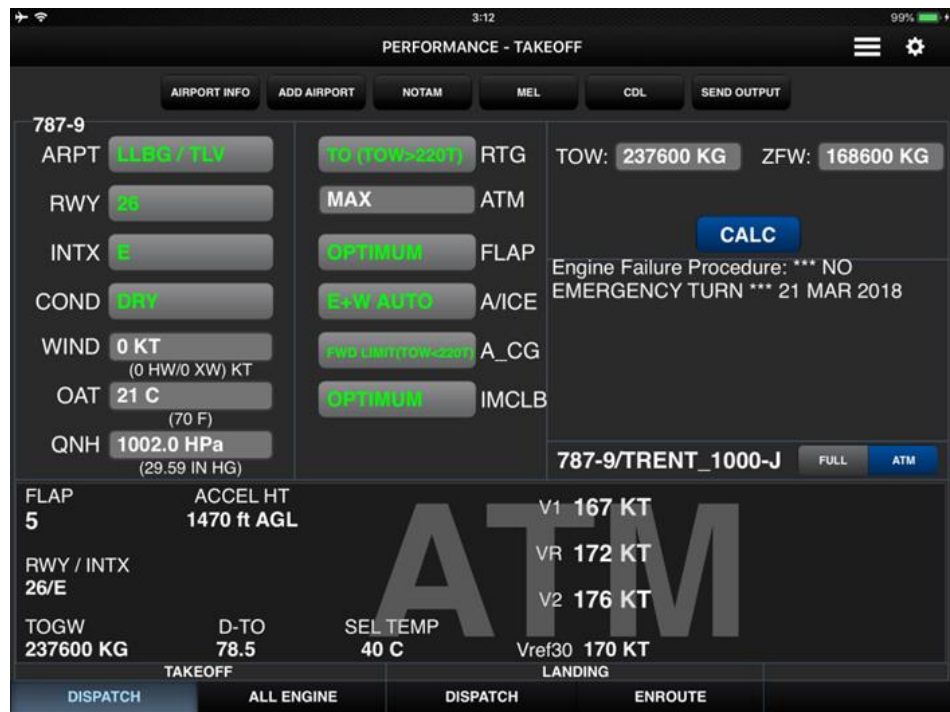
Correct computation according to true data

- General: The crew computed takeoff parameters based on a low weight. Consequently, the calculated thrust and speeds used for takeoff were substantially lower than required for the actual gross weight. On the other hand, the thrust setting and takeoff speeds were adequate for the gross weight used.
- Calculating too low thrust and speeds have a hazardous effect in several areas:
 - ✓ Acceleration substantially lower than required.
 - ✓ Reaching V1 decision speed at a runway point different than required.

2.1.1 Computed power and takeoff speeds – Correct data versus the crew calculations

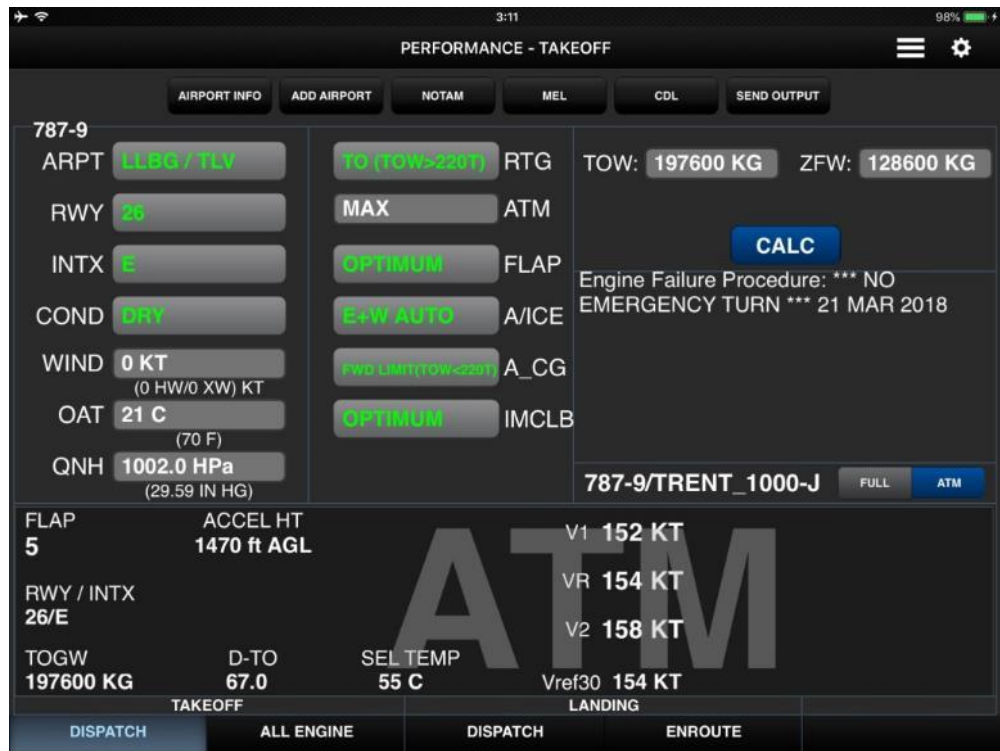
Computed parameters on which the takeoff was made

Comparison Table

FLAPS	SEL TEMP	TPR	V1****	VR	V2	Vref
TRUE	5	40	75	167	172	176	170
FALSE**	5	55	67***	152	154	158	154
MARGIN	0	15	8	15	18	18	16
NO IMPR.*	5	38	80	165	169	173	170
MARGIN*	5	17	13	13	15	15	16

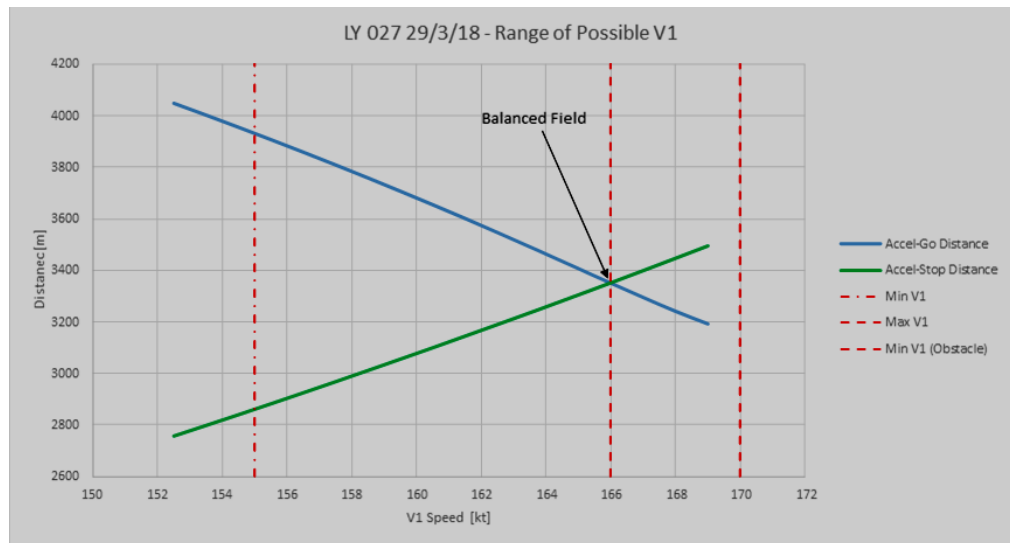
Theoretical takeoff performance for the true gross weight and required thrust

2.1.2 Takeoff speeds performance along the runway

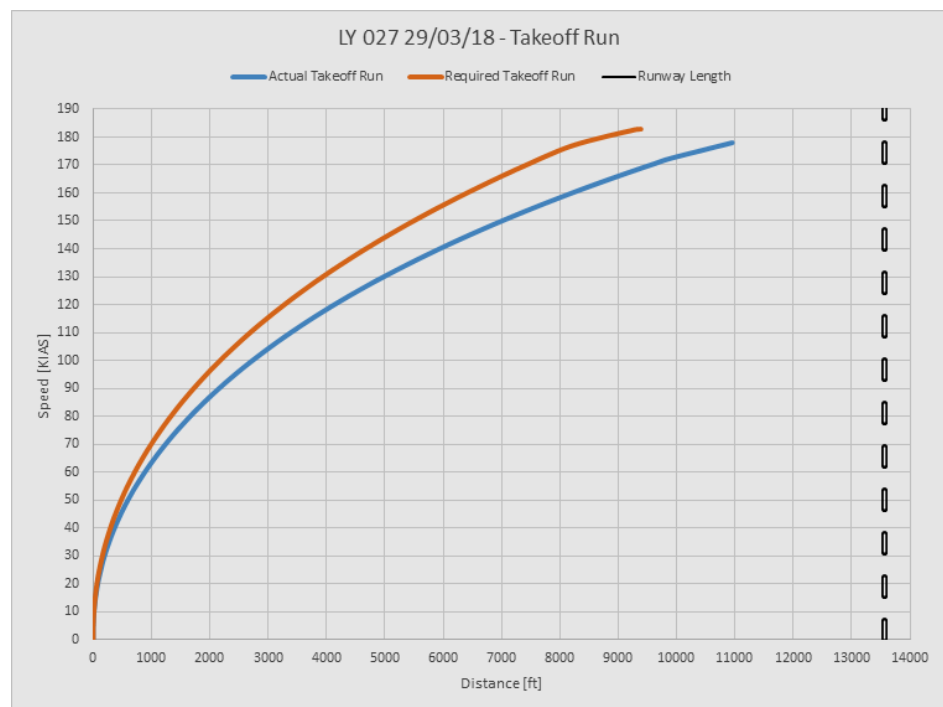
Comparison of the actual case to true weight requirement

Takeoff speed along the runway

Comparison of takeoff run distances (Feet)

V1	Vr
REQUIRED	7,000	7,400
ACTUAL	7,100	7,400

- From the point of perceiving distances along the runway, the crew was unable to detect the error.
- Acceleration was substantially slower than normal – 41 seconds from 30 knots to 154 knots, compared to 43 seconds from 30 to 180 knots, measured on a flight under similar conditions. None of the crewmembers noticed the slow acceleration.
