Investigation Report

5X004-0/01
April 2003

Kind of occurrence: Serious Incident
Date: 20. March 2001
Location: Frankfurt / Main
Type of aircraft: Transport category aeroplane
Manufacturer / Model: Airbus Industrie / A 320-200
Injuries to persons: no Injuries
Damage to aircraft: A/C not damaged
Other damage: none
Source of Information: BFU Investigation

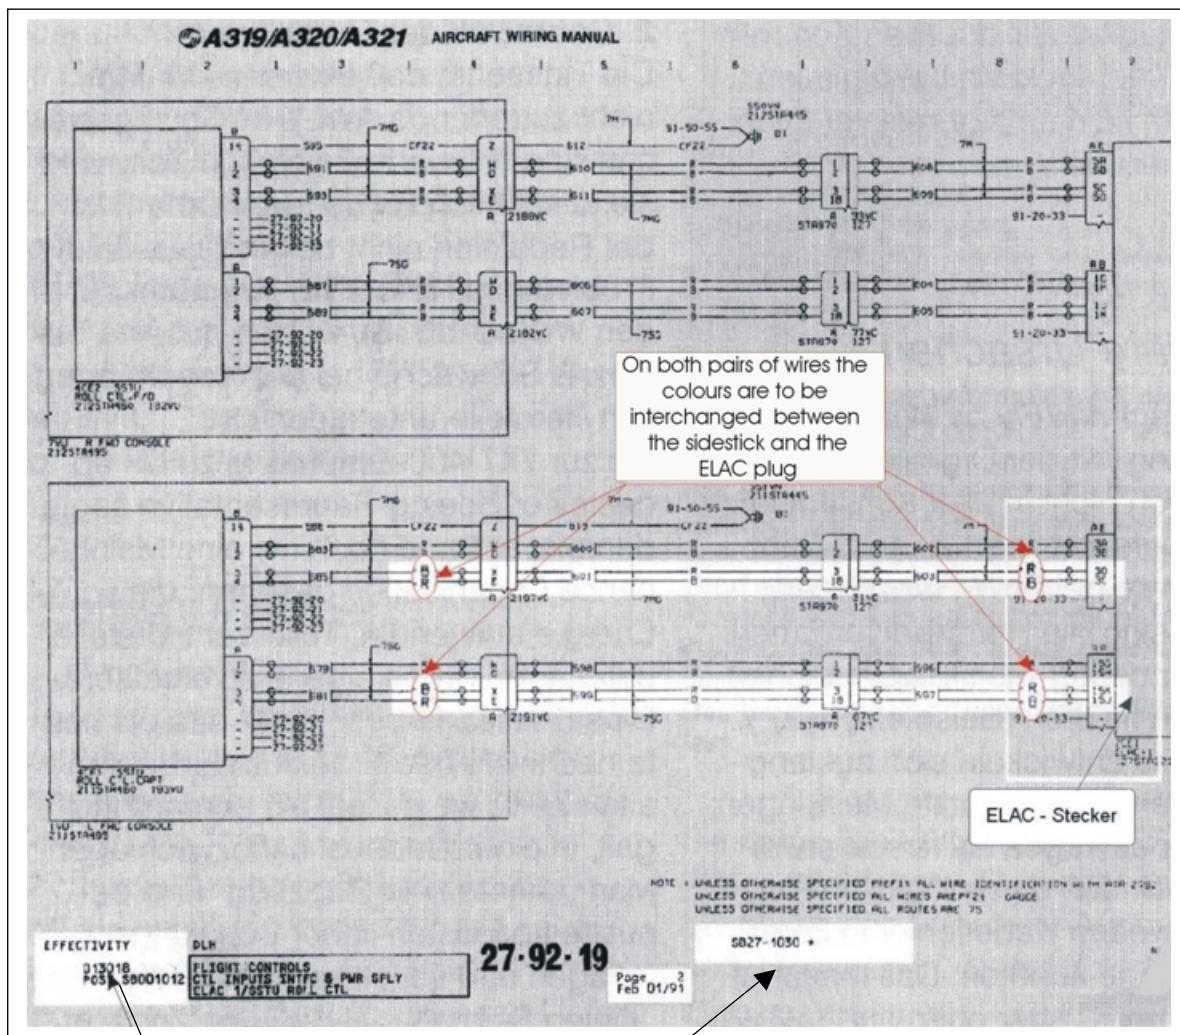
Page 2 of the AWM 27-92-19, Feb. 01/91 shows an effectivity range of 013 up to 018 (bottom left). The designation **POST SB001012** below the effectivity range **013018** on the bottom left means that this WD applies only to aeroplanes whose effectivity is within the range of **001 to 012**, if the **SB27-**

1030 has been accomplished; the accomplishment being indicated on the bottom right. The aeroplane concerned had the effectivity 017 and the SB 27-1030 had not been accomplished, therefore page 2 was applicable.

This page is applicable to all aeroplanes with an effectivity range of 013 to 018 and 001 to 012, provided on the latter the SB27-1030 has been accomplished.
