Investigation Report

AX001-1-2/02
May 2004

Kind of occurrence: Accident
Date: 1 July 2002
Location: (near) Ueberlingen/Lake of
Constance/Germany
Type of aircraft: Transport Aircraft
Manufacturer/Model: 1. Boeing B757-200
2. Tupolev TU154M
Injuries to persons: 71 fatalities
Damage to aircraft: Both aircraft destroyed
Other damage: Damage to open field and forest
Source of Information: BFU Investigation

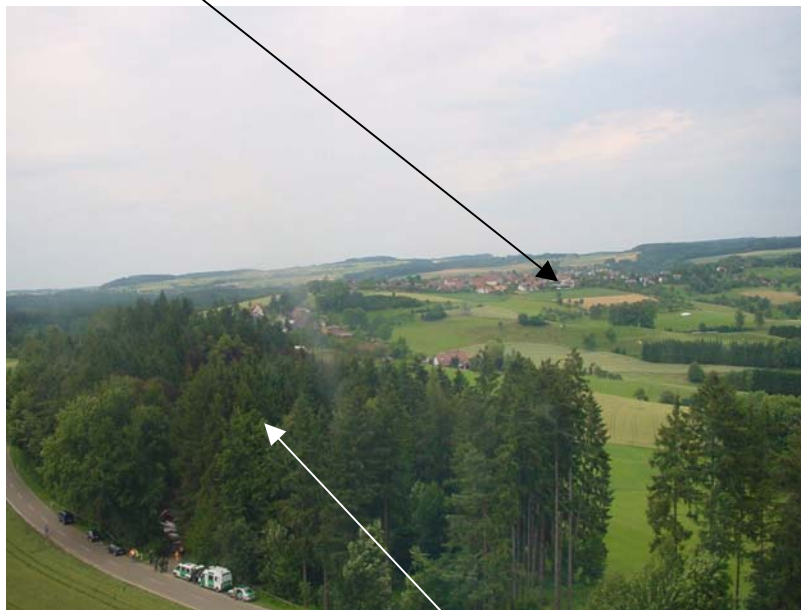
Main wreckage

The main wreckage of the B757-200 was found approximately 1 km west-south-west of the village of Taisersdorf, eastward of the street K 7788 in a mixed forest. The accident site covered an area of 110 m x 30 m.

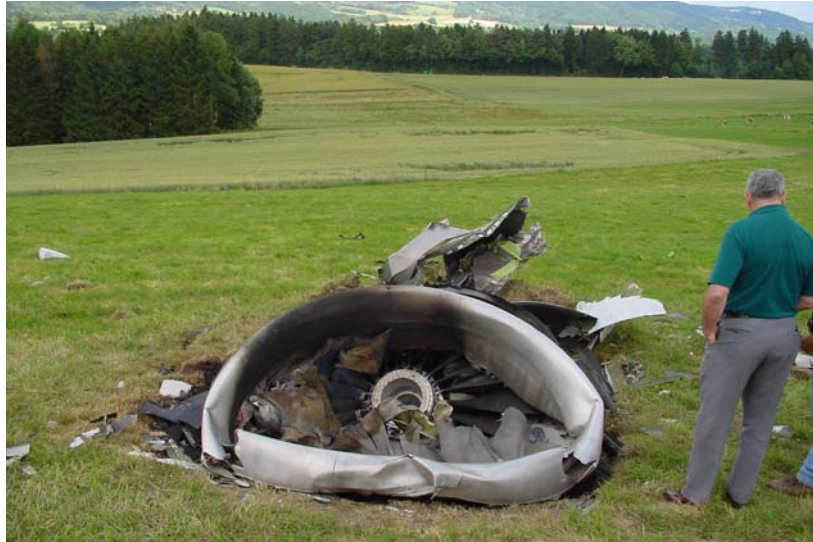
The right engine had crashed on a meadow 250 m west and the left powerplant in a corn field 300 m southwest of the main wreckage. Both engines showed traces of fire caused by the burning of the remaining fuel in the fuel systems. Both engines had penetrated the ground to such an extent that they were almost level with the surface. They exhibited significant mechanical damage.

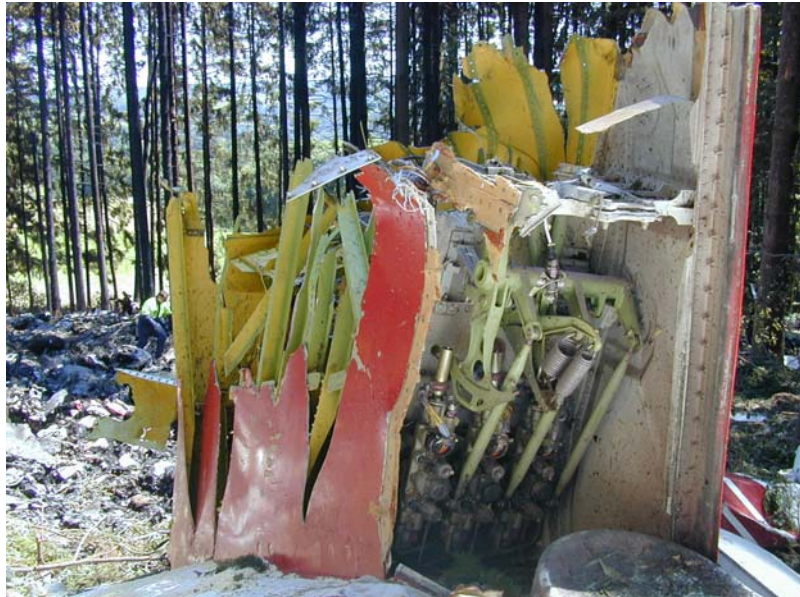
The left side of the skin was torn off in several pieces to the rear left.

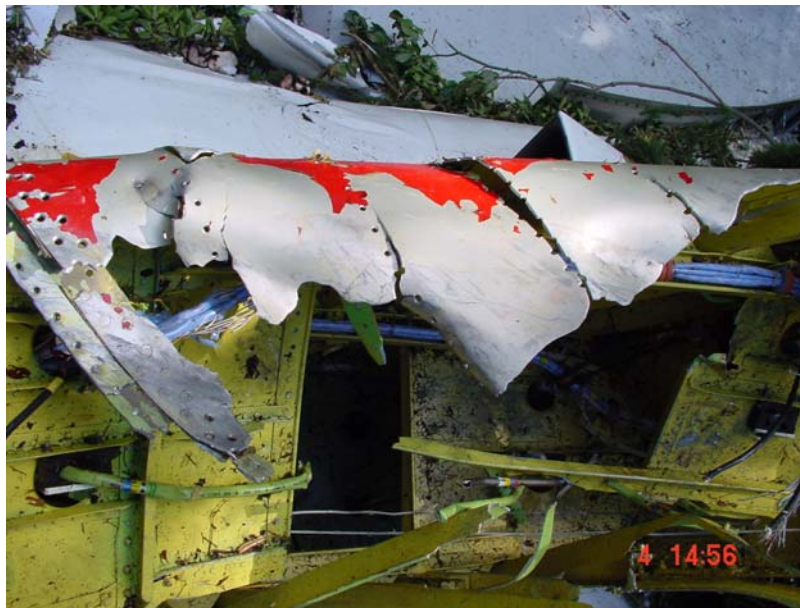
The top of the right side was bent to the rear left.

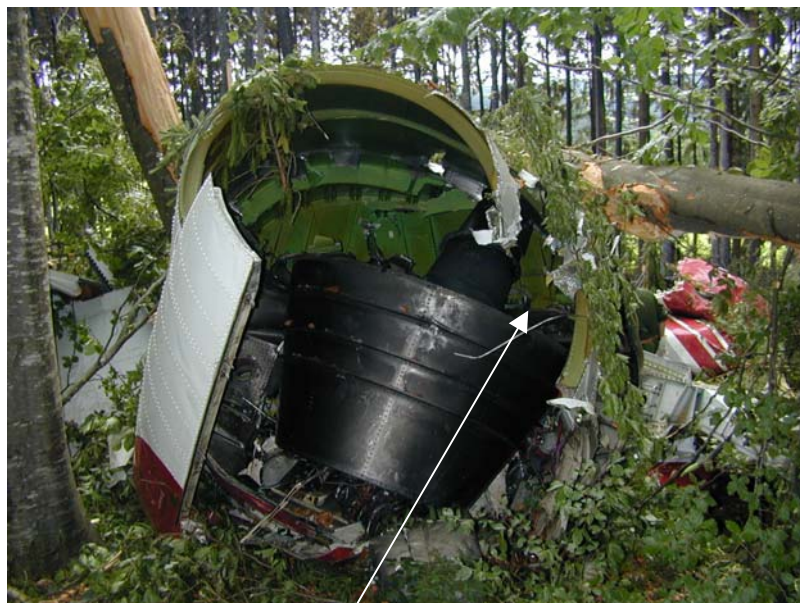
exhaust of APU

The APU access doors were present. The APU was torn off its bracings.

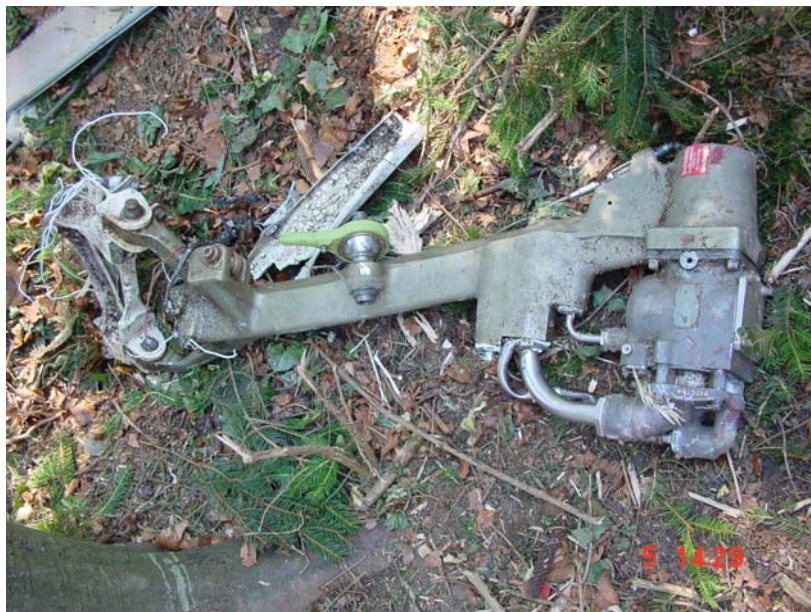
ram air turbine without propeller

The ram air turbine (RAT) was found almost undamaged and without any traces of fire.

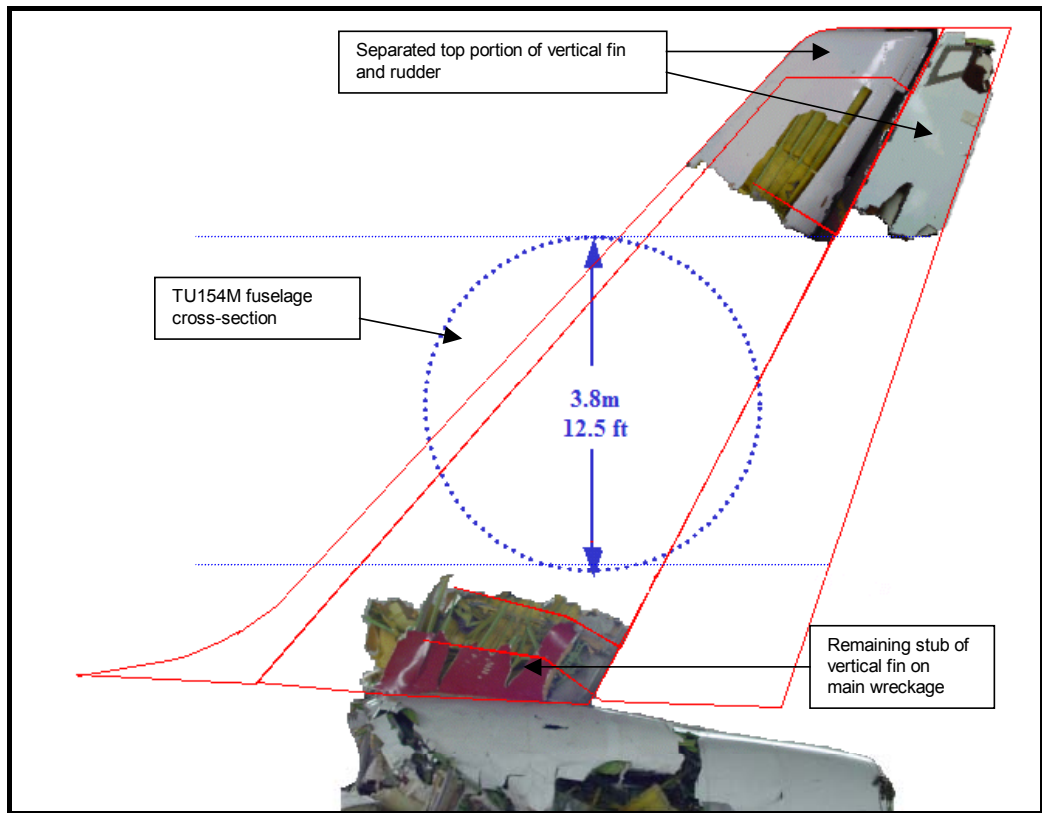
- On collision, the airplane lost about 80% of the vertical tail. The manufacturer stated that the loss caused the airplane to become aerodynamically unstable in the yaw axis.

B757-200 damage on vertical tail in relation to cross-section of TU154M

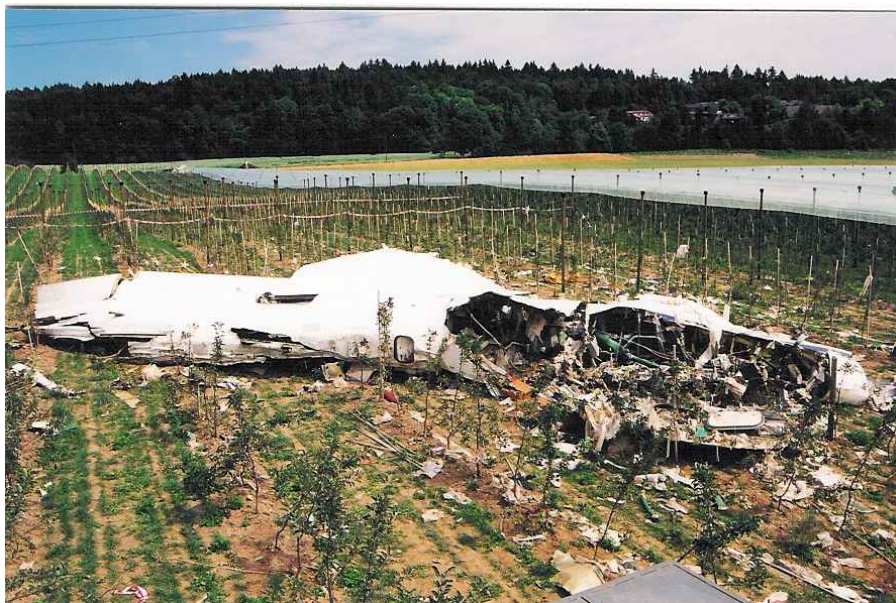
overall view – forward section of the aircraft fuselage

The forward fuselage section had crashed in the area of Brachenreuthe in level terrain (apple plantation) immediately south of a power line running in a direction of 290° and 20 m north of a paved field path. The wreckage part with a total length of about 19 m was lying on its left side. It had been separated in the area of the 41st frame of a total of 83 frames and pointed in the direction of 127°. The fuselage frames were broken. The skin on the bottom was torn open over a length of 9 m. The skin on top of the fuselage had burst open in two areas in longitudinal direction. The fuselage had been flattened to about half of its original diameter of 3.80 m.

Evidence of fire or collision evidence was not found.

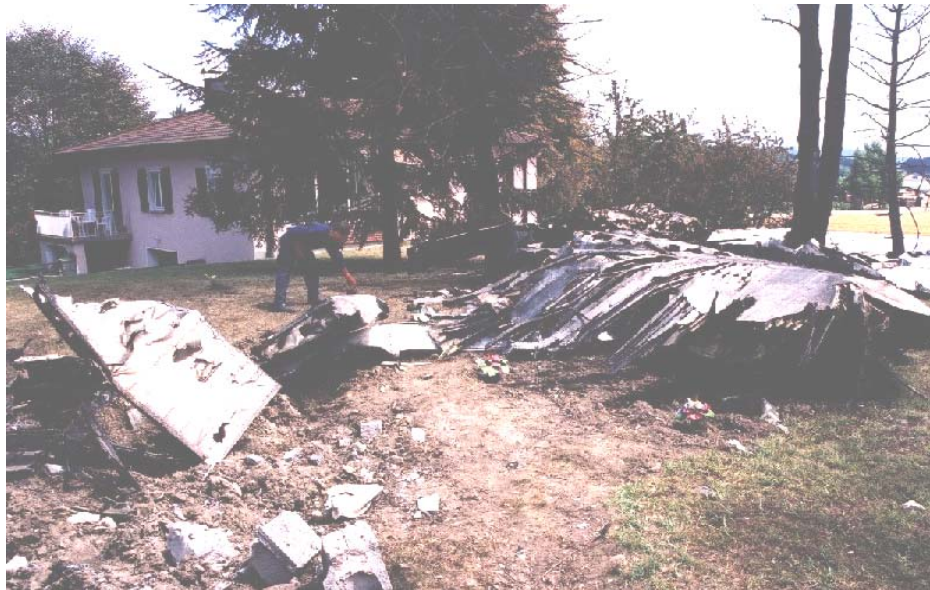
Left wing

The connection of left wing and centre wing section consisted of the trailing edge in the area of the inboard flap and hydraulic lines. The wing was found at a residential garden at a level higher than and at a distance of about 10 m from the house. The wing had been separated from the leading edge in a transversal line in the direction of the fuselage. The point of rupture is located between wing root and inboard slat. Some parts of this wing area were not present.

The fire melted the outer third of the wing. The completeness of the wing, however, could be told by its outlines which included the wing tip.

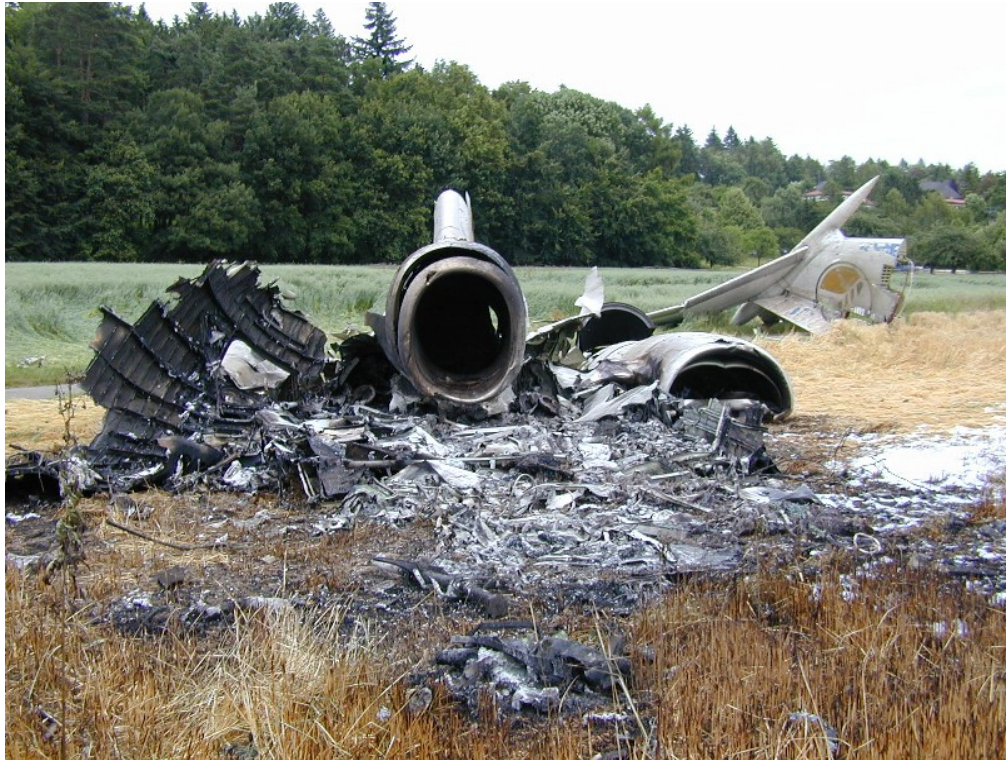
overall view – rear fuselage section/tail unit

The rear fuselage had on the left side broken off at frame 56 and on the right side at frame 52. It was destroyed by fire and impact forces and pointed into the direction of 235°.

No collision evidence was found on the leading edges of the vertical fin and horizontal stabilizer and at the air intakes of the three engines.

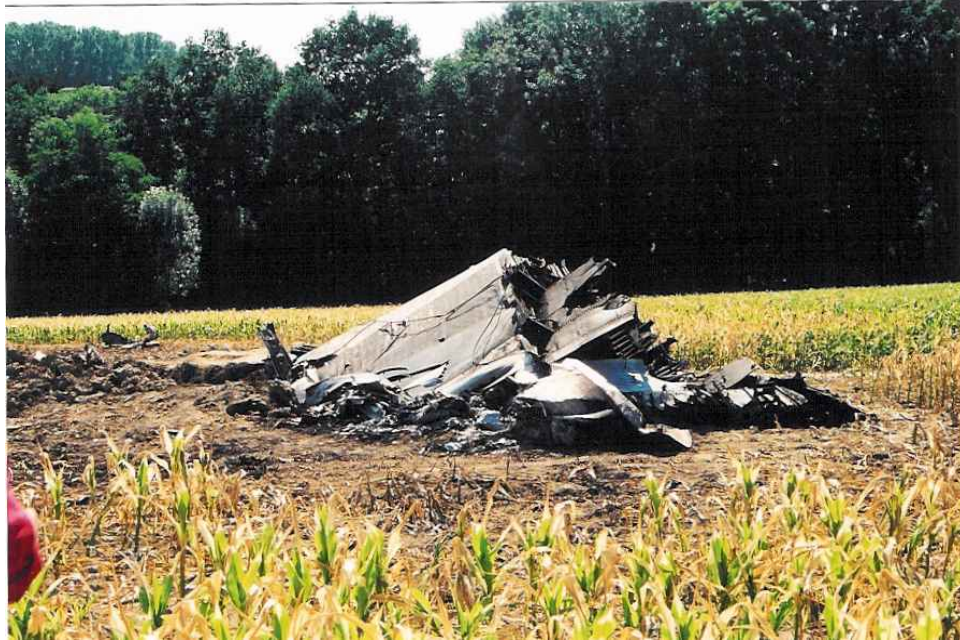
overall view – right wing

The wreckage part was found in a corn field some 800 m south of the accident site of the fuselage and some 30 m west of the district road 7786 north of the village Aufkirch. Leaking and burning fuel affected the plants in a radius of 15-20 m around the crash site. The plants showed a brownish colour.

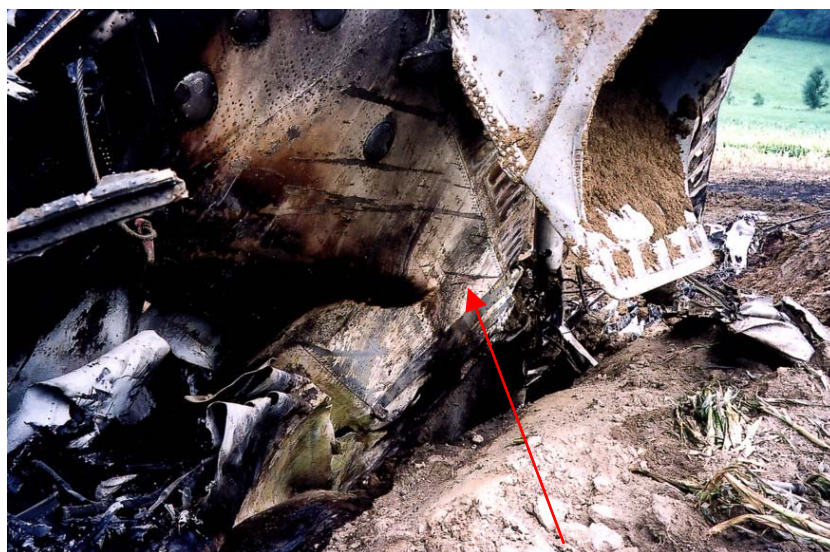
The ditch caused by the impact had a length of about 18 m and pointed into the direction of 228°. The inner section of the wing from the wing root to the main landing gear stuck 3.5 m deep in the earth. Most of the outer section of the right wing from the main landing gear to the wing tip had been destroyed by the fire except for the leading edge and the slats. A 6 m long wreckage part of the right wing's upper surface including the remains of the registration marks was found some 20 m from the wing's crash site. On the wing's lower surface between the wing root and the main landing gear scratch marks of about 3.6 m length and 0.9 m width and red paint transfer were found. The flap track and carriage of the inner flap, one landing gear door and the rear part of the main landing gear fairing were missing.

lower surface of the right wing with scratch marks

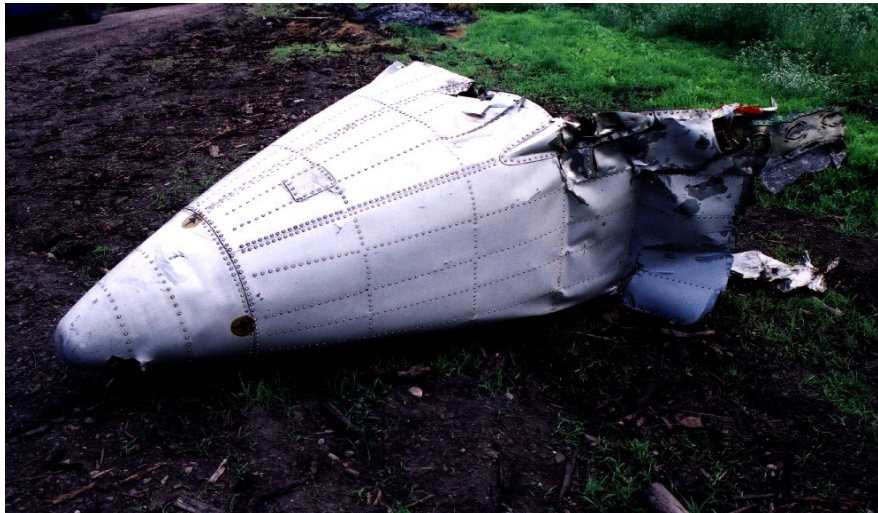
Fairing of right main landing gear

A 2.80 m long part of the TU154M's fairing of the right main landing gear was found 1 kilometre west of Steinhöfe. It showed traces of red paint and remains of the honeycomb structure of the B757-200.

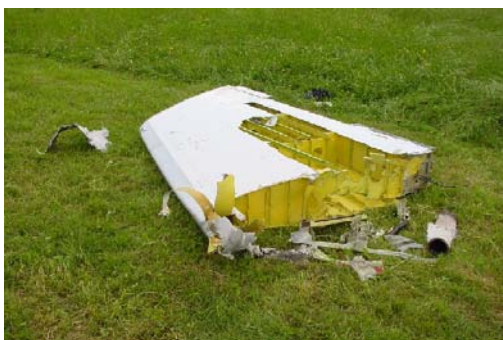
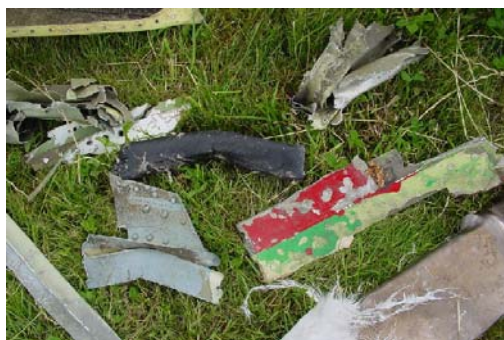
West of Altheim, debris of both airplanes was found on an area of about 4 km². The top part of the B757-200's vertical stabilizer was found in the immediate vicinity of two parts of the Tu-154's left wing leading edge of about 30 cm in width each.

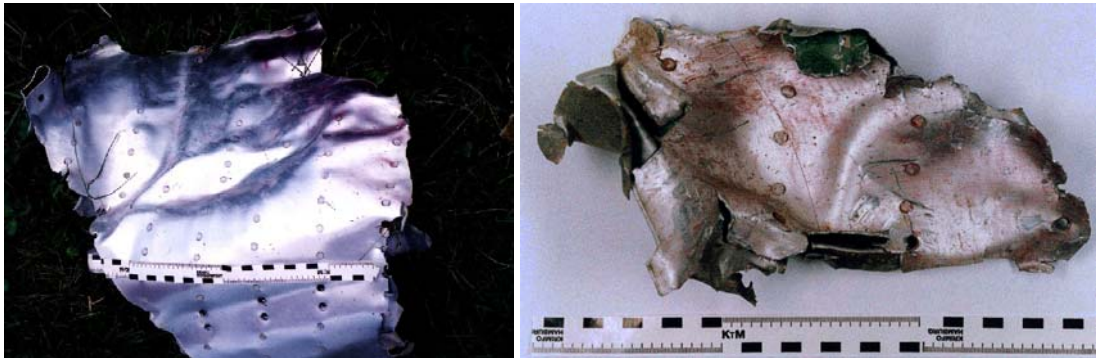
On the left wing collision traces between the wing root and the inboard slat were found. The fragments of the wing leading edge showed traces of red paint.

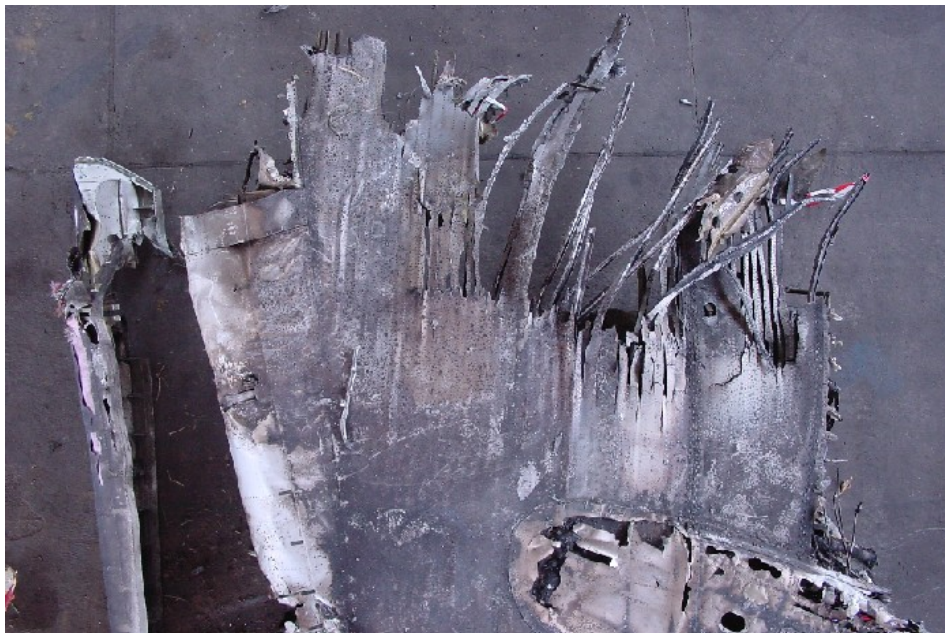
The wing including the wing spars had been severed by the collision. At the point of rupture the stringers of the wing were bent rearwards.

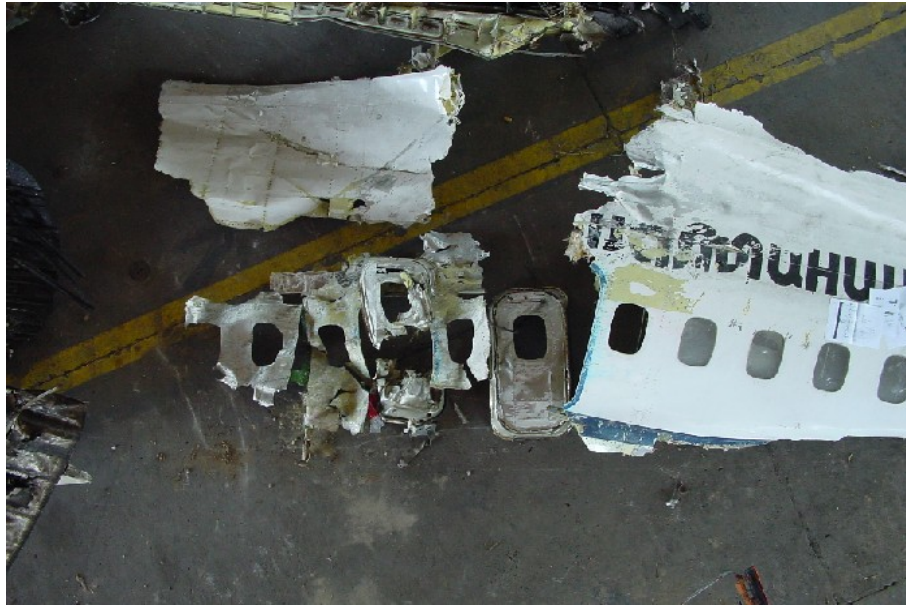
The area of both overwing emergency exits on the left side of the fuselage was smashed. Scratch marks, an extensive paint scrape-off and traces of red paint were found.

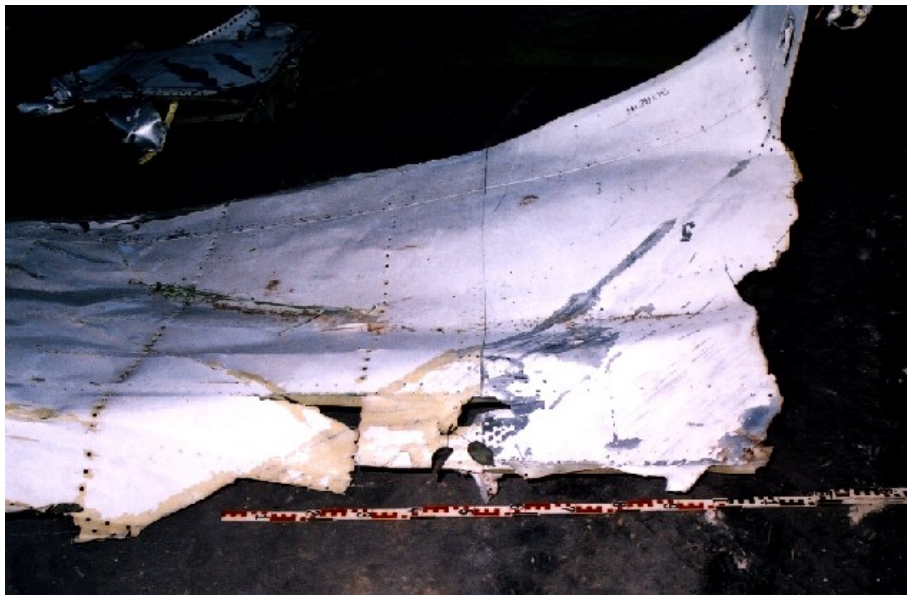
The angle between the scratch marks found on parts of the fuselage roof and the TU154M's longitudinal axis was 46° .

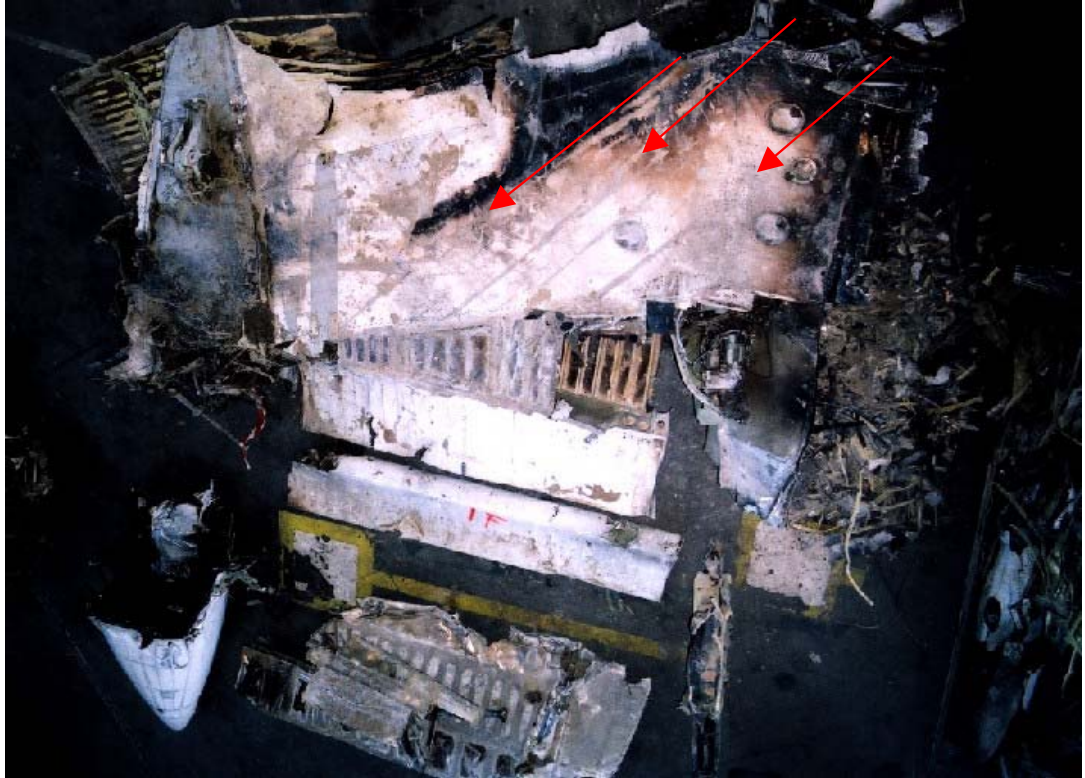
On the right wing's lower surface several parallel scratch marks of 3.60 m maximum length and 0,90 m width were found. They ran at an angle of 46° to the airplane's longitudinal axis into the direction of the right main landing gear. Traces of red paint were also found in this area.

right wing lower surface with traces of the collision

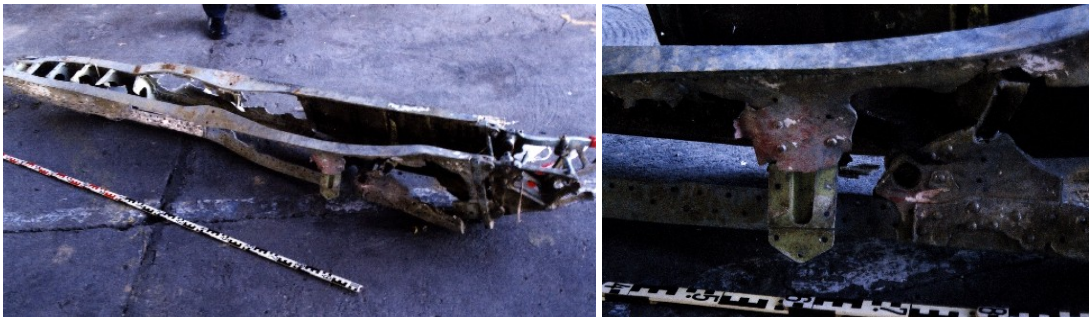
On the inboard side of the flap trap and carriage originating from the right wing, mechanical deformations and traces of red paint were found.

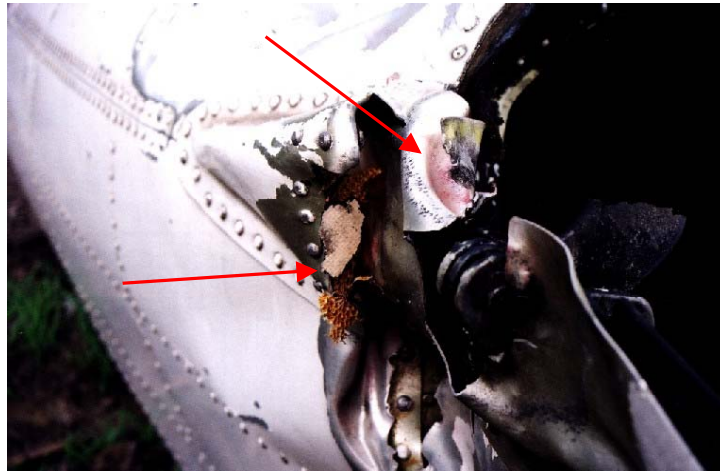
On the rear part of the fairing of the right main landing gear which had also been separated from the wing, traces of red paint and remains of the honeycomb structure of the B757-200 rudder were found.

Red paint and debris of the B757-200
