National Transportation Safety Board
Investigative Update
Southwest Airlines Flight 1380 Engine Failure

DCA18MA142 SWA1380 INVESTIGATIVE UPDATE

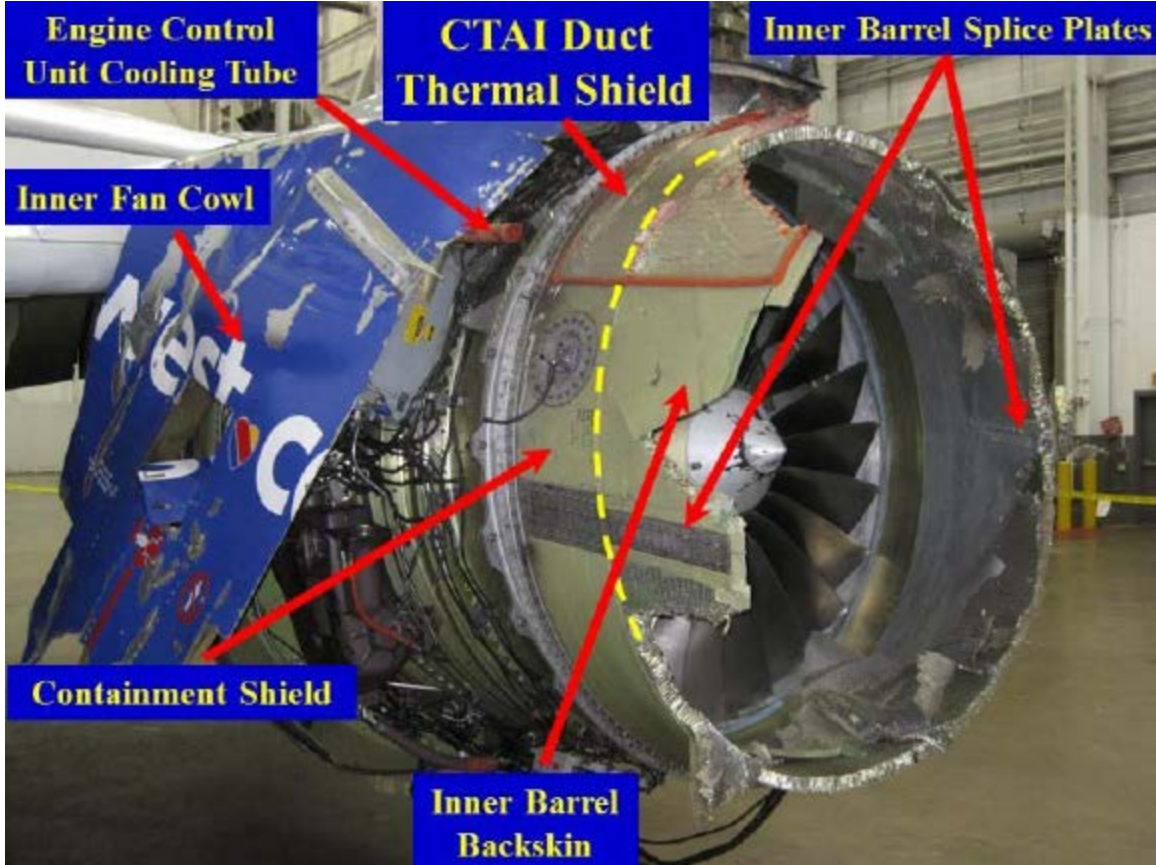
Initial examination of the airplane revealed that the majority of the inlet cowl was missing, including the entire outer barrel, the aft bulkhead, and the inner barrel forward of the containment ring. The inlet cowl containment ring was intact but exhibited numerous impact witness marks. Examination of the fan case revealed no through-hole fragment exit penetrations; however, it did exhibit a breach hole that corresponded to one of the fan blade impact marks and fan case tearing. (See figure 1.)

Figure 1. Damage to cowl - inboard

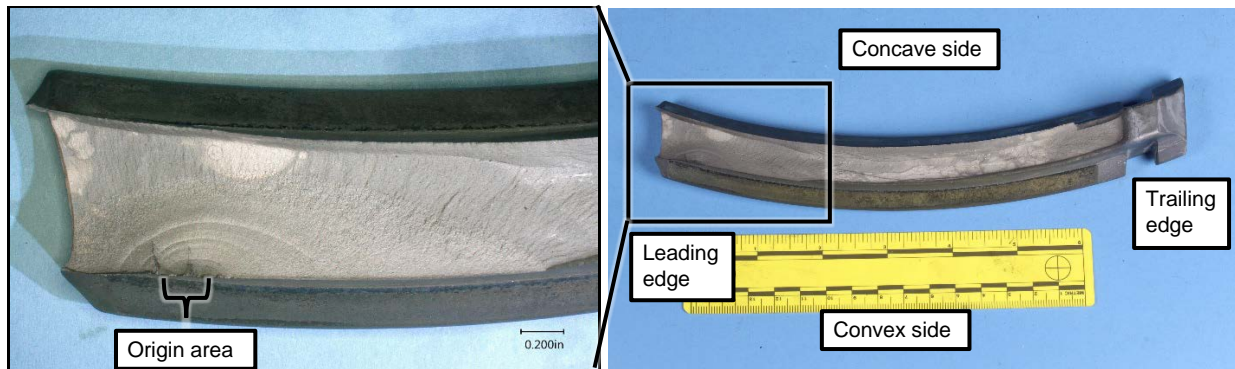
The No.13 fan blade had separated at the root; the dovetail remained installed in the fan disk. Examination of the No. 13 fan blade dovetail exhibited features consistent with metal fatigue initiating at the convex side near the leading edge. Two pieces of fan blade No. 13 were recovered within the engine between the fan blades and the outlet guide vanes. One piece was part of the blade airfoil root that mated with the dovetail that remained in the fan disk; it was about 12 inches spanwise and full width and weighed about 6.825 pounds. The other piece, identified as another part of the airfoil, measured about 2 inches spanwise, appeared to be full width, was twisted, and weighed about 0.650 pound. All the remaining fan blades exhibited a combination of trailing edge airfoil hard body impact damage, trailing edge tears, and missing material. Some also exhibited airfoil leading edge tip curl or distortion. After the general in-situ engine inspection was completed, the remaining fan blades were removed from the fan disk and an ultrasonic inspection was performed consistent with CFM International Service Bulletin 72-1033. No cracks were identified on the remaining blades.

The No. 13 fan blade was examined further at the NTSB Materials Laboratory; Figure 2 shows a portion of the blade in detail. Fatigue fracture features emanated from multiple origins at the convex side and were centered about 0.568 inch aft of the leading edge face of the dovetail and were located 0.610 inch outboard of the root end face. The origin area was located outboard of

the dovetail contact face coating, and the visual condition of the coating appeared uniform with no evidence of spalls or disbonding. The fatigue region extended up to 0.483 inch deep through the thickness of the dovetail and was 2.232 inches long at the convex surface. Six crack arrest lines (not including the fatigue boundary) were observed within the fatigue region. The fracture surface was further examined using a scanning electron microscope, and striations consistent with low-cycle fatigue crack growth were observed.

Figure 2. Fracture surface with fatigue indications

On April 20, 2018, CFM International issued Service Bulletin 72-1033 applicable to CFM International CFM 56-7B-series engines recommending ultrasonic inspections of all fan blades on engines that have accumulated 20,000 engine cycles and subsequently at intervals not to exceed 3,000 engine cycles.

On April 20, 2018, the FAA issued emergency AD (EAD) 2018-09-15 based on the CFM International service bulletin. The EAD required CFM56-7B engine fleet fan blade inspections

for engines with 30,000 or greater cycles. The EAD required that within 20 days of issuance that all CFM56-7B engine fan blade configurations to be ultrasonically inspected for cracks per the instructions provided in CFM International SB 72-1033, and, if any crack indications were found, the affected fan blade must be removed from service before further flight. On the same day, EASA also issued EAD 2018-0093E (superseding EASA AD 2018-0071) that required the same ultrasonic fan blade inspections to be performed.

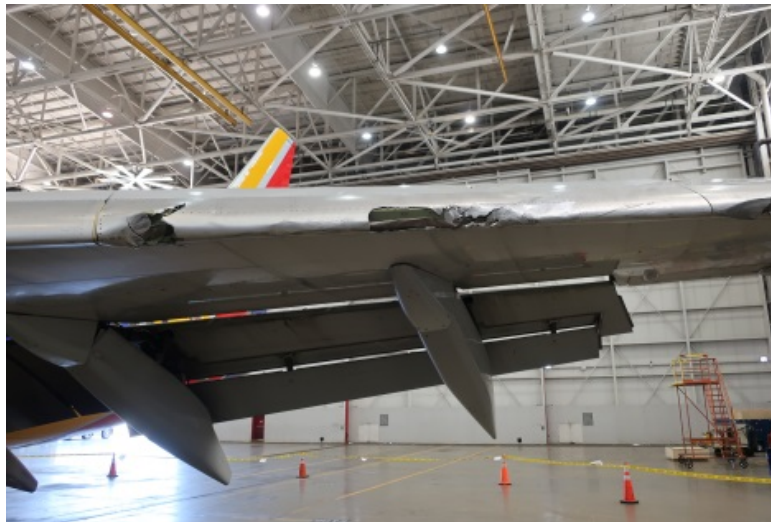
The remainder of the accident airplane's airframe exhibited significant impact damage to the leading edge of the left wing, left side of the fuselage, and left horizontal stabilizer. (See figure 3.) A large gouge impact mark, consistent in shape to a recovered portion of fan cowl and latching mechanism, was adjacent to the row 14 window (see figure 4; the window was entirely missing. No window, airplane structure, or engine material was found inside the cabin.

Figure 3. Damage to leading edge of left wing

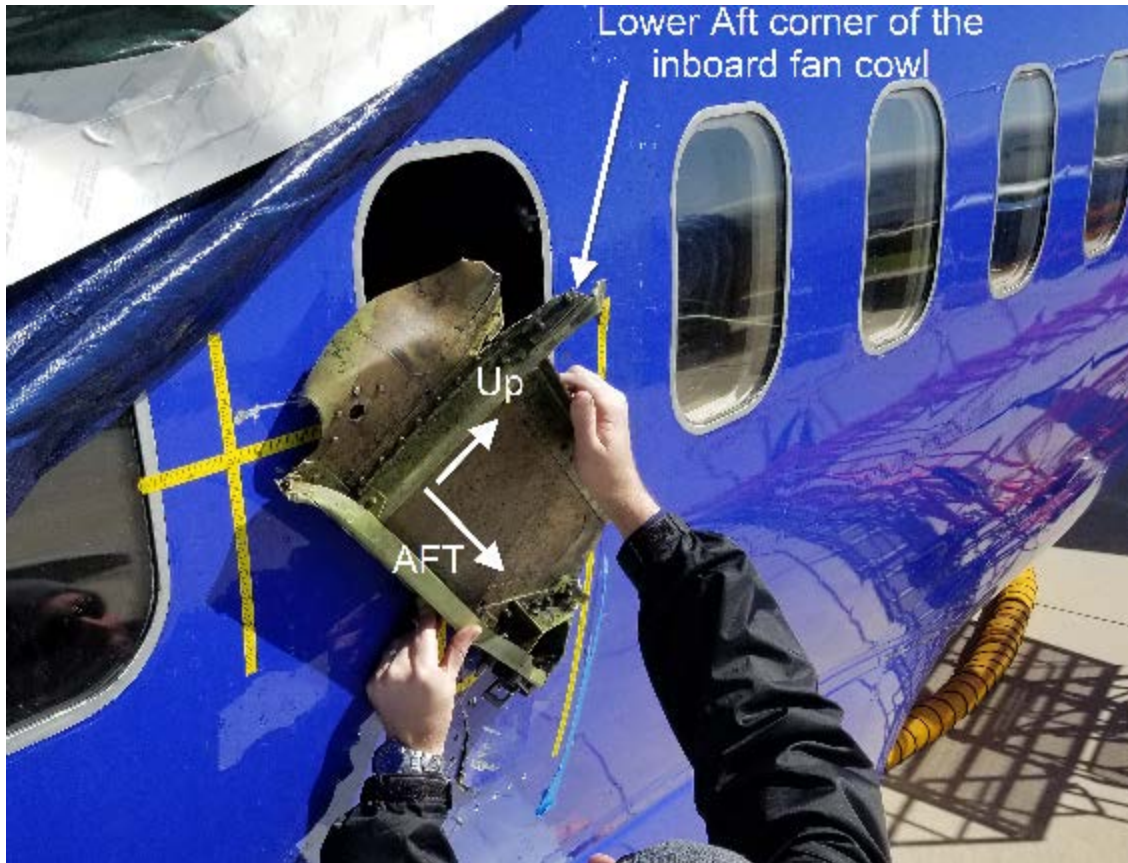
Figure 4. Picture of window 14 with portion of engine inboard fan cowl.
