# Interim Report

Accident on **27 November 2008**  
off the coast of **Canet-Plage (66)**  
to the **Airbus A320-232**  
registered **D-AXLA**  
operated by **XL Airways Germany**

**BEA**

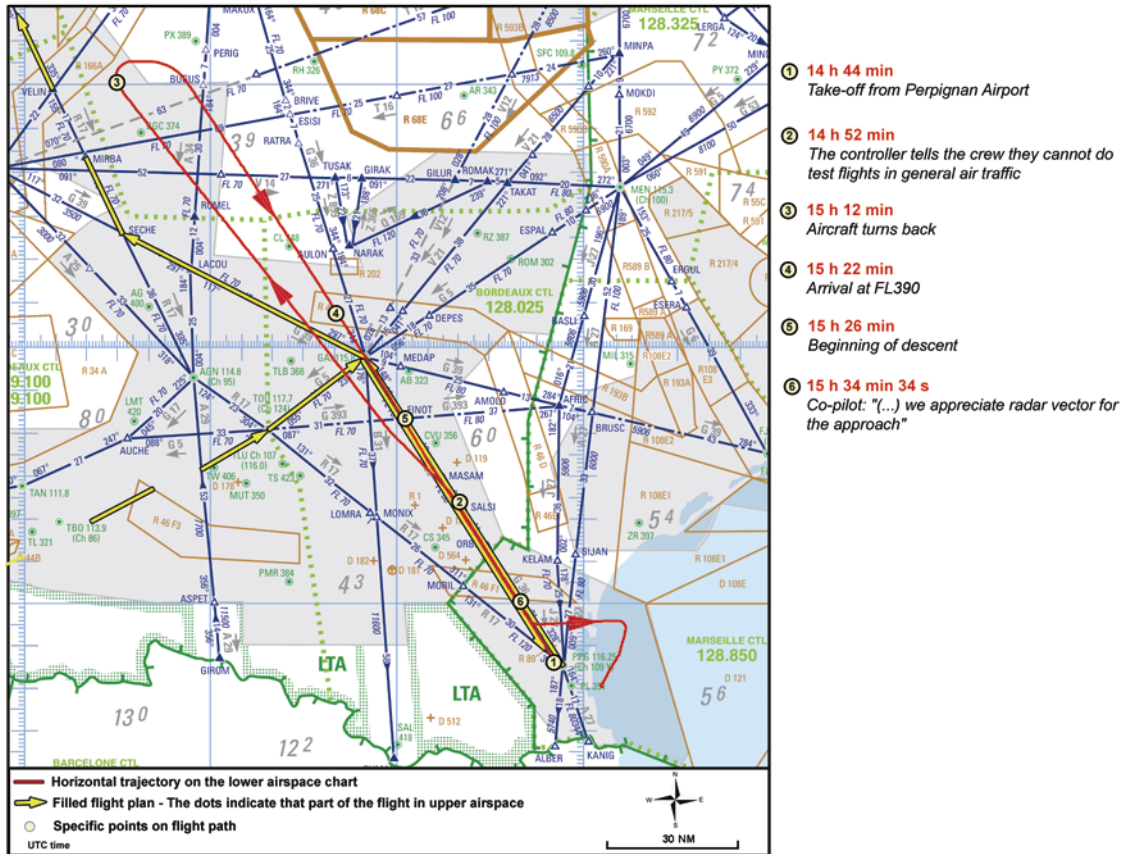
- ① 14 h 44 min  
Take-off from Perpignan Airport
- ② 14 h 52 min  
The controller tells the crew they cannot do test flights in general air traffic
- ③ 15 h 12 min  
Aircraft turns back
- ④ 15 h 22 min  
Arrival at FL390
- ⑤ 15 h 26 min  
Beginning of descent
- ⑥ 15 h 34 min 34 s  
Co-pilot: "(...) we appreciate radar vector for the approach"

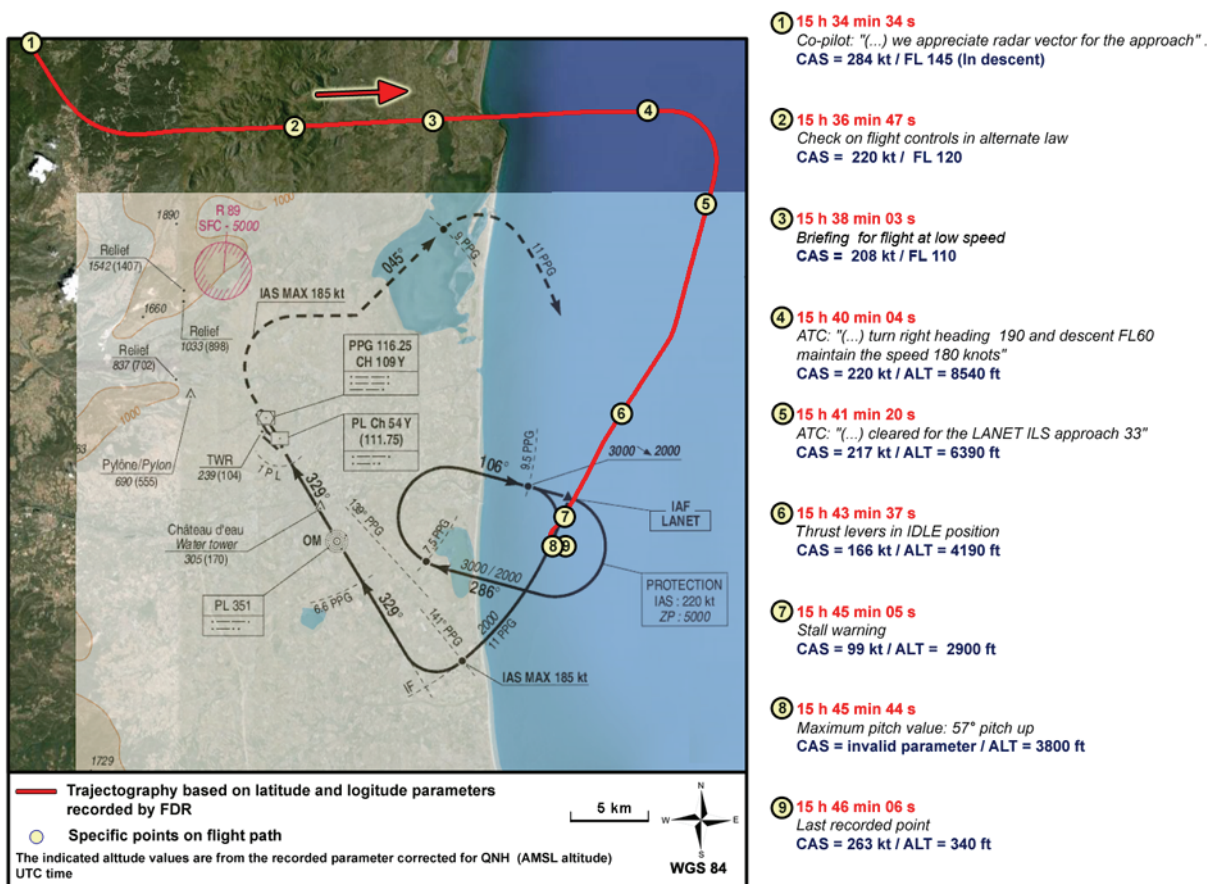
The following horizontal flight trajectory was made based on data from the FDR and the CVR.
