# Interim Report n°3

On the accident on **1<sup>st</sup> June 2009**  
to the **Airbus A330-203**  
registered **F-GZCP**  
operated by **Air France**  
**flight AF 447 Rio de Janeiro - Paris**

**BEA**

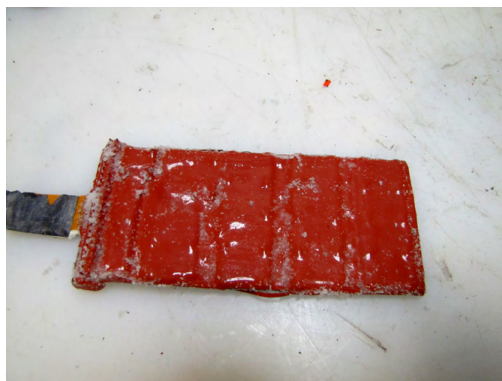
The memory board was cleaned. Visual inspection did not reveal any damage to the board. The board was placed in an oven for 36 hours in order to remove the moisture in the components and the printed circuit board. The impedance measurements that were then made on the input connector were in accordance with the measurements made on reference units.

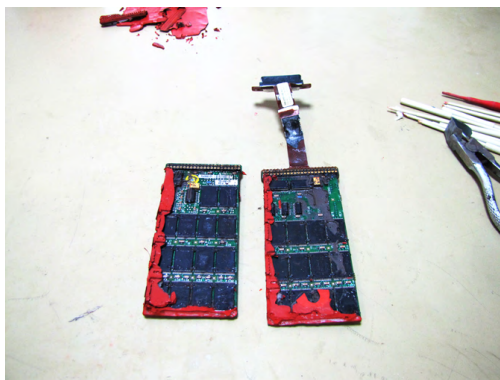
*CVR memory boards after cleaning*

Visual inspection of the boards revealed damage: a capacitor and a resistor were cracked on one of the boards; two decoder-type components were damaged on the other board.

The boards were placed in an oven for 42 hours. The damaged components were unsoldered and replaced. The impedance value measured at the input connector complied with the measurements made on reference boards.

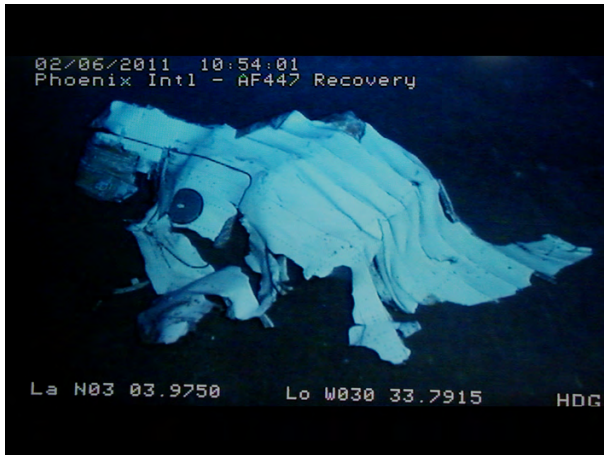
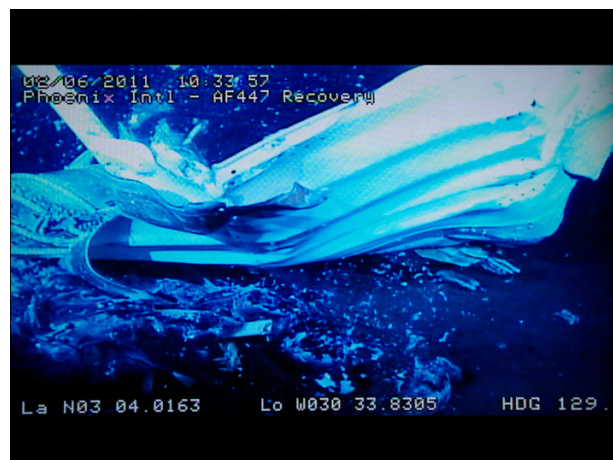
The lower elements of the fuselage were badly broken up and deformed. In these areas, crushing of the sheet-metal between the ribbing was noted, which indicates a vertical component at the time of impact.

*Parts of the fuselage*

The upper elements of the fuselage are generally larger. They often had significant lengthwise folding.

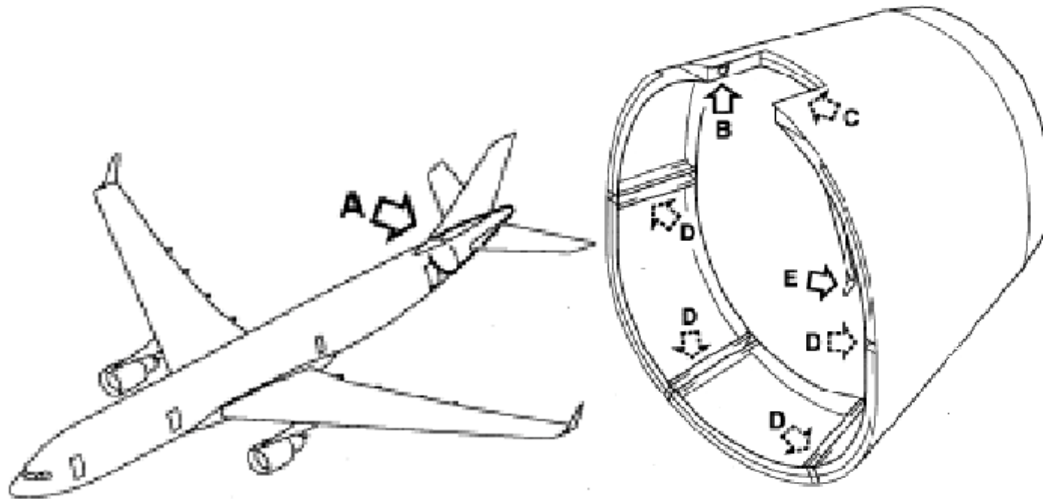
The APU exhaust broke off from the fuselage rear cone on impact. It had deformations on the whole of the lower section.

*APU exhaust*

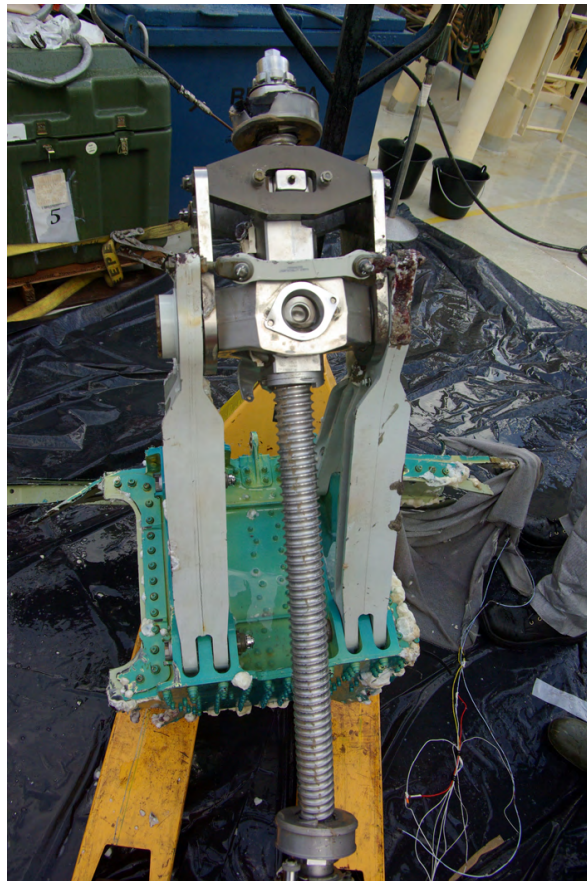
According to the manufacturer's technical documentation, the relative position of the actuator and the THS screwjack corresponded to a THS position of between 13° and 13.5° nose-up.

*Trimmable horizontal stabiliser screwjack after being raised on board*

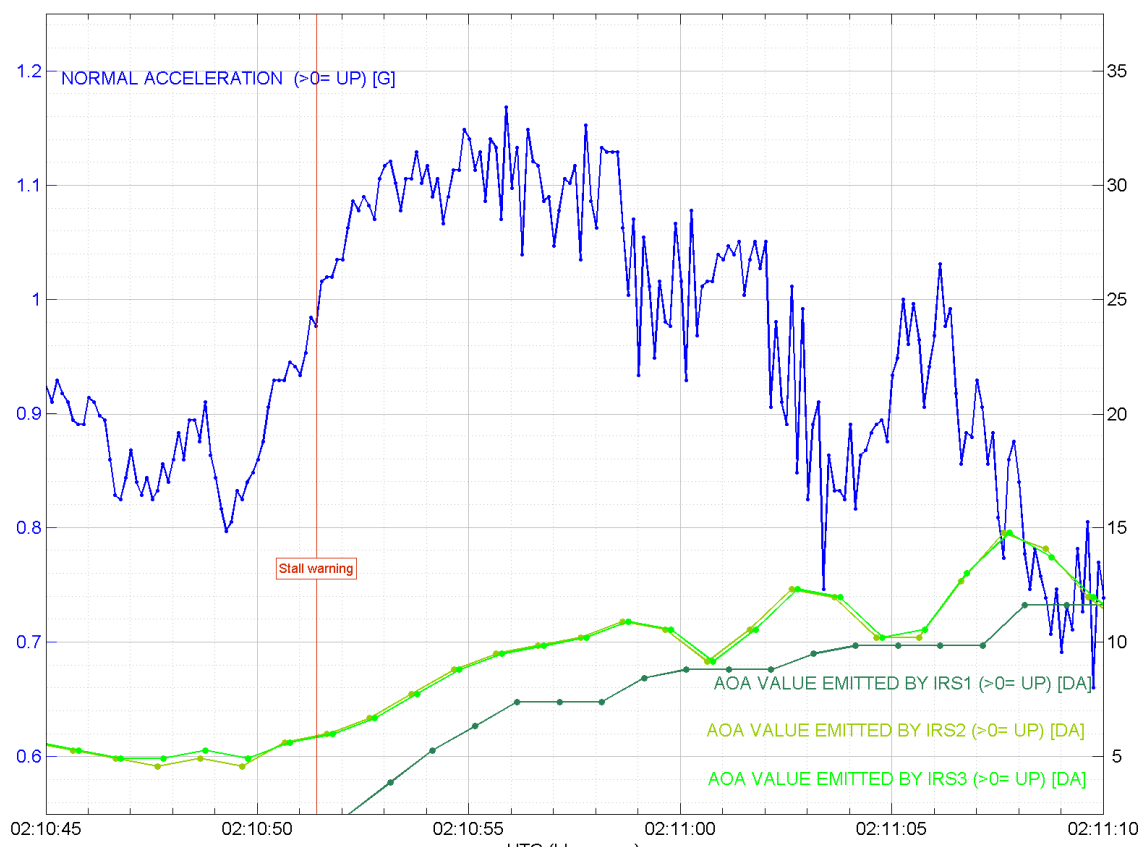
At 2 h 10 min 51, when the aircraft was at about 37,500 ft and still climbing, the stall warning was activated (refer to 1.6.3). A change in the recorded normal acceleration behaviour was revealed from 2 h 10 min 53, at an angle of attack about 1 to 2 degrees greater than the warning activation threshold.

*Evolution in the normal acceleration recorded at the time of the triggering of the stall warning*

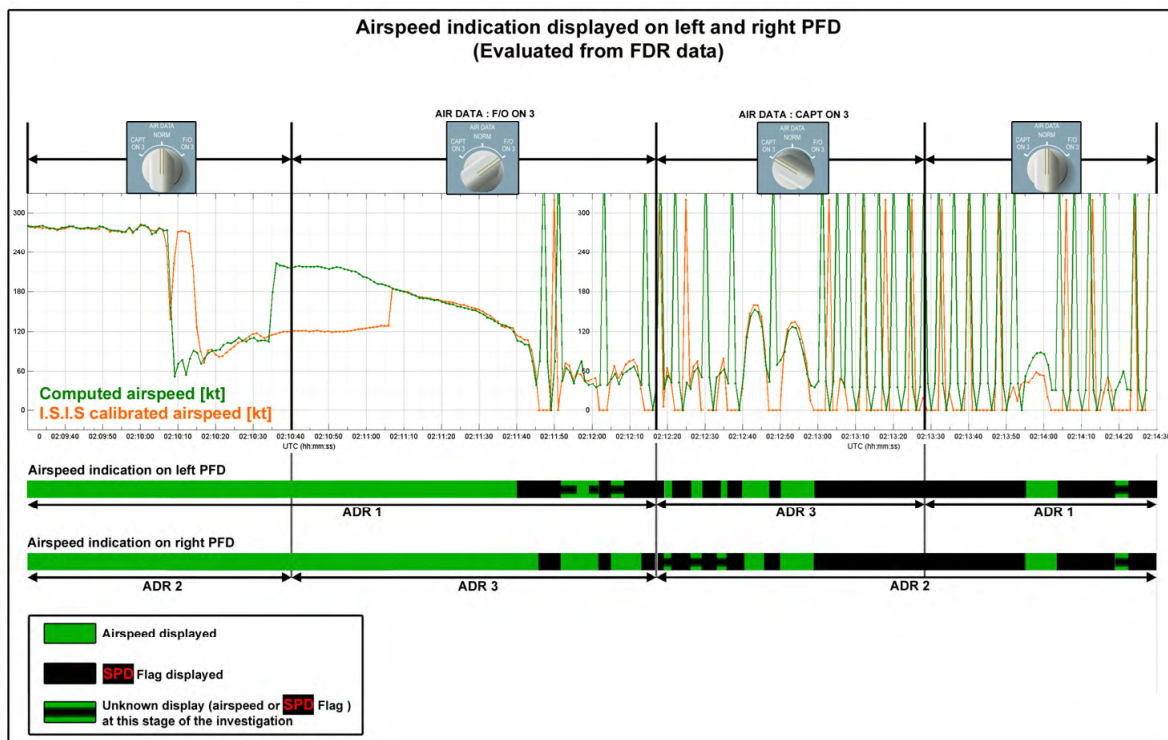
At this stage in the investigation, the changes in displayed airspeeds may be summarised as follows:

*Evolution of the speeds displayed by the right and left PFDs*
