**TECHNICAL INVESTIGATION INTO THE ACCIDENT OF  
THE B737-800 REGISTRATION 5Y-KYA OPERATED BY  
KENYA AIRWAYS THAT OCCURRED ON THE 5<sup>th</sup> OF  
MAY 2007 IN DOUALA**

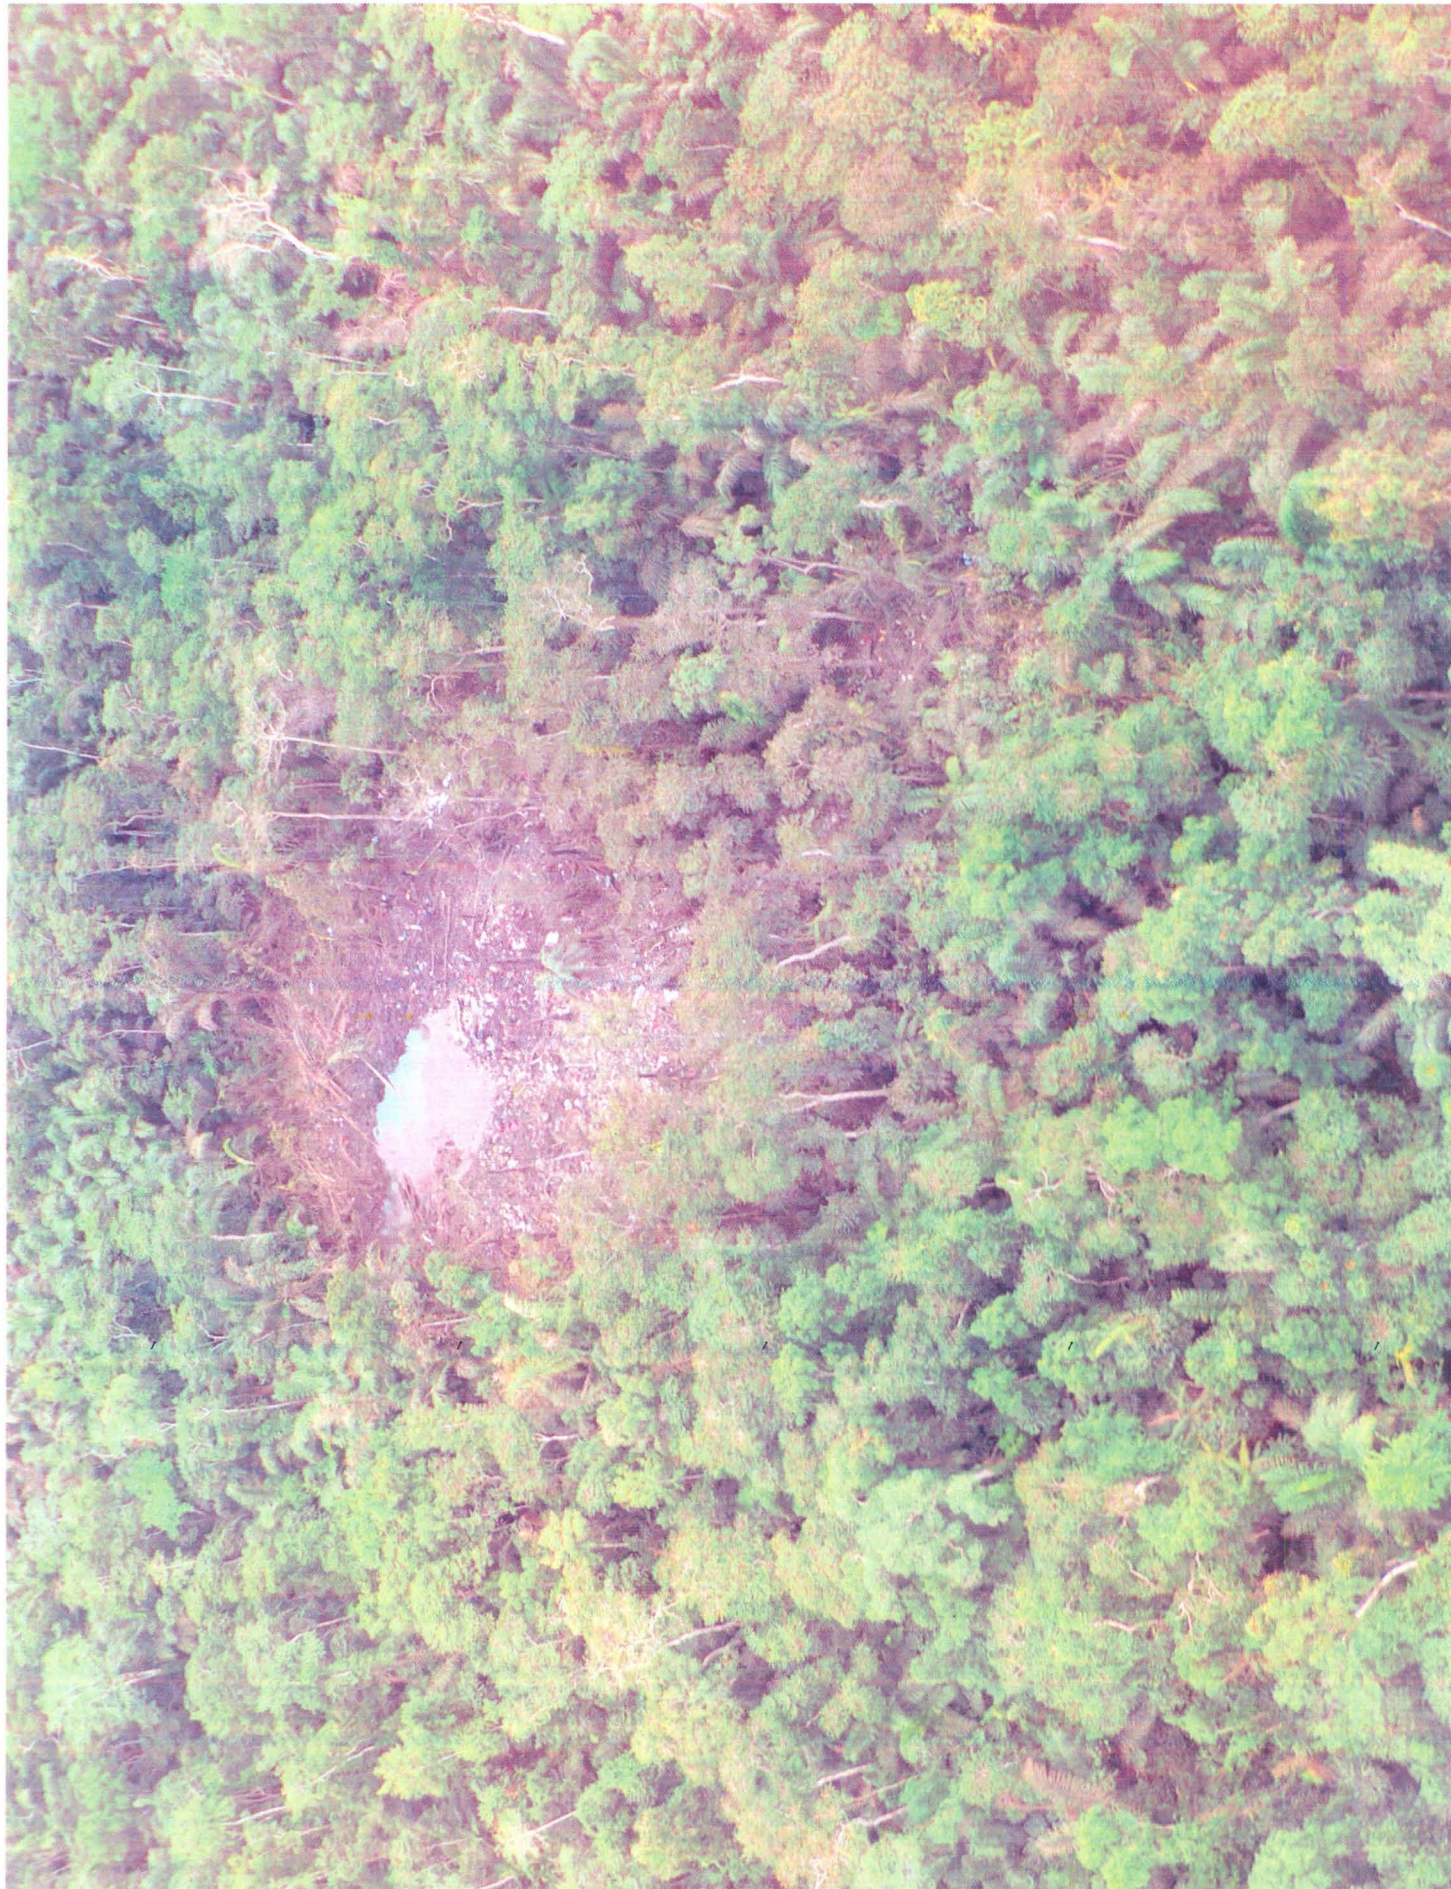
**Aerial photo of crash site**

A significant mass of overturned mud is found on the North West and South West borders of the crater. The vegetation all around is covered with mud up to 30 m away. The trees in the immediate vicinity of the crater are lying down because they were either uprooted or broken. The damage done to the vegetation extends over a surface area of about 2000 m<sup>2</sup>. The North West side of the crater is the most affected.

The content of the airplane (flight deck, cabin and cargo compartment) is found concentrated in the 70° direction as follows: nearest to the crater-economic class (blue seats); next first class (red seats); and finally the front part of the plane.
