MH17 Crash

Crash of Malaysia Airlines flight MH17

Hrabove, Ukraine, 17 July 2014

The Hague, October 2015

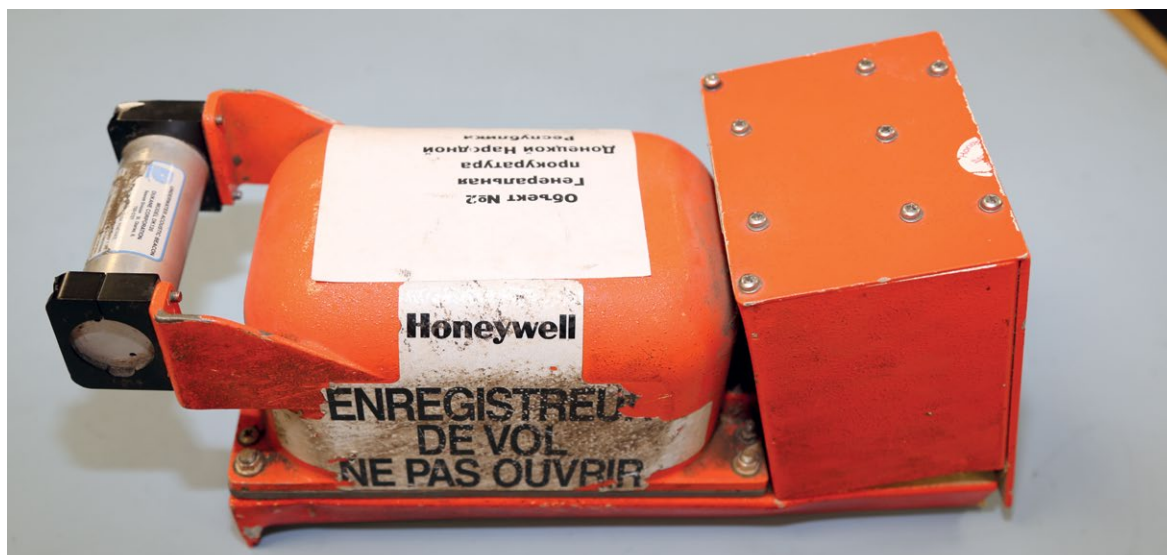
The housing of the Cockpit Voice Recorder (Figure 8) was damaged. The model and serial numbers were unreadable on the data plate, but the serial number 1366, was stamped on the underside of the chassis. The serial number 1366 was also provided by Malaysia Airlines. The external damage to the Cockpit Voice Recorder was consistent with impact damage; however, the internal memory module was intact. The Cockpit Voice Recorder was successfully downloaded and contained valid data from the flight.

Figure 8: Cockpit Voice Recorder. (Source: Dutch Safety Board)

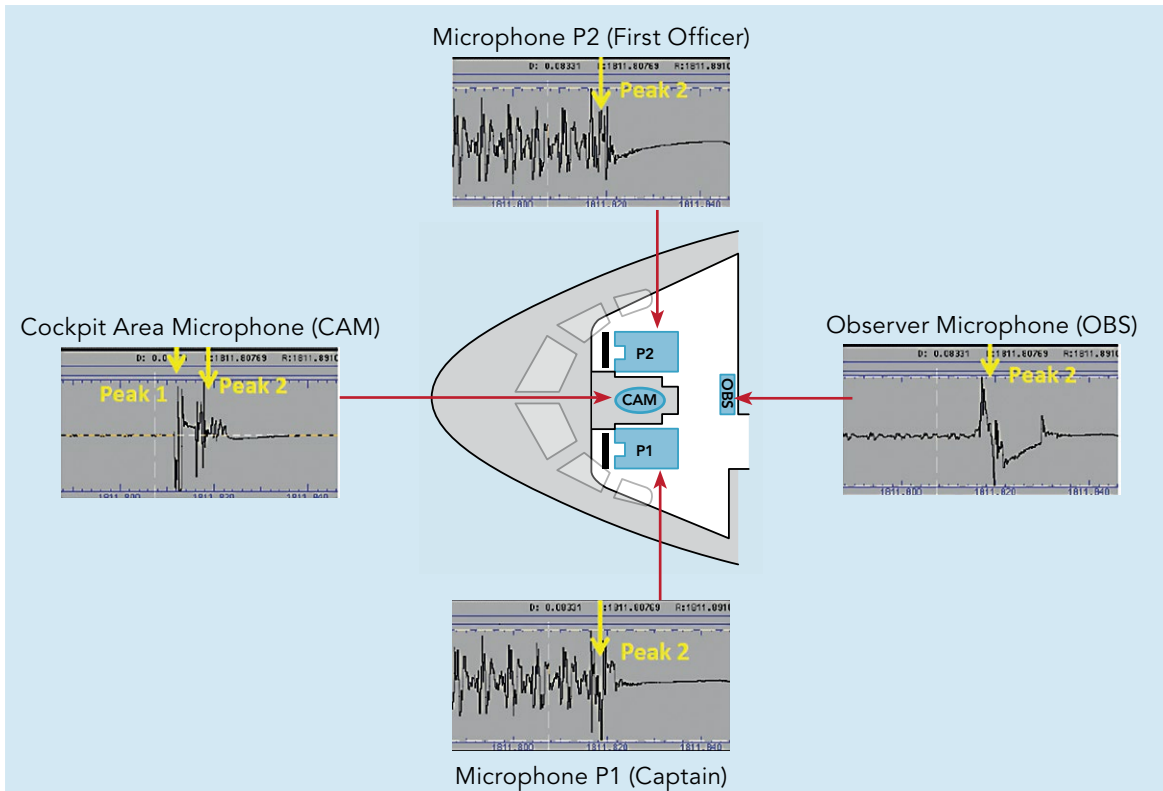
At the end of the recording, two sound peaks were identified on the last 20 milliseconds of the recording. A graphic representation of the two sound peaks for the four Cockpit Voice Recorder microphones is shown in Figure 9.

Figure 9: Sound peaks recorded at the end of the CVR recording. (Source: Dutch Safety Board)

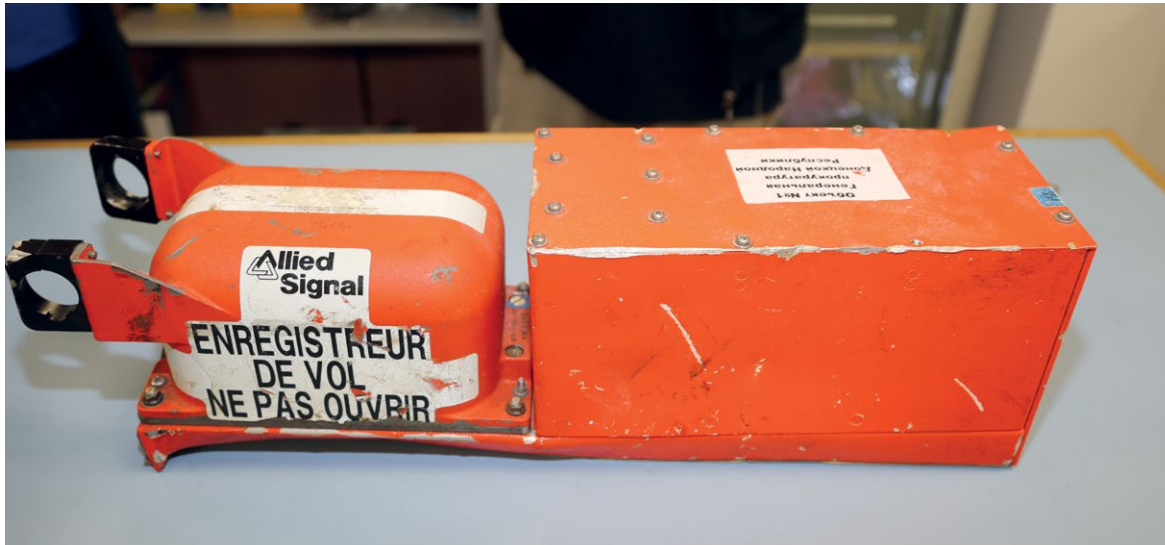
The exterior of the flight data recorder was slightly damaged, but the internal memory module was intact. The external damage on the Flight Data Recorder and the loss of the underwater locator beacon was consistent with impact damage. The Flight Data Recorder, designed so that a minimum of the last 25 hours of operational data is retained on the recording medium, was successfully downloaded and contained valid data from flight MH17.

Figure 10: Flight data recorder without Underwater Locator Beacon. (Source: Dutch Safety Board)

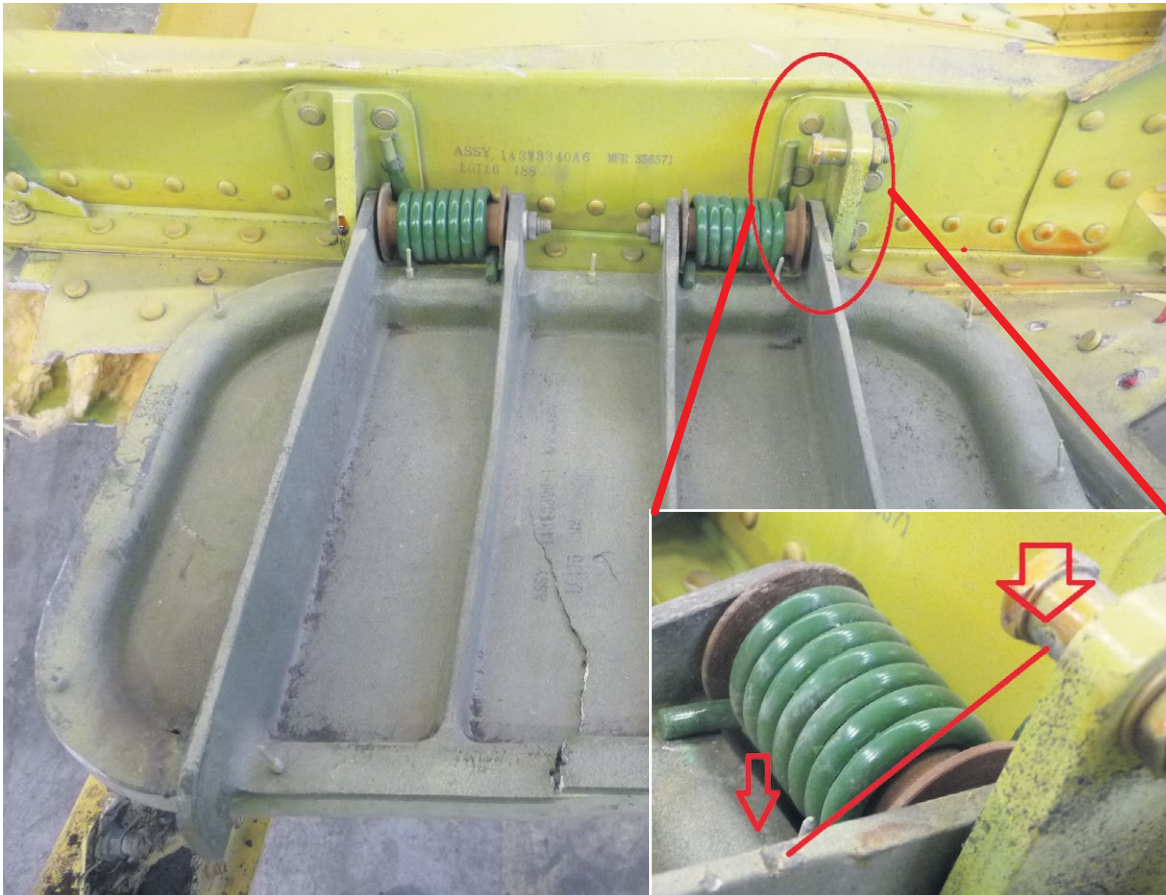
The negative pressure relief valve itself was cracked over the half of its vertical length. The valve showed damage consistent with the valve being fully opened and striking the adjacent rib (Figure 16).

Figure 16: Inside of the valve in closed position with crack and marked bracket. Inset shows detail of the bracket with pin showing damage on pin and rib. (Source: Dutch Safety Board)

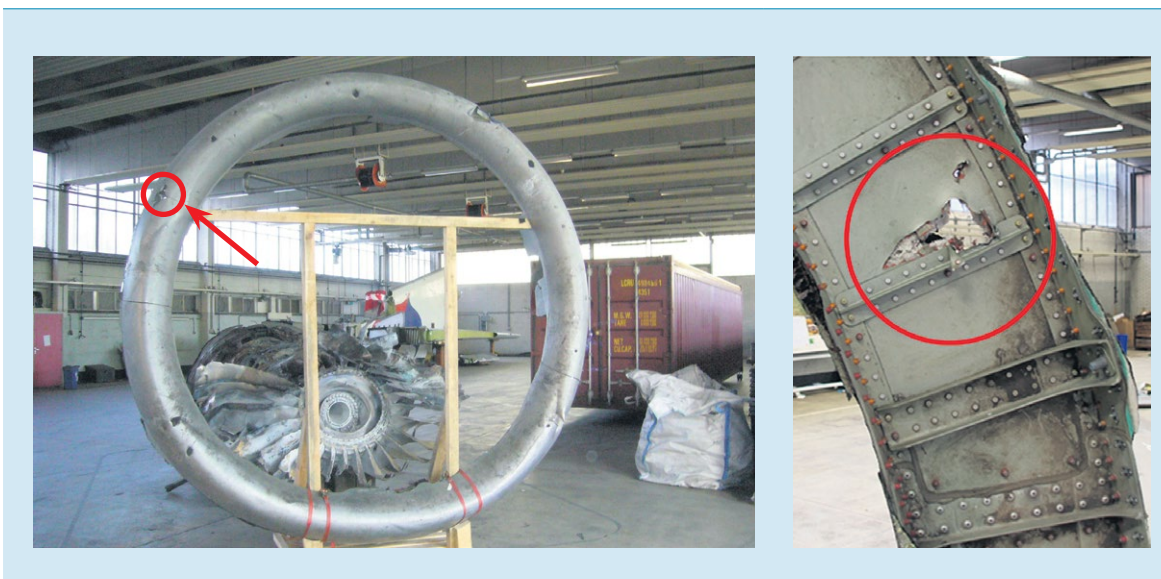
Figure 17: Damaged left engine intake ring, with impact marks seen from the front side (left photo) and from the rear side (right photo). (Source: Dutch Safety Board)

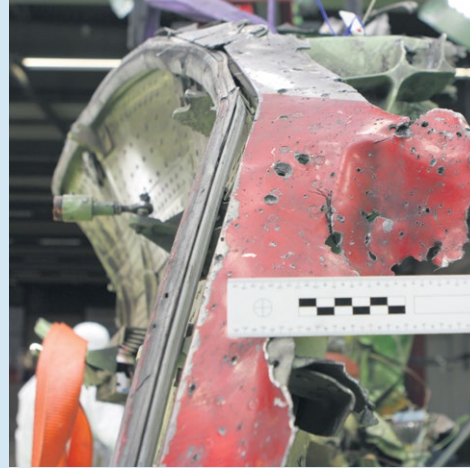
Figure 21: Puncture holes on left hand fuselage at the forward pressure bulkhead. (Source: Dutch Safety Board)

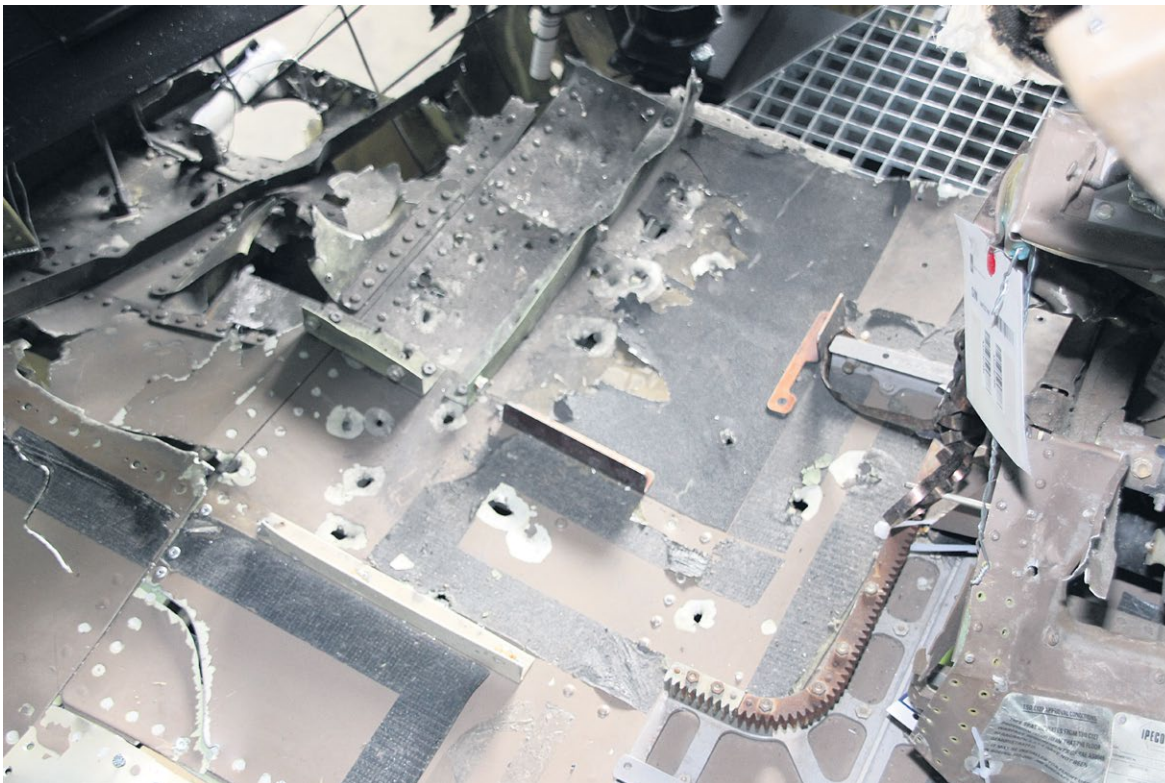
Figure 22: Cockpit floor with floor parts showing perforation holes. (Source: Dutch Safety Board)

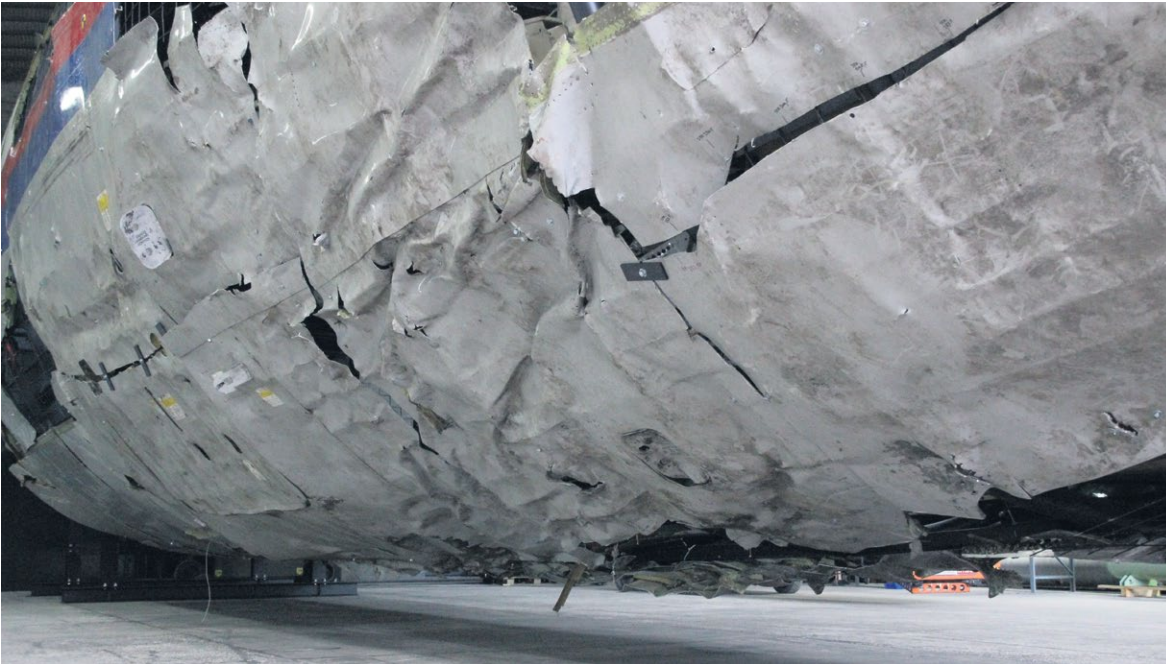
Figure 23: Fuselage skin pushed in between stringers and frame. (Source: Dutch Safety Board)

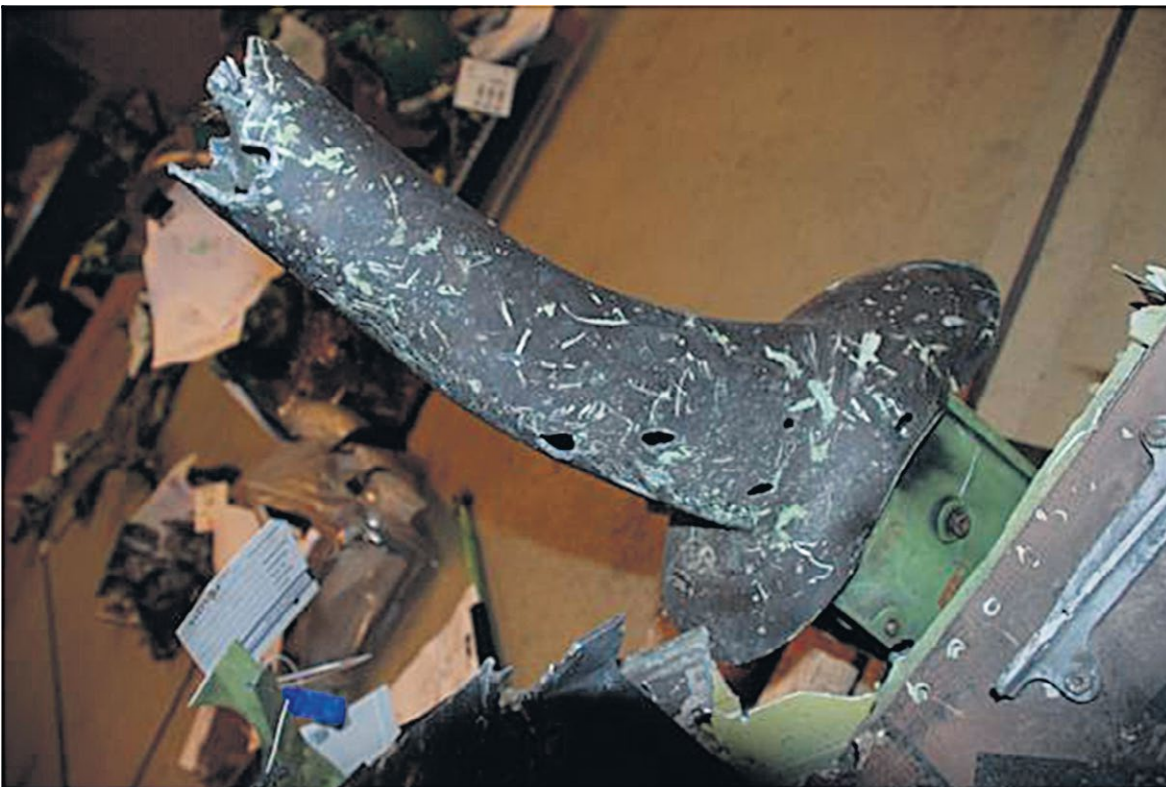
Figure 24: Lower part of Captain's control column showing perforation damage. (Source: NLR)

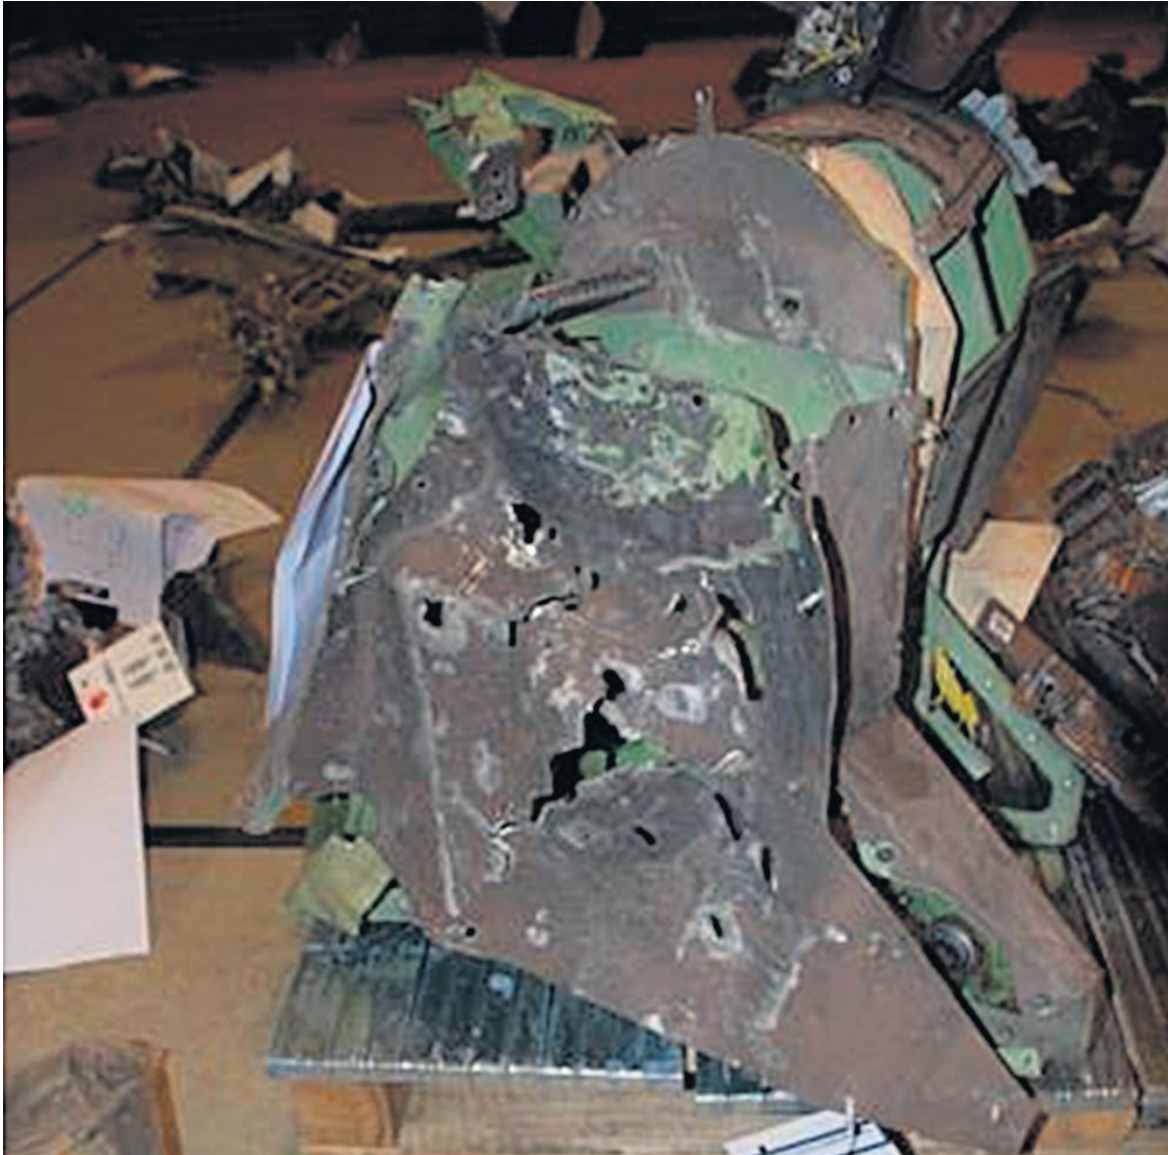
Figure 25: Throttle quadrant (viewed from the left hand side) showing perforation damage. (Source: NLR)

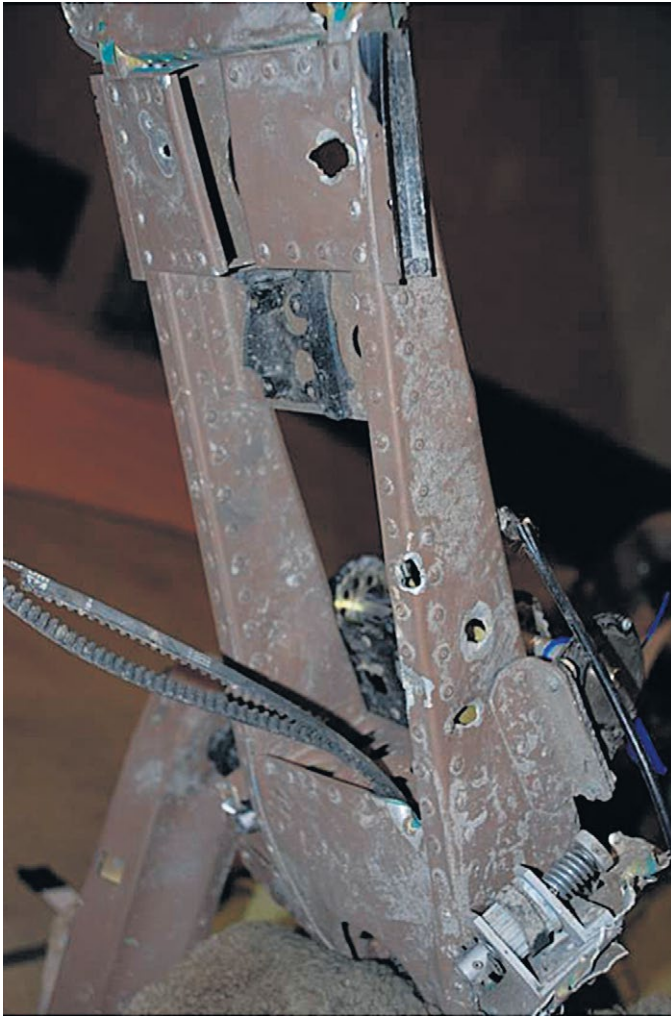
Figure 26: Backrest support of first officer's seat, showing perforation damage. (Source: NLR)

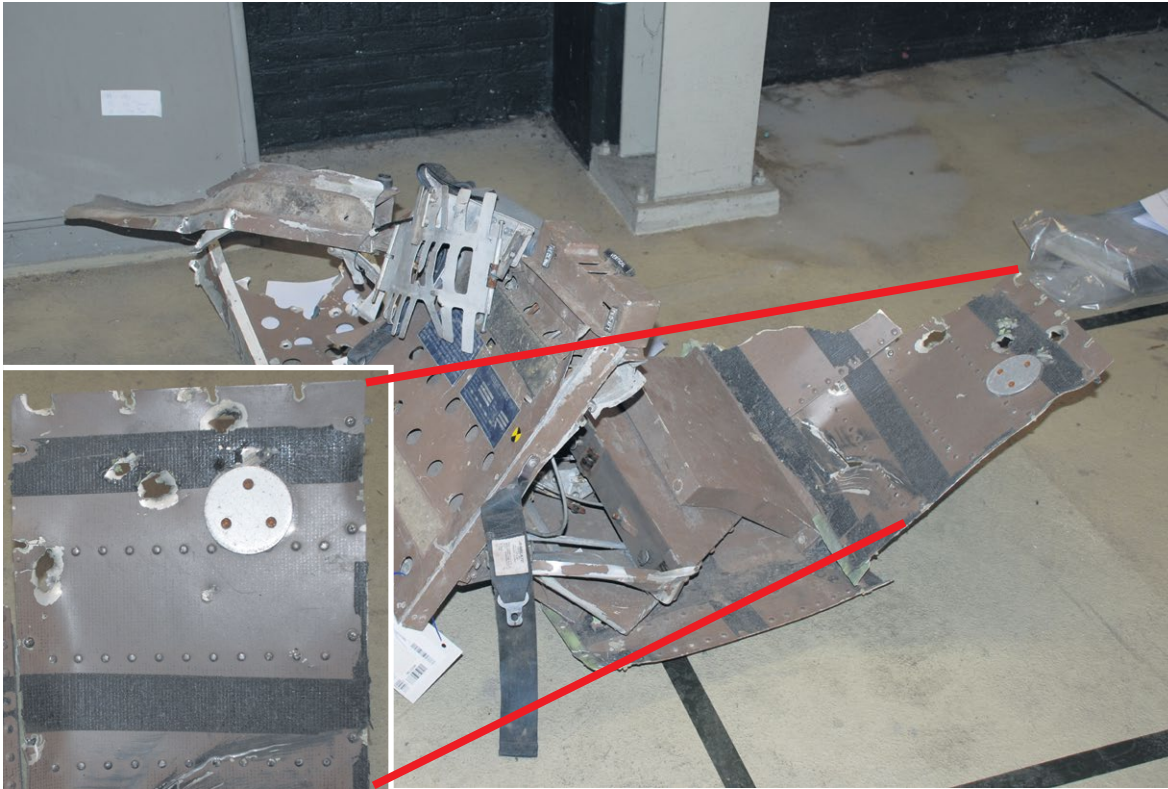
Figure 27: Perforation holes in seat back panel of left observer seat. Note: The seat back panel is shown flat on the floor in this image. (Source: NLR)

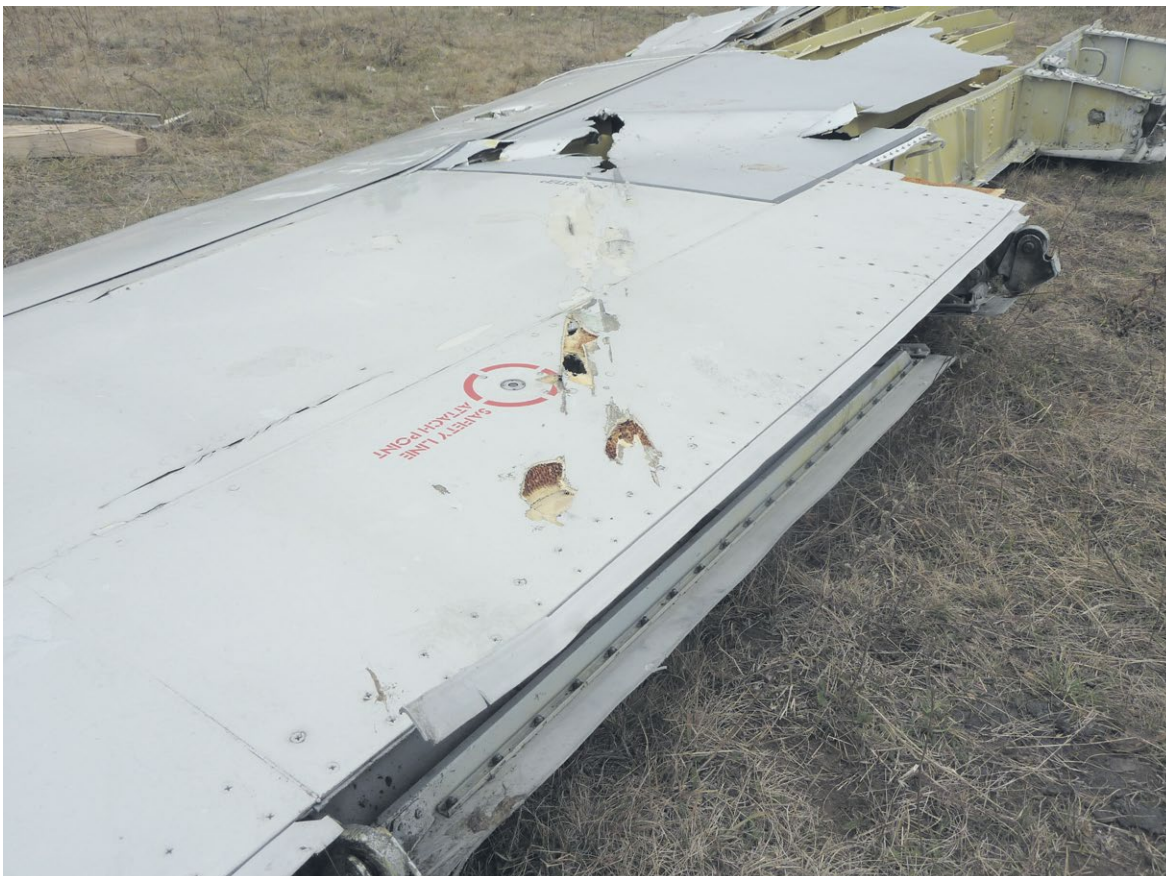
Figure 29: Left wing tip with impact damage near and outboard of the safety line attachment point. (Source: Dutch Safety Board)

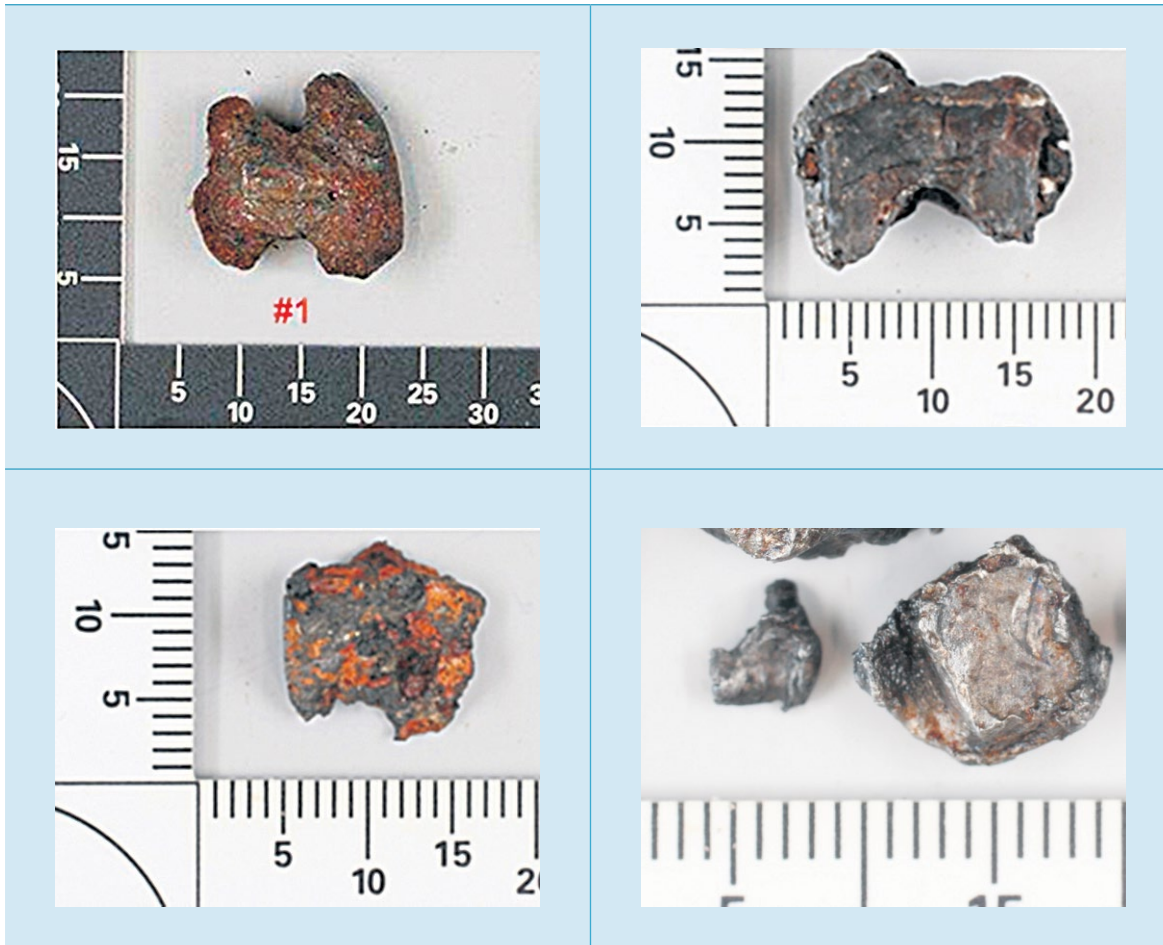
Figure 37: Four distinctly shaped fragments. Top left: cockpit. Top right: Captain's body. Bottom left: Purser's body. Bottom right: First Officer's body. (Source: NFI). Scale is in millimetres.

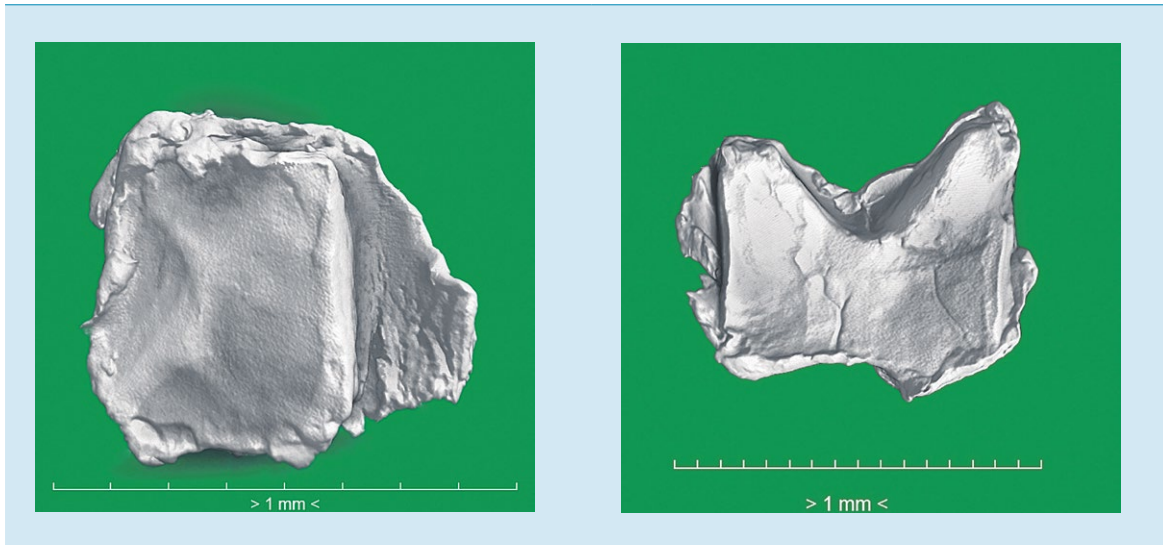
Figure 39: Micro CT-images of the fragments (shown at the right side of Figure 37, left from the First Officer's and right from the Captain's body) show the deformation of the fragments. (Source: NFI)

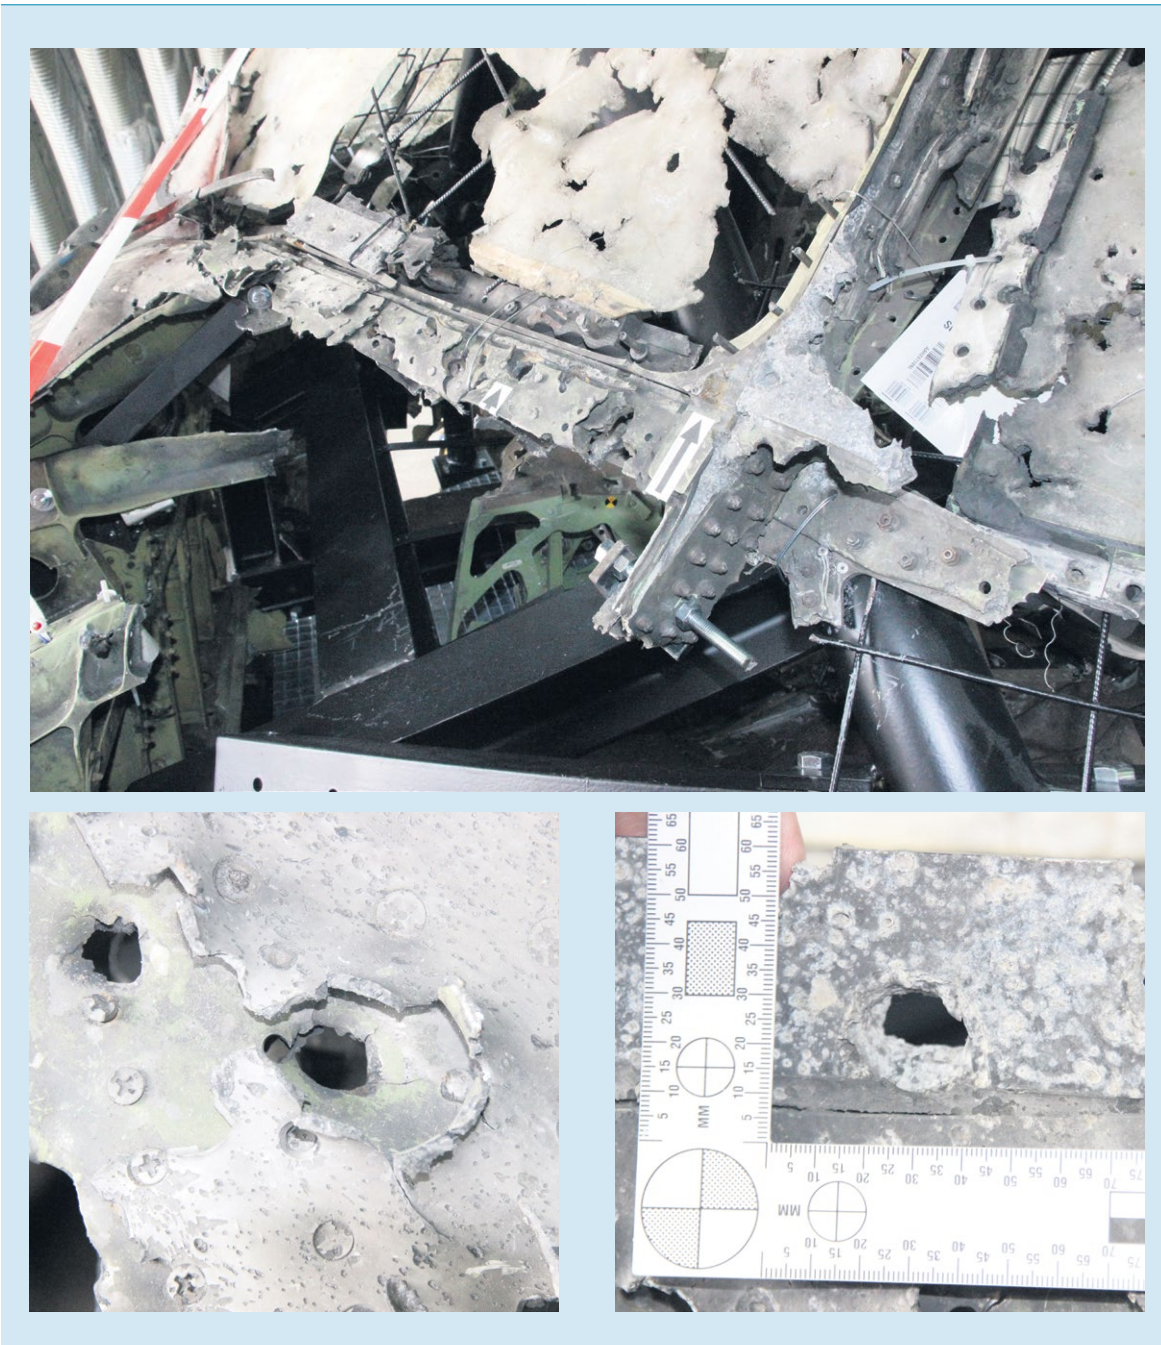
Figure 47: Part of the left hand cockpit window frame with enlarged detail. The perforation damage had a regular pattern of larger and smaller holes. (Source: Dutch Safety Board)

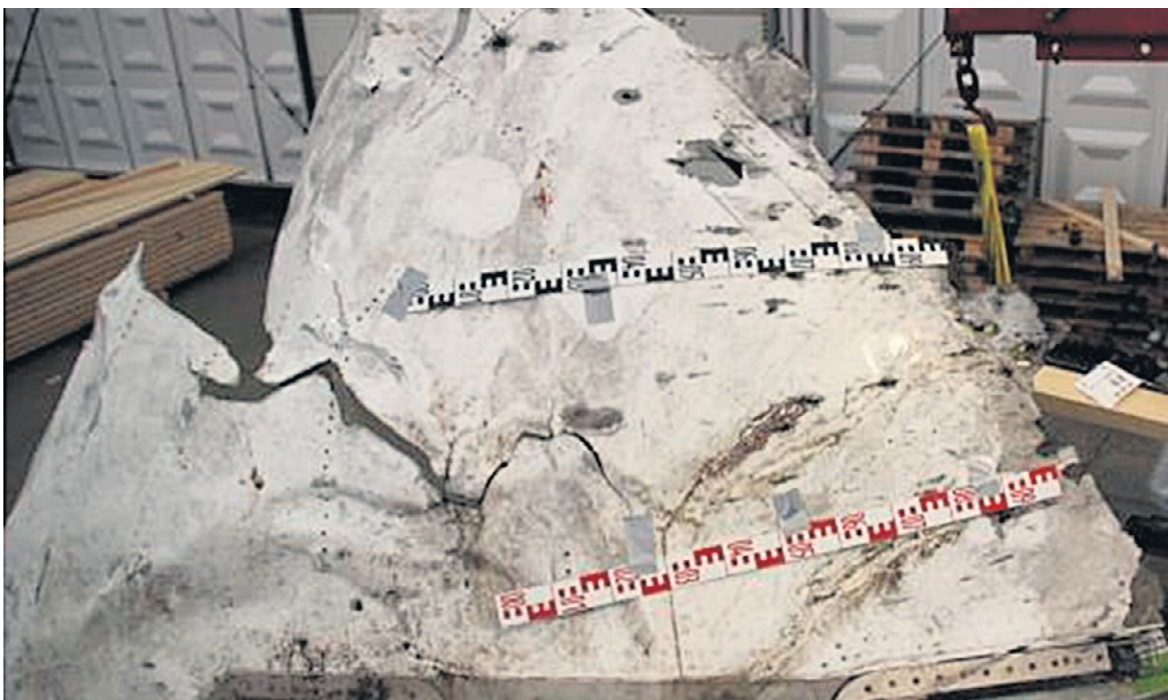
Figure 49: Grazing on cockpit roof. (Source: NLR)

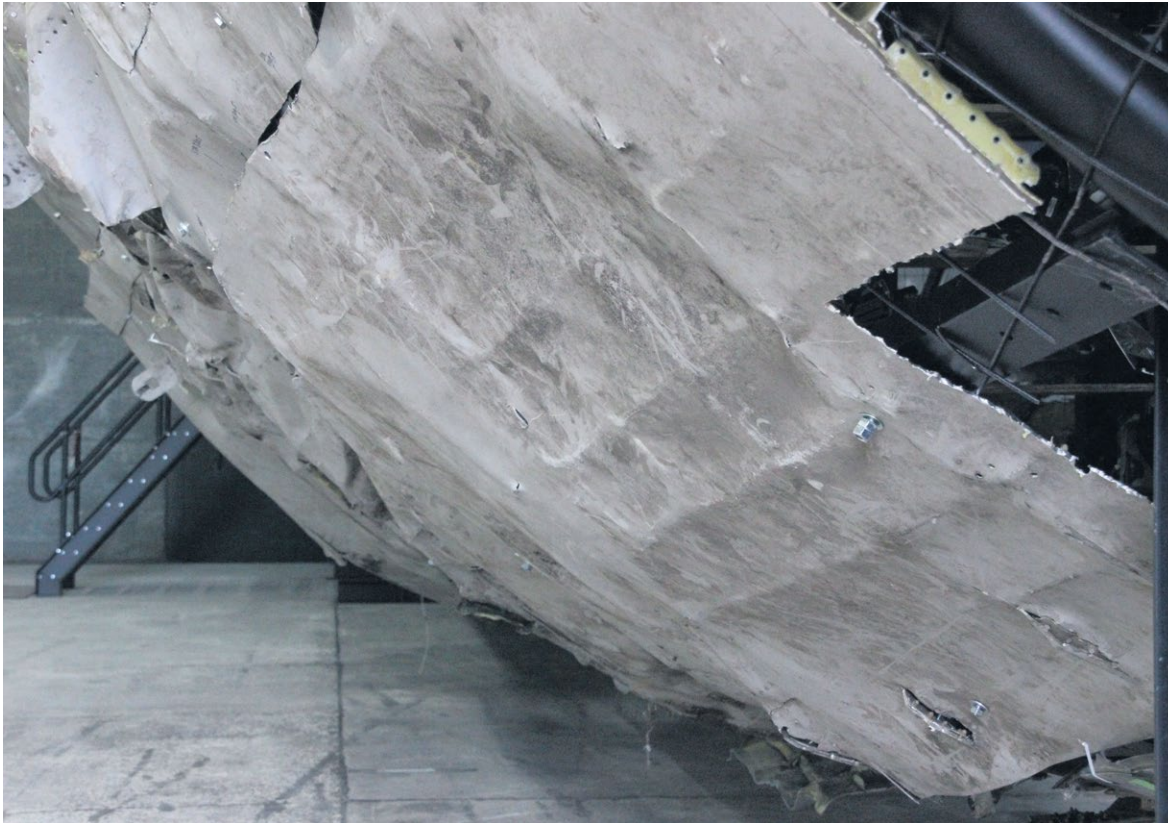
Figure 51: Blast damage on the forward right hand side of the fuselage. The panel was also damaged by the break-up of the aeroplane and impact with the ground. (Source: Dutch Safety Board)

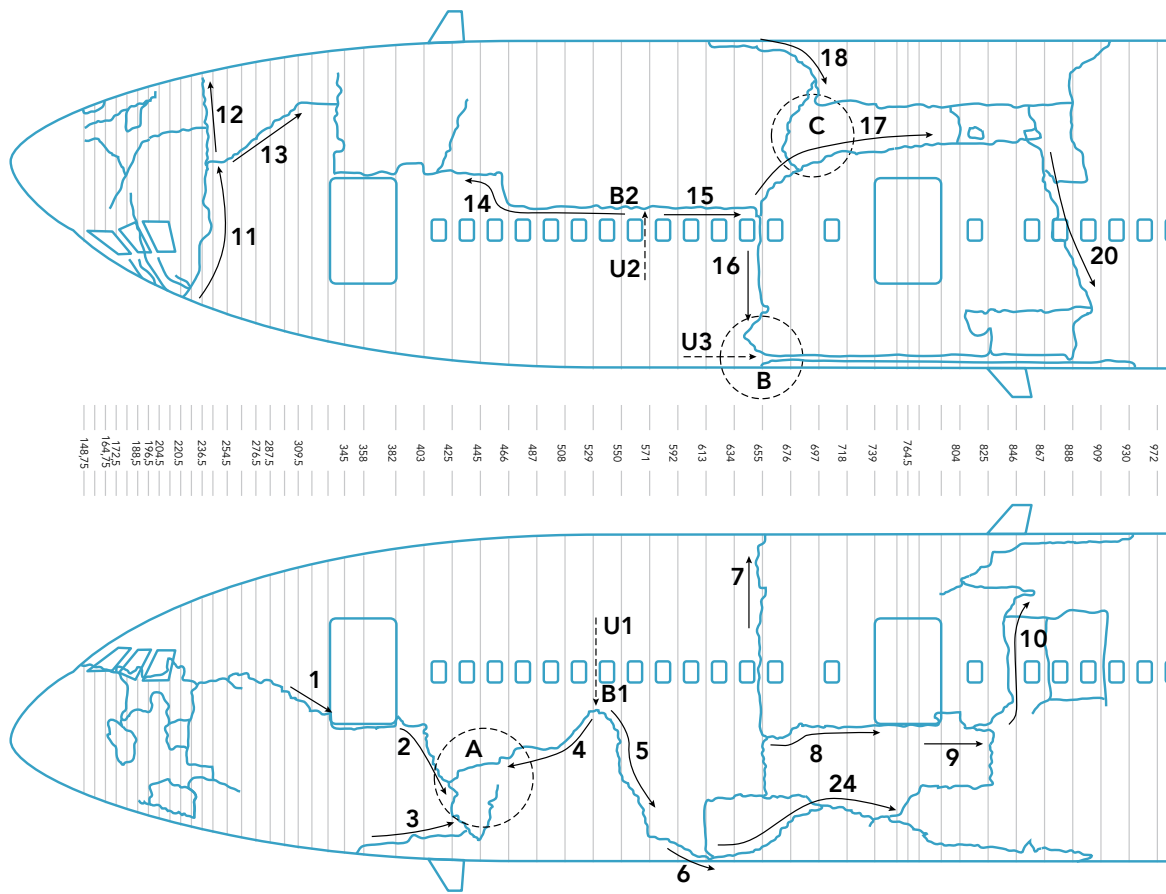
Figure 67: Front fuselage left hand side (bottom) and right hand side (top) view with main fracture lines and fracture growth directions. The arrows represent the growth direction. The lack of an arrow besides (part of) a fracture indicates that the growth direction could not be established. Frame locations are indicated by STA numbers. (Source: Dutch Safety Board)

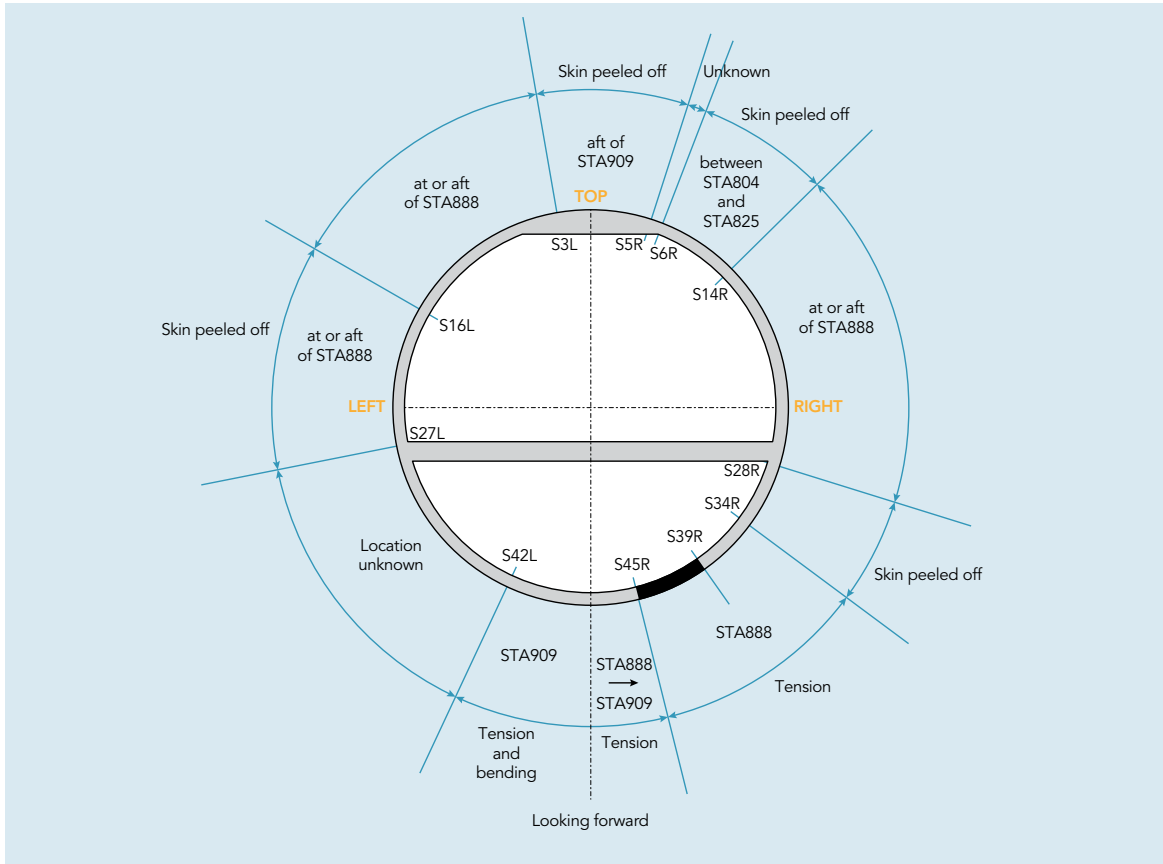
Figure 68: Observed position of fracture at STA 888/909 and type of loading of the fracture at STA888/909. Only between stringers 45R and 39R parts from the front and the centre fuselage fitted together. In the figure the thick line indicates this location. (Source: Dutch Safety Board)

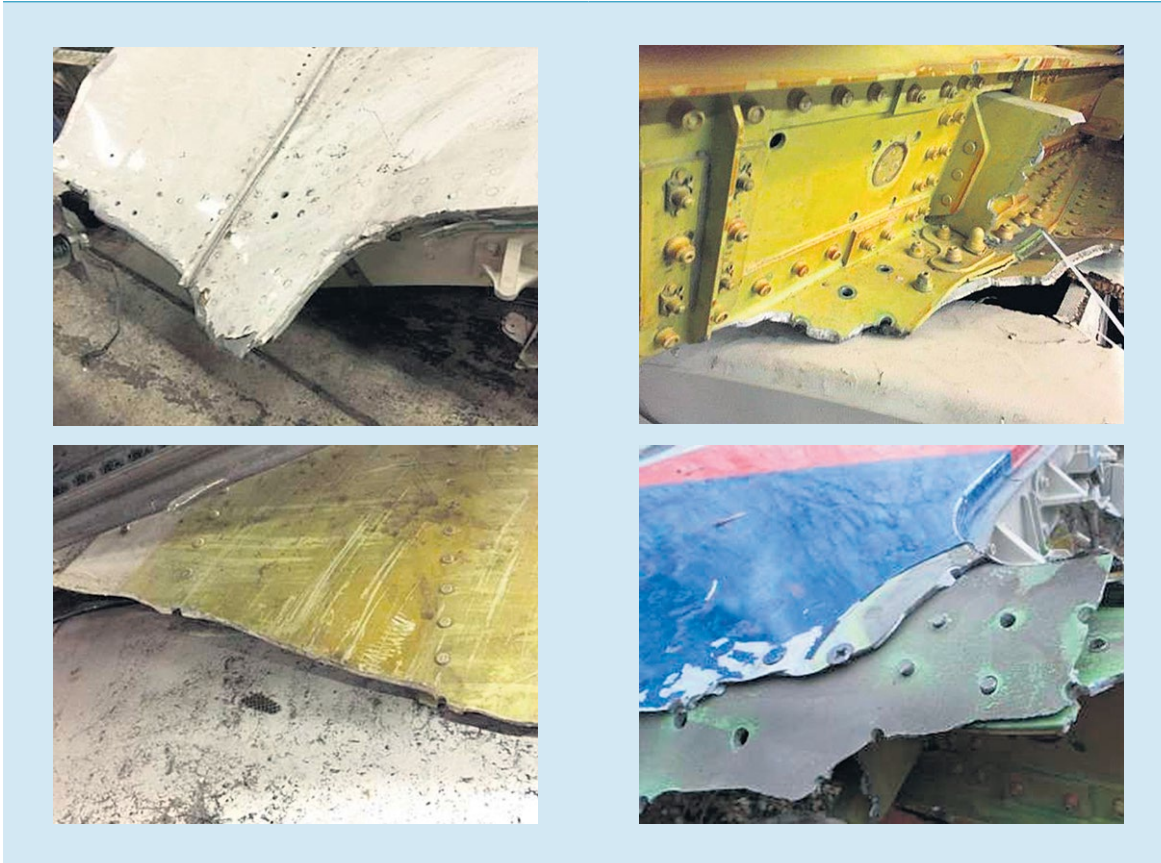
Figure 69: Examples of tensile overstress fracture at passenger doors 3L and 3R. (Source: Dutch Safety Board)

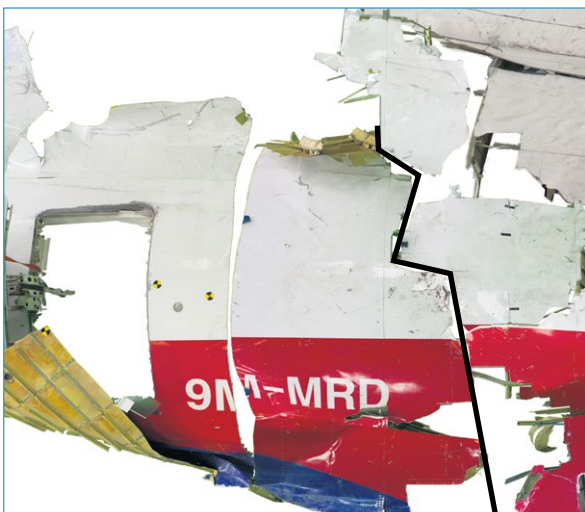
Figure 70: Left hand side separation fracture between rear fuselage and the tail. Separation is at the irregular fracture indicated by the black line. The vertical cut through the left letter M was made for transportation purposes. (Source: Dutch Safety Board)

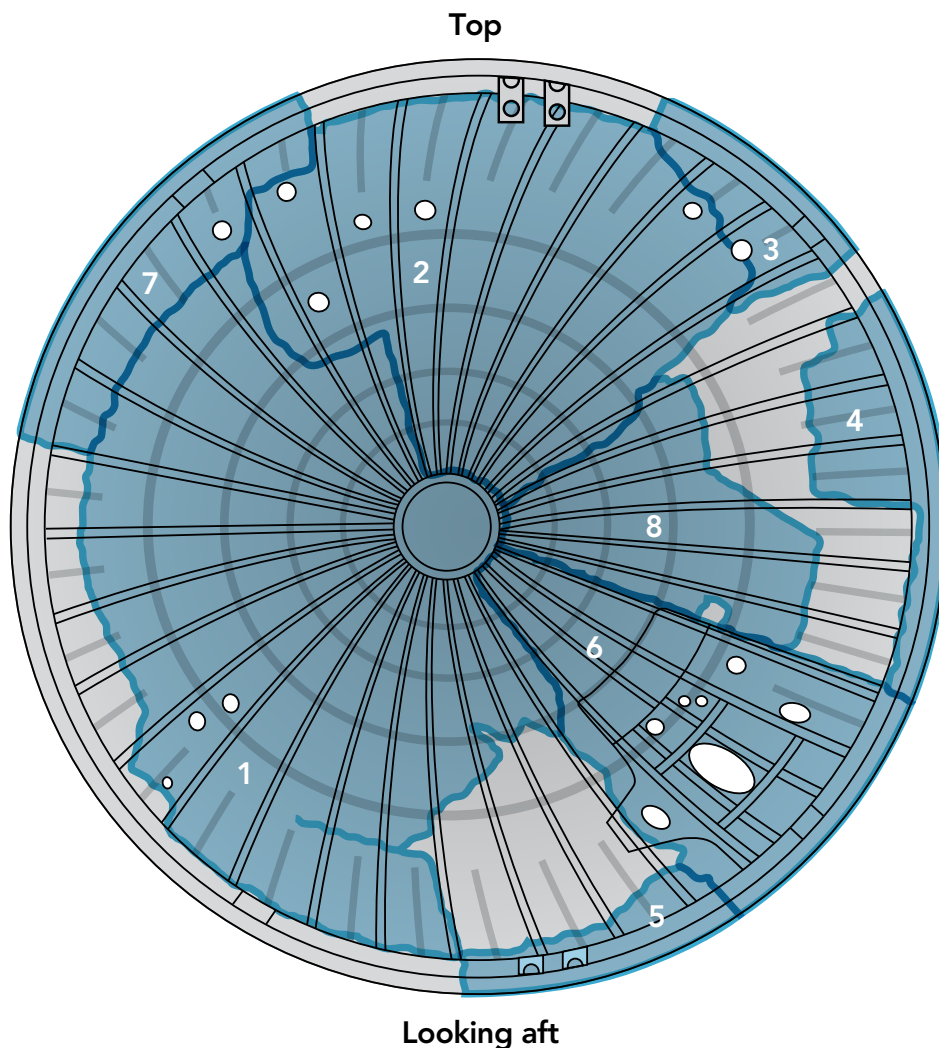
Figure 71: Fractures in rear pressure bulkhead. Looking aft. The parts that were available for investigation are numbered 1 to 8. (Source: Dutch Safety Board)

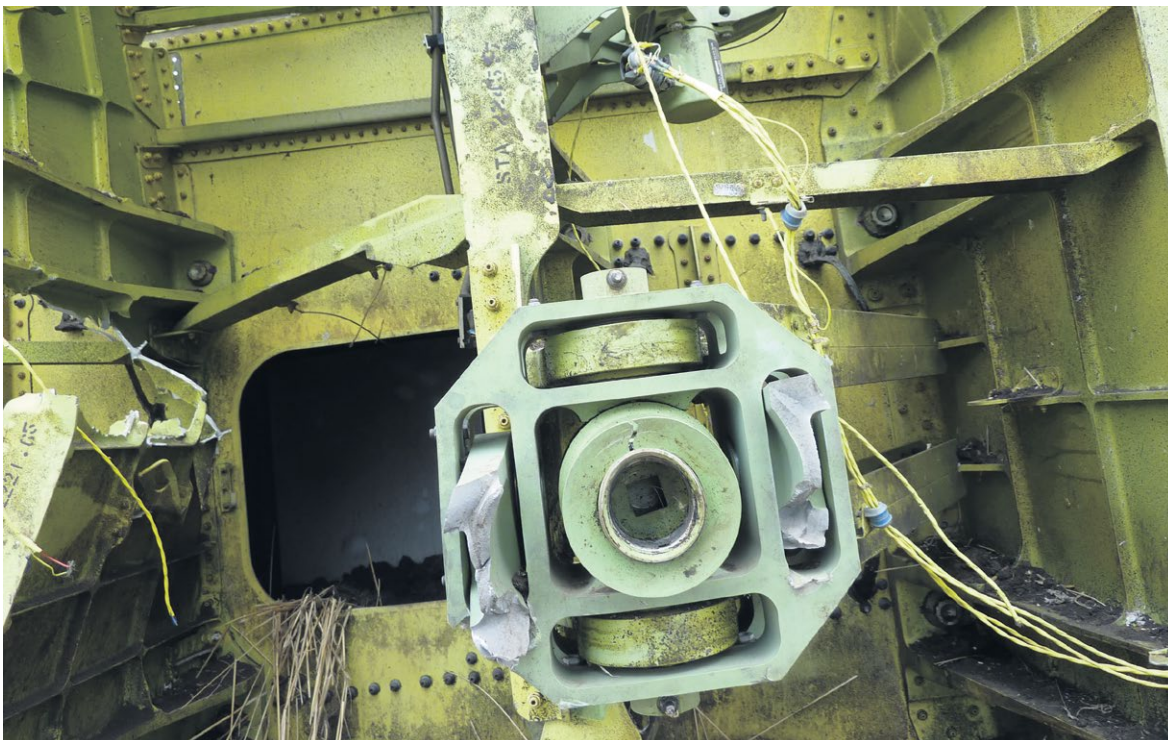
Figure 72: Overload failure of the vertical stabilizer. (Source: Dutch Safety Board)

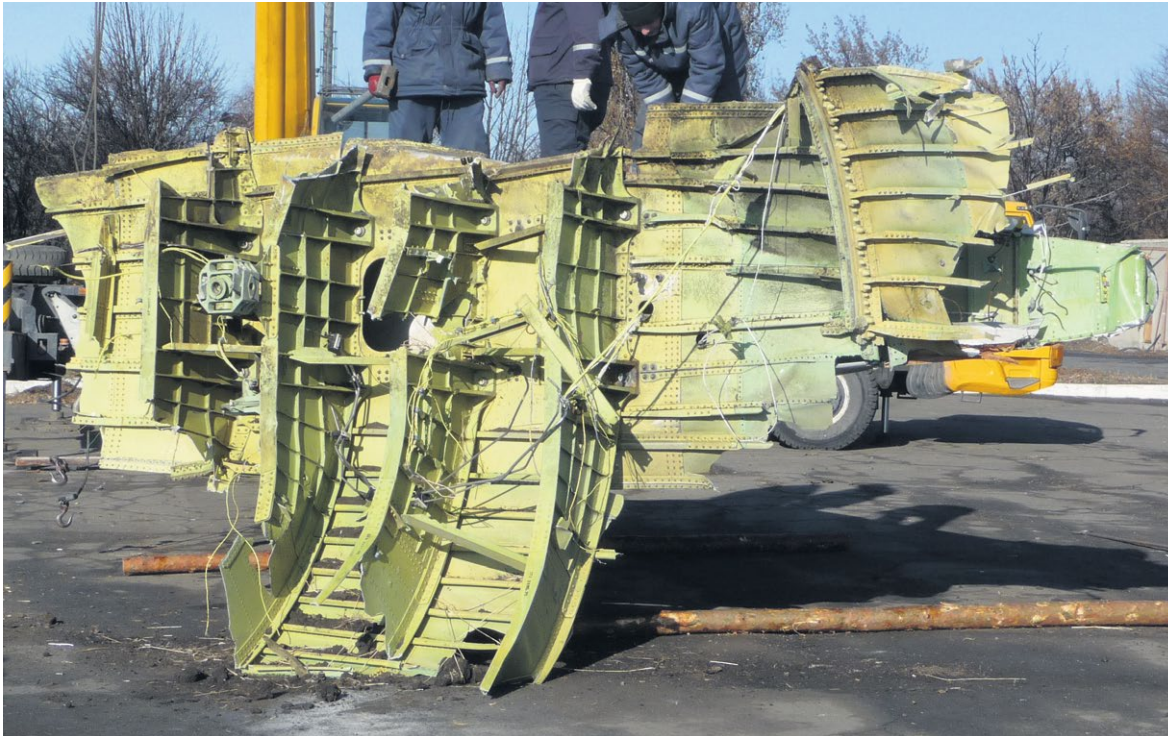
Figure 73: Fracture separating the vertical stabilizer from the fuselage. Attached skin and broken vertical stabilizer-to-fuselage frames bended out of their plane and fractured. (Source: Dutch Safety Board)
