**SERVICE INQUIRY INVESTIGATION INTO AN INCIDENT INVOLVING VOYAGER ZZ333
ON 9 FEB 14**

MAA DG/SI/01/14 – CONVENING ORDER FOR SERVICE INQUIRY INTO AIRCRAFT OCCURRENCE INVOLVING VOYAGER ZZ333 ON 9 FEB 14 AT 1549Z

**TERMS OF REFERENCE FOR SI INTO AVIATION OCCURRENCE INVOLVING VOYAGER
ZZ333 ON 9 FEB 14 AT 1549Z OVER THE BLACK SEA.**

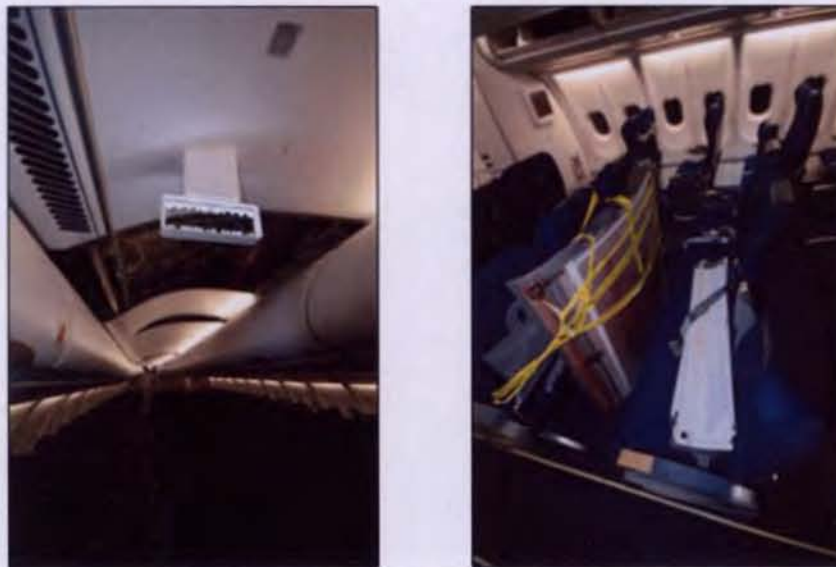
1.3.26 The damage to the aircraft comprised: 50 in-flight entertainment sockets broken or headphone pins sheared inside; seven ceiling panels dented; five florescent light tubes broken; five hand rails damaged; two seat belt brackets bent and one emergency exit sign broken (adjacent to door 2R). Initially, the rear facing lens of the exit sign at door 2R was missing (Figure 1), but it was subsequently found and put back in place for landing. Its cracked frame was sufficiently stable to accept and hold the replaced lens in order that the emergency function was not compromised for the landing.

Figure 1: Internal damage to ZZ333.
