PART 1.4 – FINDINGS

Executive Summary of Findings

1.4.1 The incident involving Voyager KC Mk 3 (ZZ333) on 9 Feb 14 occurred when the aircraft suddenly pitched down while in the cruise at FL330 (33,000 ft). The pitch-down command persisted for a total of 33 seconds, during which time the aircraft lost 4,400 ft in height. The aircraft's self-protection measures initiated a recovery from the dive.

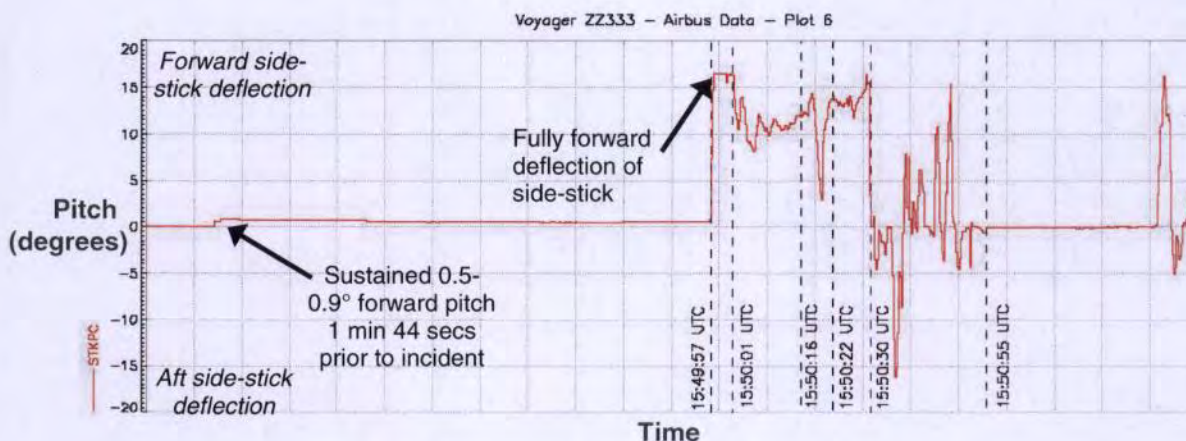
Figure 1: DFDR extract showing Captain's side-stick pitch commands.

1.4.19 At 1548:13 UTC, one minute and 44 seconds prior to the event, the DFDR (Figure 1) detected a low frequency fluctuating pitch-down command of 0.5 to 0.9 degrees from the Captain's side-stick. This input endured until the onset of the full pitch-down command. This initial forward input was pure in pitch with no discernible lateral input. The force and displacement of the side-stick during this command did not disengage the autopilot, because a five deca-Newton force and five degree displacement of the side-stick (in pitch) is required before the autopilot will disengage. All side-stick movements, including those below the threshold for autopilot disconnection are recorded by the DFDR. Therefore, the aircraft remained initially in level flight with the autopilot engaged. At 1549:57 UTC, a fully forward input was made by the Captain's side-stick. This input was also pure in pitch and at constant rate. It had no discernible lateral input and was held initially for approximately four seconds at a fully forward deflection. It was this input which initiated the pitch-down event. Exhibit 30

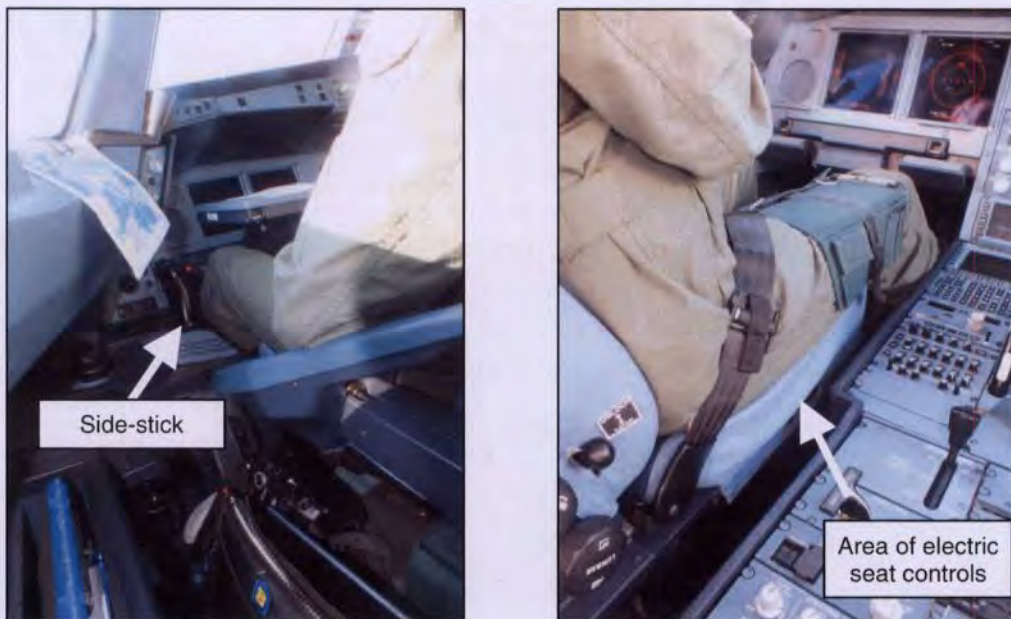
Figure 2: Captain's seat position.

1.4.21 Early analysis of the CVR identified a distinctive noise on the flight deck at one minute and 44 seconds prior to the event, and at the onset of the event itself. Spectral analysis of the noise identified it as the electrical motor used to adjust the flight deck crew seats (identified by its frequency of 1900-2000 Hz). The seats are adjustable by means of a switch which is located on the base of the seat itself. The Captain's seat is on the left-hand side of the flight deck and his adjustment switch is on the bottom right-hand side of the seat (Figure 2). In the two minutes leading up to the event the Captain was the only person present on the flight deck, indicating that the motor noise came from the Captain's seat. There was no evidence that the seat had malfunctioned in flight and functional tests carried out after the event showed that the seat was fully serviceable. It was quite normal for the seat to be adjusted several times during the flight, either for reasons of comfort or for the performing of a specific task. The Captain confirmed that his seat may have moved forward at this time, although he could not specifically recall it.

1.4.22 There was an obvious and strong temporal and directional correlation between the seat motor movement and the side-stick movement. The Panel examined the possibility that the movement of the Captain's seat and the Captain's side-stick were connected. For there to have been a direct relationship, the seat and the stick would have to be physically connected, either by the occupant of the seat or by an object (other methods of interference are dealt with in a separate

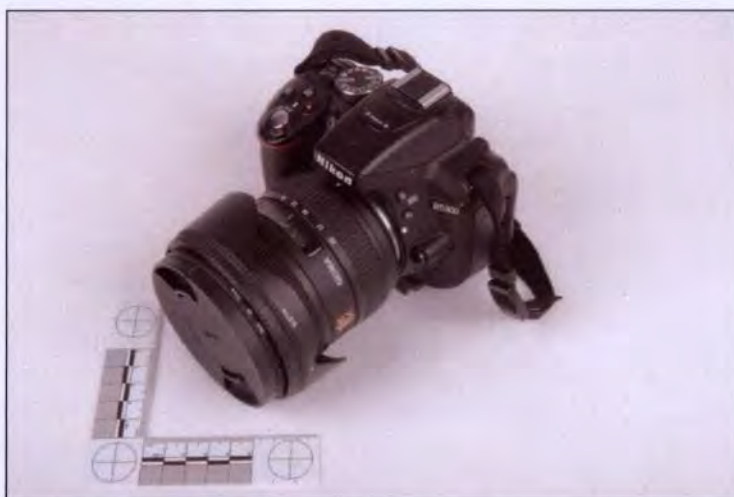
Figure 3: Nikon D5300 D-SLR camera as received.

1.4.24 As a result, the Panel's focus turned to the possibility of an object connecting the seat and the side-stick. The Panel collected the official items and personal effects which had been on the flight deck at the time, in order to ascertain which of them could have interfered with the side-stick. In an interview with the Co-pilot, it became evident that a Nikon Digital Single Lens Reflex (D-SLR) D5300 Camera (Figure 3) belonging to the Captain had been present on the flight deck in the minutes leading up to the pitch-down event. Specifically, the camera had been seen by the Co-pilot on the surface area near the base of the Captain's side-stick shortly before the event. He had also seen the Captain using the camera during the flight.

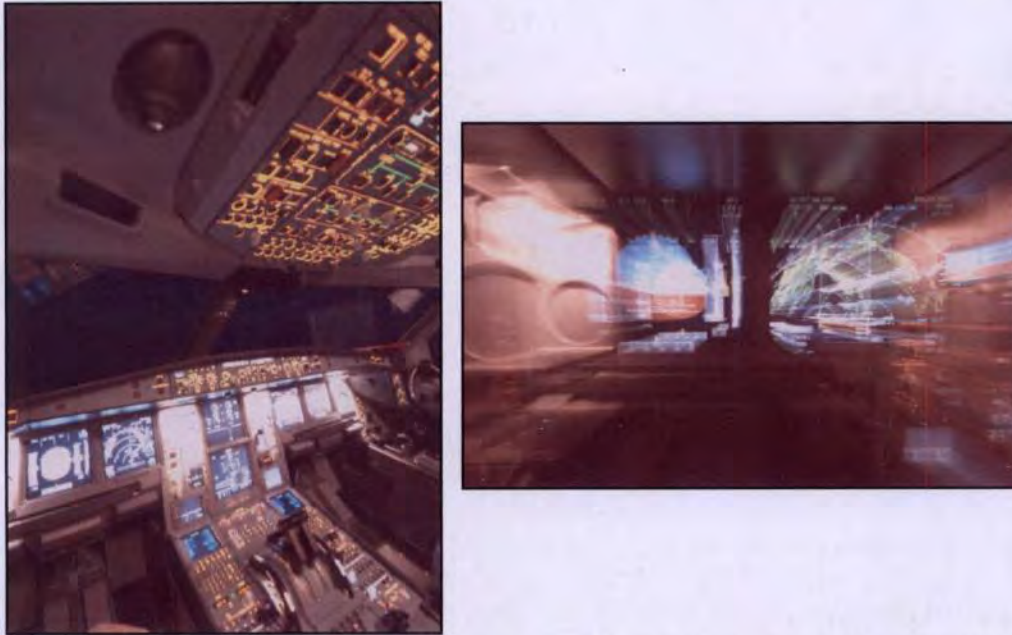
Figure 4: Sample of 28 photographs taken on flight deck shortly before incident.

Analysis of [redacted] photographs submitted subsequently by the Captain indicated that 28 photographs were taken during a period of darkness between around eight minutes and three minutes prior to the incident (Figure 4). It was established that, in all, 77 photographs were taken during the flight. In one photograph, the GPS digital clock on the flight deck could be seen, allowing a comparison to be made between the aircraft's internal time measurement and that of the camera.

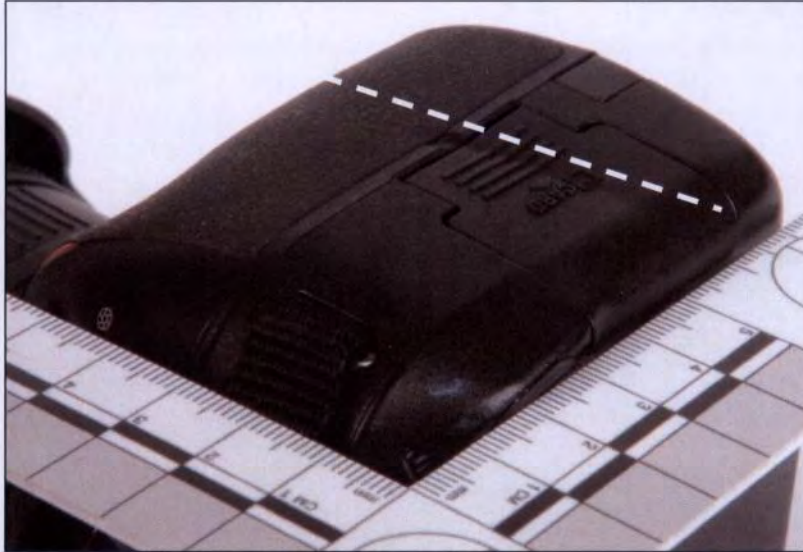
Figure 6: Location and orientation of large dent in camera (dotted line).

1.4.27 The camera was found to have a large linear dent on its right hand side (Figure 6). The dent extended from the softer hand grip region towards the front of the camera, across a thin part of the main body frame, and across the memory card flap.

1.4.28 The profile of the large dent was mapped forensically using surface profilometry and compared with the hand grip flange (Figure 7) at the base of the side-stick. The dent in the camera was found to be consistent with having been caused by the flange of the side-stick. Furthermore, chemical analysis indicated that trace amounts of materials present in a swab from the camera indentation were consistent with the material type of the side-stick. The rubber gaiter at the

base of the side-stick was examined using binocular microscopy, revealing two distinct perforations. The perforations were assessed to be the result of the gaiter material being pushed against the edges of the lower side-stick flange from the outside. When considered alongside other smaller witness marks on the camera, it was assessed as highly likely that the camera had experienced a significant compression against the base of the side-stick at some point during the flight. Specifically, it was assessed that the damage was consistent with the side-stick being pulled back forcefully against the body of the camera.

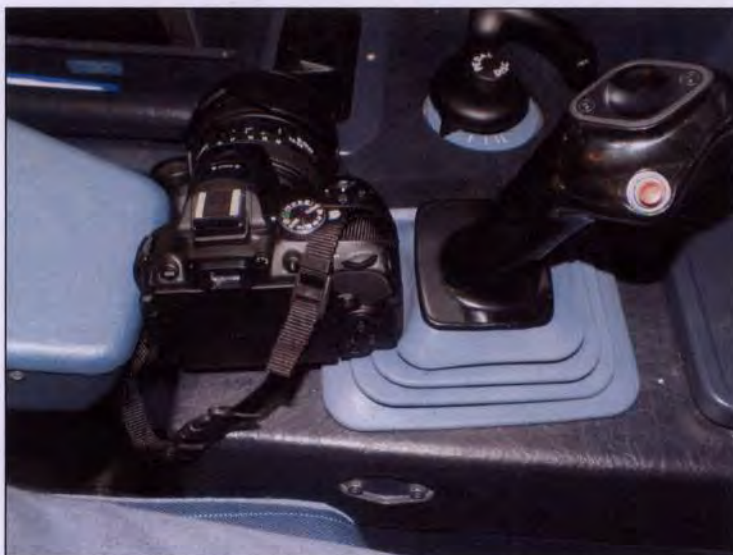
Figure 8: Re-construction of Captain's camera behind side-stick.

1.4.29 Using the Voyager simulator, the Panel reconstructed an arrangement of the armrest, the camera and the side-stick to assess the possibility of causing flight-control interference (Figure 8). The armrest was adjusted to the specific parameters used by the Captain on the flight in order to re-create the angle that was present during the event. Although the setting was within limits, it created an unusual angle, resulting in a particularly steep downward incline from back to front. The camera was placed in the gap between the armrest and the side-stick, with the damaged side presented towards the grip flange at the base of the side-stick. The seat motor was moved forward until the camera was gently flush against the base of the side-stick.

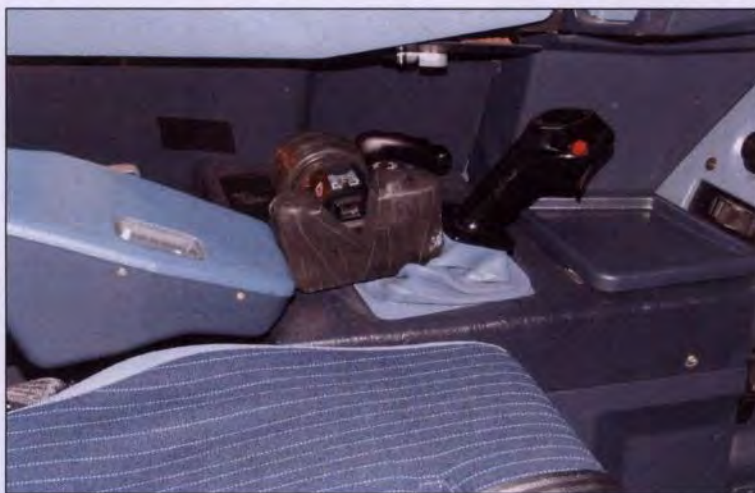
Figure 9: Side-stick locked in fully forward position (substitute camera).

1.4.30 The seat motor was operated in a forwards direction as heard at the onset of the pitch-down event. The effect was to push and hold the side-stick fully forward in a manner consistent with the pitch-down command seen on the DFDR (Figure 9). The motion resulted in the grip flange becoming aligned with a location exactly consistent with the dent in the camera. The re-construction took no more than a few seconds to set up.

1.4.31 Using the calculated movement of the seat, the position of the armrest and the location of the camera, the analysis found that it was feasible for the seat movement recorded on the CVR to have caused the movement of the side-stick to the fully-forward position.

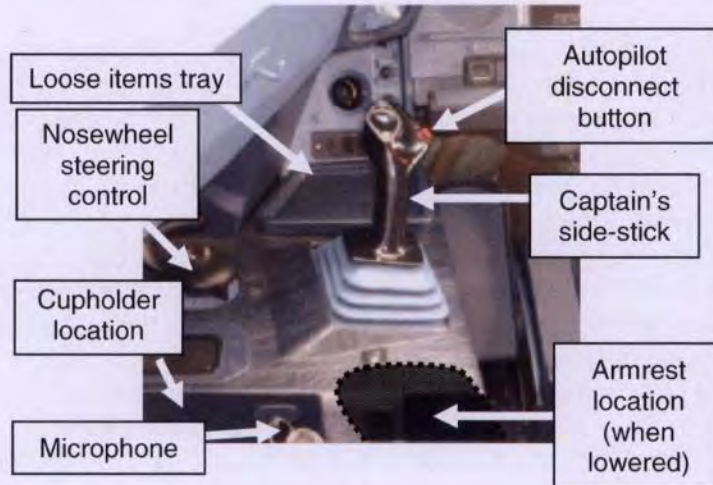
Figure 14: Layout of Captain's side-stick area.

(1) **Layout.** The seat can be positioned so that the side-stick is within the reach of the pilot. An armrest provides support to the pilot's elbow while using the side-stick, which is in line with good ergonomic practice to enable continuous adjustments and extended periods of use². The armrest is adjustable to enable the pilot to achieve a comfortable working posture. A combination of the setting of the armrest and the seat position brings the armrest into the vicinity of the side-stick. The minimum distance the armrest can achieve relative to the side-stick when the seat is moved is 50mm. There is a minimum of 140mm clearance between the side-stick and the nearest fixed obstruction (Figure 14).

(2) **Design to prevent accidental operation of the side-stick.** Joystick controls, such as the Voyager side-stick have a high likelihood of inadvertent operation³. Spurious or accidental operation of controls has been identified as an issue in safety critical systems⁴, so it is good practice to include design features to reduce the likelihood of such accidental operation. For instance, British Standard (BS) 894 Part 3, though not specific to aviation, offers guidance on how equipment design can mitigate the likelihood of accidental operation such as recessing the control, shrouding the control, placing a collar around the control, using a lock out system, or requiring two-handed controls. European aviation regulations (specifically European Air Safety Agency (EASA) regulation CS25.777) state that controls must be designed 'to prevent inadvertent movement'. The nature of the protection against spurious operation that is appropriate will depend entirely on the context in which the control is operated. The certification of Voyager when it was brought into military service was conducted in
