PART 1.4 – FINDINGS

Executive Summary of Findings

1.4.1 The incident involving Voyager KC Mk 3 (ZZ333) on 9 Feb 14 occurred when the aircraft suddenly pitched down while in the cruise at FL330 (33,000 ft). The pitch-down command persisted for a total of 33 seconds, during which time the aircraft lost 4,400 ft in height. The aircraft's self-protection measures initiated a recovery from the dive.

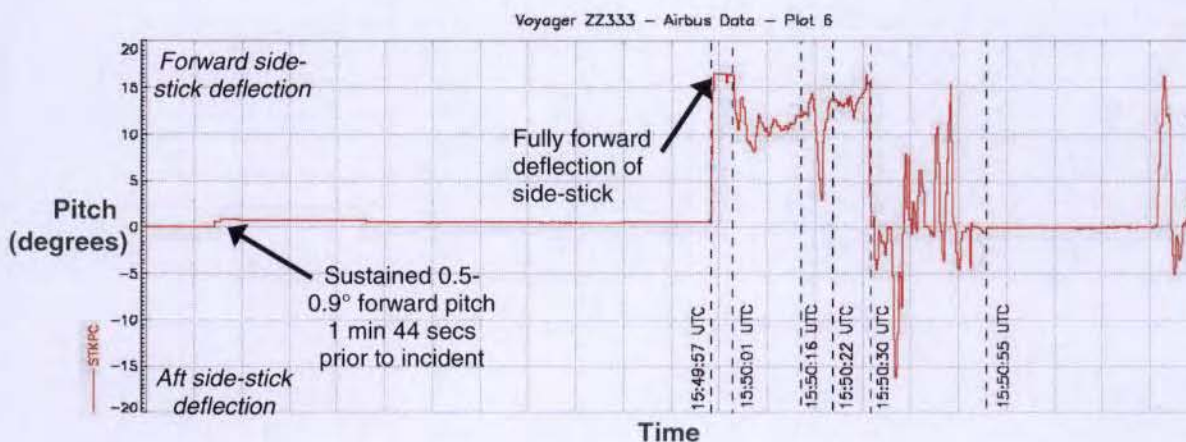
1.4.19 At 1548:13 UTC, one minute and 44 seconds prior to the event, the DFDR (Figure 1) detected a low frequency fluctuating pitch-down command of 0.5 to 0.9 degrees from the Captain's side-stick. This input endured until the onset of the full pitch-down command. This initial forward input was pure in pitch with no discernible lateral input. The force and displacement of the side-stick during this command did not disengage the autopilot, because a five deca-Newton force and five degree displacement of the side-stick (in pitch) is required before the autopilot will disengage. All side-stick movements, including those below the threshold for autopilot disconnection are recorded by the DFDR. Therefore, the aircraft remained initially in level flight with the autopilot engaged. At 1549:57 UTC, a fully forward input was made by the Captain's side-stick. This input was also pure in pitch and at constant rate. It had no discernible lateral input and was held initially for approximately four seconds at a fully forward deflection. It was this input which initiated the pitch-down event. Exhibit 30

Figure 1: DFDR extract showing Captain's side-stick pitch commands.

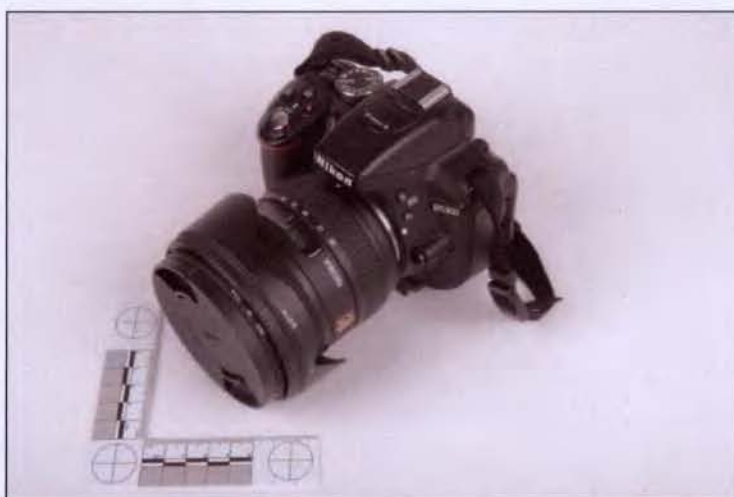
1.4.24 As a result, the Panel's focus turned to the possibility of an object connecting the seat and the side-stick. The Panel collected the official items and personal effects which had been on the flight deck at the time, in order to ascertain which of them could have interfered with the side-stick. In an interview with the Co-pilot, it became evident that a Nikon Digital Single Lens Reflex (D-SLR) D5300 Camera (Figure 3) belonging to the Captain had been present on the flight deck in the minutes leading up to the pitch-down event. Specifically, the camera had been seen by the Co-pilot on the surface area near the base of the Captain's side-stick shortly before the event. He had also seen the Captain using the camera during the flight.

Figure 3: Nikon D5300 D-SLR camera as received.

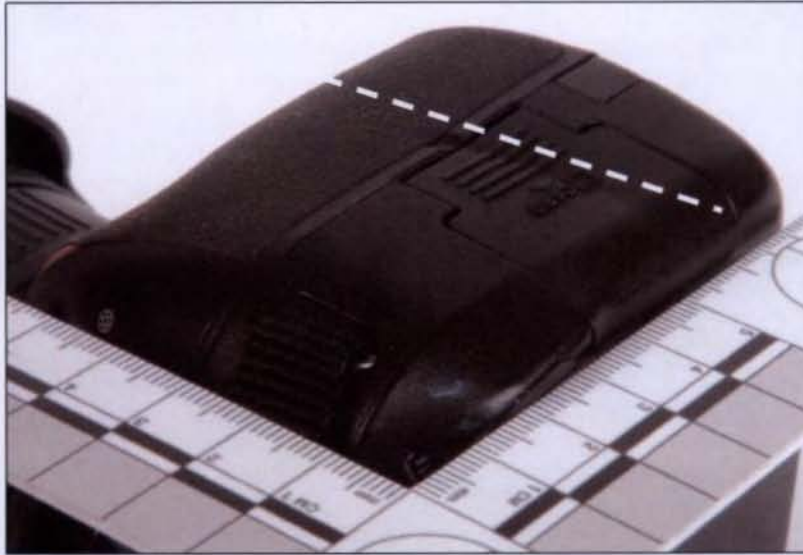
Figure 6: Location and orientation of large dent in camera (dotted line).

1.4.27 The camera was found to have a large linear dent on its right hand side (Figure 6). The dent extended from the softer hand grip region towards the front of the camera, across a thin part of the main body frame, and across the memory card flap.

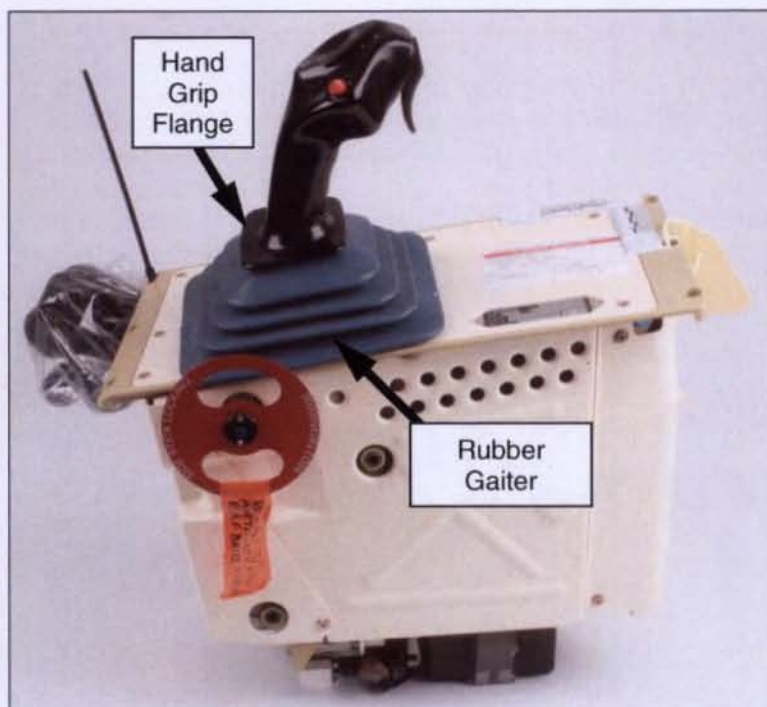
Figure 7: Side-stick unit as received by Panel.

1.4.28 The profile of the large dent was mapped forensically using surface profilometry and compared with the hand grip flange (Figure 7) at the base of the side-stick. The dent in the camera was found to be consistent with having been caused by the flange of the side-stick. Furthermore, chemical analysis indicated that trace amounts of materials present in a swab from the camera indentation were consistent with the material type of the side-stick. The rubber gaiter at the

base of the side-stick was examined using binocular microscopy, revealing two distinct perforations. The perforations were assessed to be the result of the gaiter material being pushed against the edges of the lower side-stick flange from the outside. When considered alongside other smaller witness marks on the camera, it was assessed as highly likely that the camera had experienced a significant compression against the base of the side-stick at some point during the flight. Specifically, it was assessed that the damage was consistent with the side-stick being pulled back forcefully against the body of the camera.

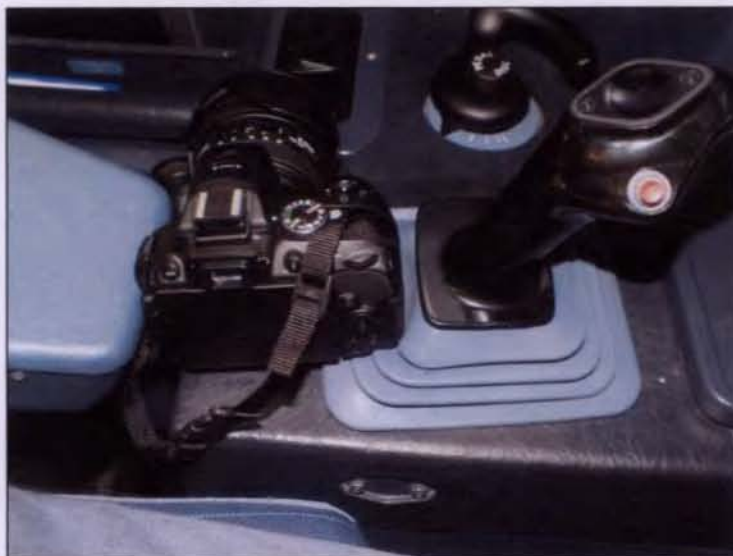
Figure 8: Re-construction of Captain's camera behind side-stick.

1.4.29 Using the Voyager simulator, the Panel reconstructed an arrangement of the armrest, the camera and the side-stick to assess the possibility of causing flight-control interference (Figure 8). The armrest was adjusted to the specific parameters used by the Captain on the flight in order to re-create the angle that was present during the event. Although the setting was within limits, it created an unusual angle, resulting in a particularly steep downward incline from back to front. The camera was placed in the gap between the armrest and the side-stick, with the damaged side presented towards the grip flange at the base of the side-stick. The seat motor was moved forward until the camera was gently flush against the base of the side-stick.

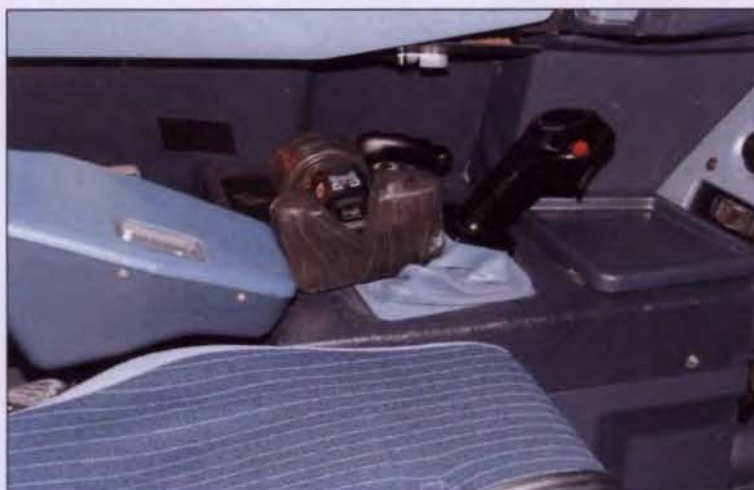
Figure 9: Side-stick locked in fully forward position (substitute camera).

1.4.30 The seat motor was operated in a forwards direction as heard at the onset of the pitch-down event. The effect was to push and hold the side-stick fully forward in a manner consistent with the pitch-down command seen on the DFDR (Figure 9). The motion resulted in the grip flange becoming aligned with a location exactly consistent with the dent in the camera. The re-construction took no more than a few seconds to set up.

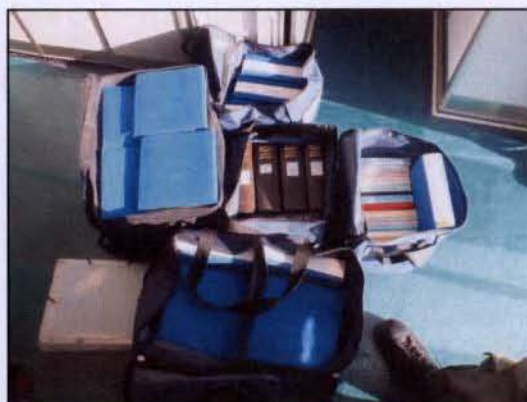
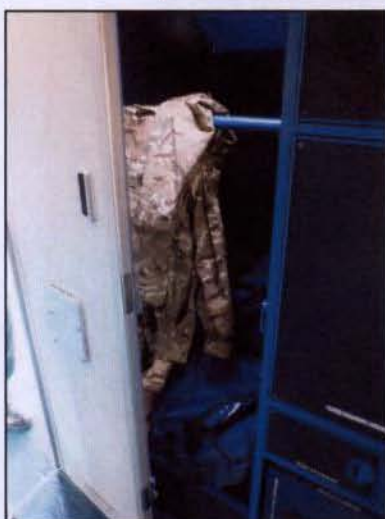
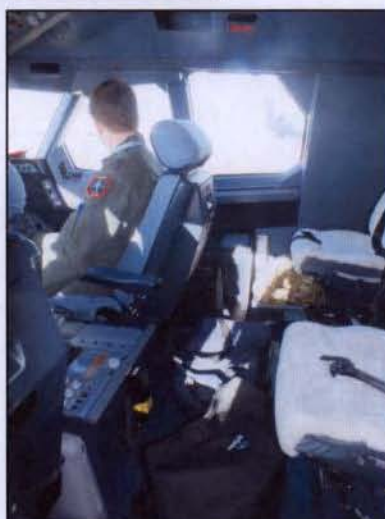
Figure 11: Carriage of in-flight publications.

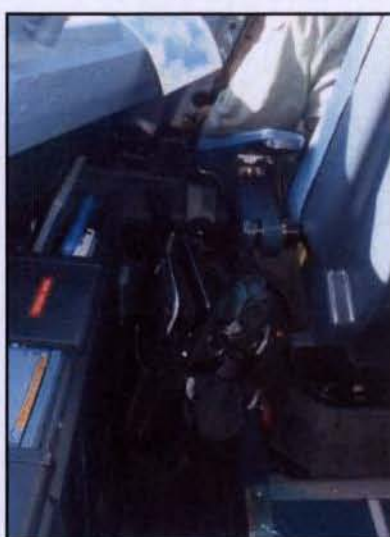
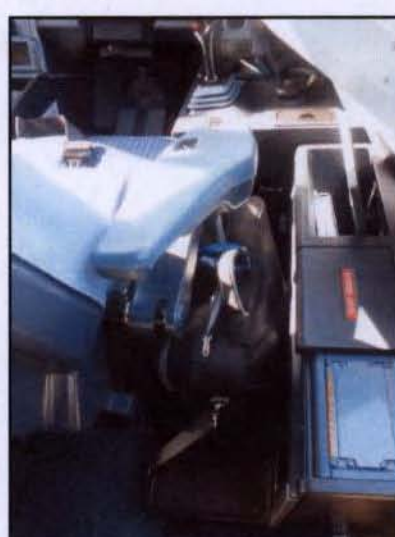
Figure 12: Floor area around Captain's and Co-pilot's seat.

(4) On the flight deck of any large aircraft a certain number of loose articles are inevitable if the aircraft is to operate effectively (pens, notebooks, spectacles etc). There was no evidence however, of official guidance or training within 2 Gp which related to the carriage and use of these items and how they should be stored and positioned on the flight deck, increasing the likelihood that personnel would develop their own norms and practices as a result of experience and advice of others. Photographs taken on the flight deck of ZZ333 shortly before the incident indicated that there were a number of loose articles placed in areas around the flight deck, some not officially designated for stowage (Figure 13). The selection of typical locations used to store items illustrates the challenge imposed by the imbalance between the available storage on the flight deck, the required volume of official equipment and documentation and the carriage of personal items. While the Voyager flight deck had adequate space for these items to be carried, there were not enough dedicated storage locations for the sheer volume of official items, resulting in items being stored on the floor and in ad hoc areas. In particular, the area around the side-stick appeared to be treated no differently to any other surface on the flight deck.

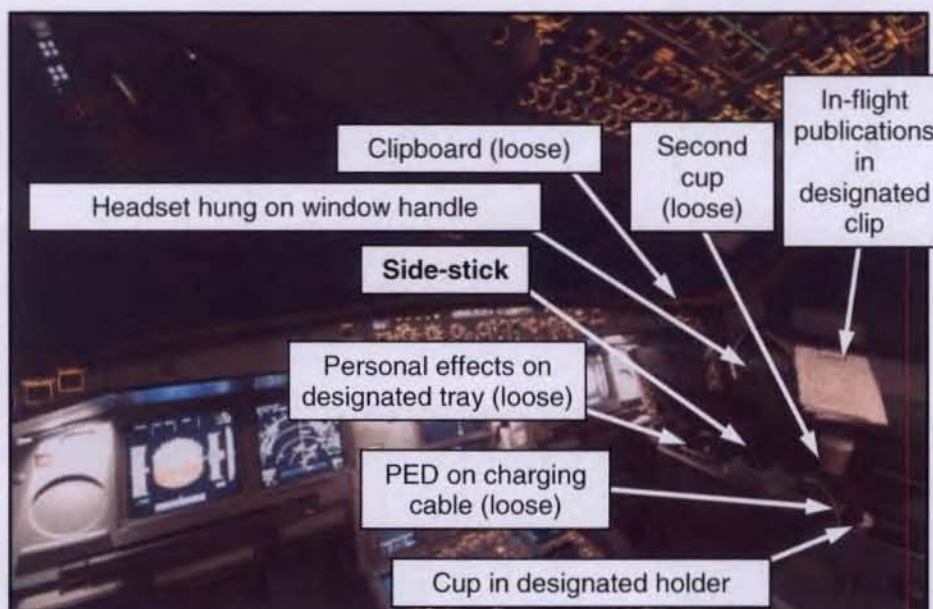
Figure 13: Photograph of Co-pilot's position 6 mins 15 seconds prior to incident.

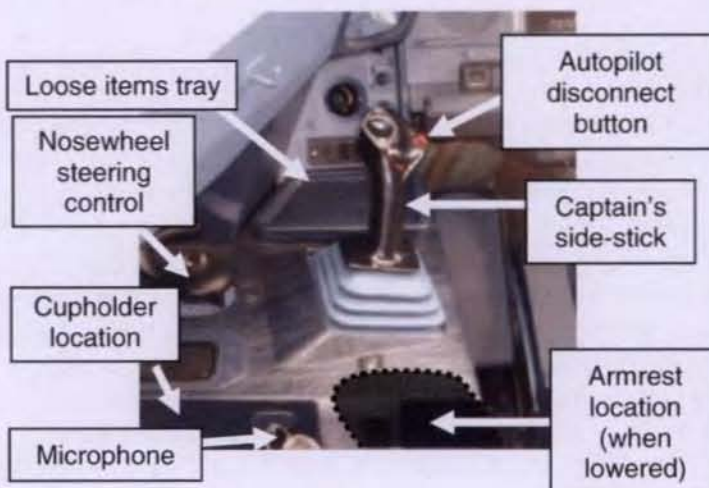
(1) **Layout.** The seat can be positioned so that the side-stick is within the reach of the pilot. An armrest provides support to the pilot's elbow while using the side-stick, which is in line with good ergonomic practice to enable continuous adjustments and extended periods of use². The armrest is adjustable to enable the pilot to achieve a comfortable working posture. A combination of the setting of the armrest and the seat position brings the armrest into the vicinity of the side-stick. The minimum distance the armrest can achieve relative to the side-stick when the seat is moved is 50mm. There is a minimum of 140mm clearance between the side-stick and the nearest fixed obstruction (Figure 14).

Figure 14: Layout of Captain's side-stick area.
