**OFFICIAL SENSITIVE — SERVICE INQUIRY**

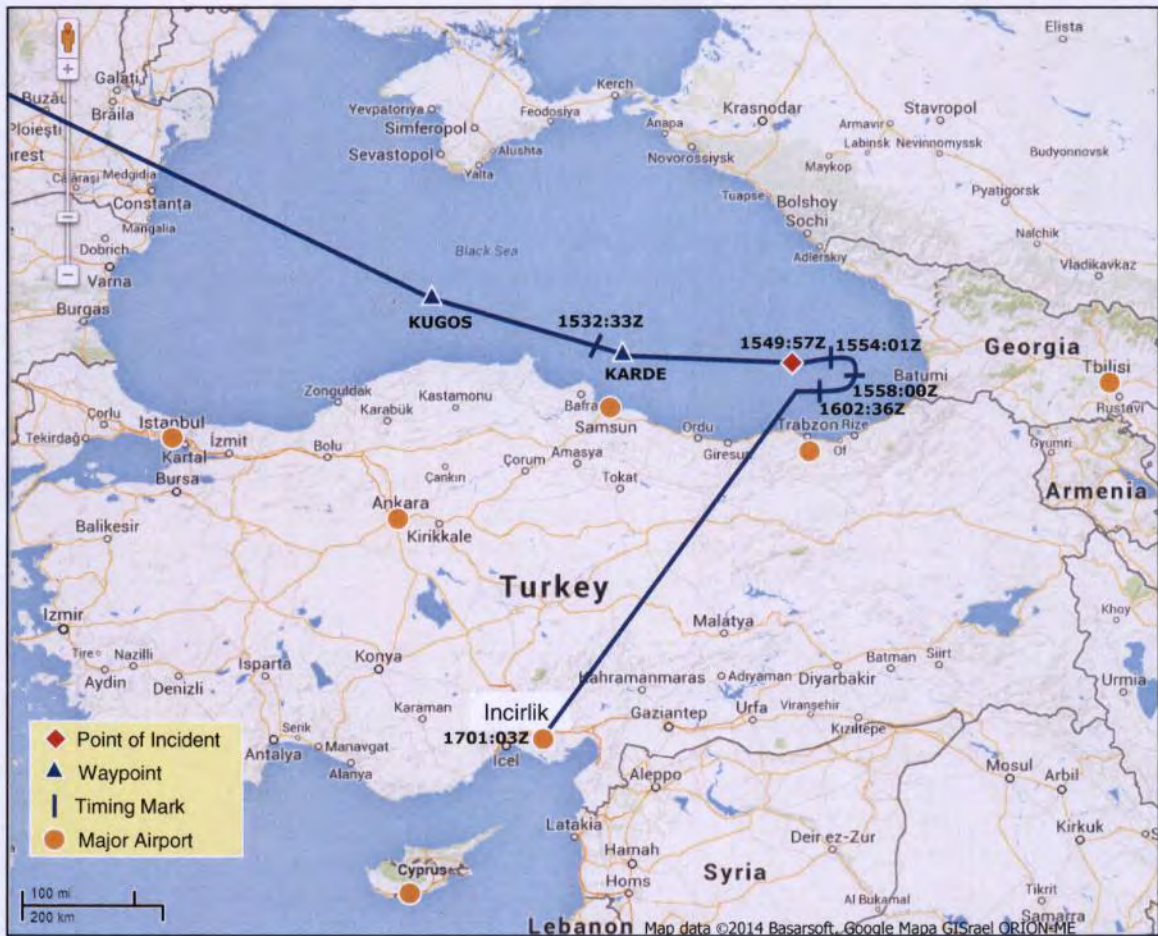
Figure 25: Illustration of diversion route (map data © 2014 Google, Basarsoft.)

1.4.98 As the incident developed, the Captain elected to divert and land the aircraft as soon as possible. The Co-pilot asked Turkish ATC for, 'an immediate diversion to a suitable airfield of our choice.' ATC suggested Trabzon (LTCG), some 60nm south of the aircraft's position. The flight-deck route bag, compiled by AirTanker Services, contained Terminal Approach Plates for the following recommended en-route diversion airfields: Trabzon (60 nm range); Samsun (142 nm range); Tbilisi; (242 nm range); Ankara (331 nm range), and Istanbul (486 nm range) (Figure 25). In discussing Trabzon, the pilots were uncertain regarding its suitability and instead tried to recall, 'the name of the major airfield in Turkey.' The crew then asked ATC for a diversion to Istanbul Airport, approximately 500nm from their position. Initially, ATC agreed to this request and instructed the crew to set course to Istanbul. After a few minutes however, ATC relayed a message from the Turkish Military Authorities that it would be better if the aircraft diverted to Incirlik (LTAG) where the USAF was based, at a range of some 340nm. This was accepted by the Captain, who turned the aircraft towards Incirlik. **The Panel observed that despite a number of suggested en-route diversions being within safe range of the aircraft, no pre-planned diversion formed part of the crew's decision-making process.** In addition to the lack of a pre-nominated diversion, Human Factors analysis indicated that it was likely the following factors influenced the diversion decision:

a. **Familiarity.** There is a tendency to judge unfamiliar items more negatively than items with which an individual is familiar. The crew had a negative response to the diversion location that they were least familiar with (Trabzon), seeking a less unfamiliar option (Istanbul), and reporting being most happy when presented with a familiar location (Incirlik).

b. **Suitability.** The runway length and distance from current location were primary considerations for the pilots as they evaluated the suitability of any possible diversion airfield. The pilots indicated that they wanted to land the aircraft as soon as possible, but they also wanted enough flying time for preparations to be made for landing. In interviews, the pilots said that time would be required to make the cabin safe and to enable a low rate of descent to be used. The pilots had also perceived that there would be a requirement to cope with medical issues on board, although at the time of selecting a diversion location the nature of any passenger injuries was not known and had not yet been discussed.

c. **Workload.** Eleven minutes elapsed between the initial decision to divert the aircraft and the selection of Incirlik. This period corresponded to the immediate aftermath of the incident and was characterised by shock, high workload and high arousal. It is likely that the capacity of the pilots to undertake complex decision making and to evaluate options from scratch would have been reduced.

d. **Decision-making aids.** Owing to the negative 'g' experienced during the incident the flight deck was in considerable disarray and both pilots were strapped into their seats, therefore they did not have immediate access to the list of approach plates which were in the route bag. Although the nearest suitable airfield could have been obtained from the Multipurpose Control and Display Unit, this did not appear to influence crew decision-making regarding a suitable diversion location. The difficulty of access to Terminal Approach Plates was mitigated by the availability of ATC primary radar, the favourable weather conditions and the lack of extensive terrain around Incirlik.

**1.4.101 Recommendation.** The Panel recommended that the Air Mobility Force Commander ensures that the list of suggested en-route diversions for operational strategic air transport tasks is informed by an operational risk assessment of the consequences of diverting into each location.
