FINAL REPORT

**ACCIDENT
INVOLVING ATR 72 AIRCRAFT
REGISTRATION MARKS TS-LBB
ditching off the coast of Capo Gallo (Palermo - Sicily)
August 6th, 2005**

AGENZIA NAZIONALE
PER LA SICUREZZA DEL VOLO

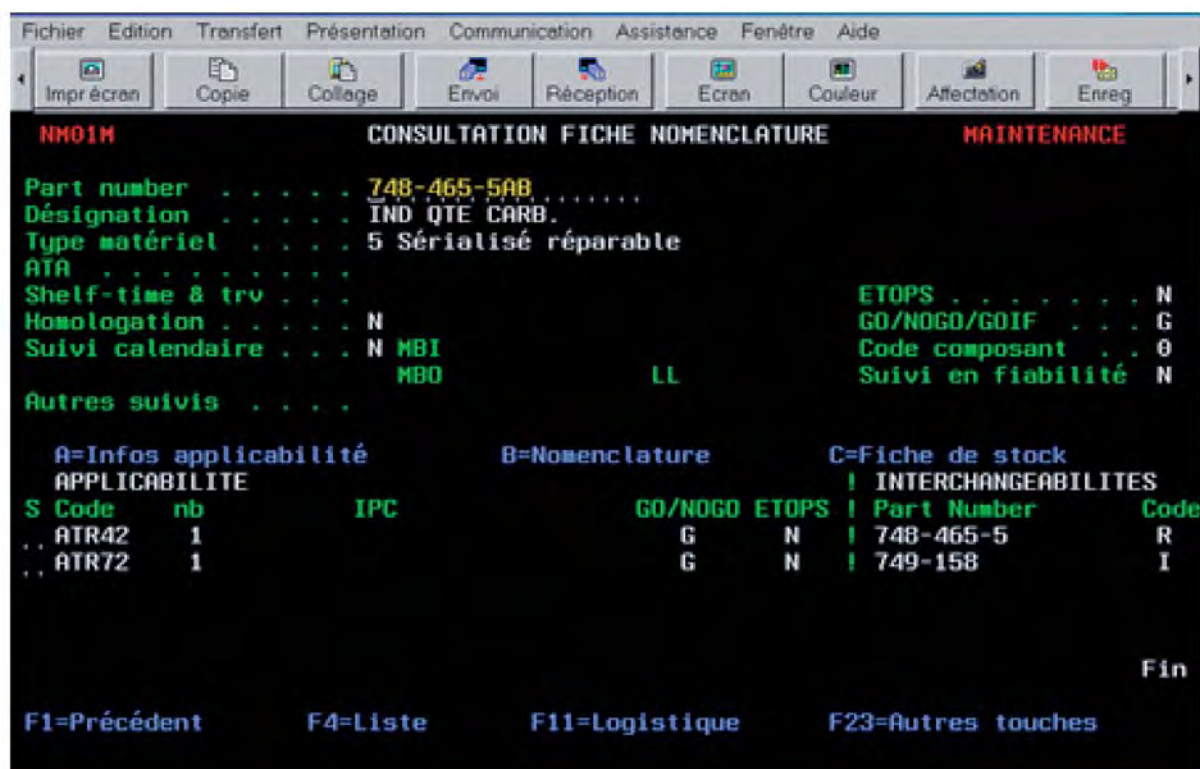
As this result was rather strange, considering that at least the FQIs already installed on the aircraft of the carrier should have shown on the information system, the technician tried to look for FQIs recorded with a P/N different from the one listed in the IPC; the technician started a new database search entering only the first three digits of the P/N, followed by a dash (“748-”), then scrolling through the list looking for any FQI suitable for installation on ATR 72 aircraft. With this method and following the search procedure of the ®AMASIS system, the technician was able to find the part called “IND QTE CARB”, identified with P/N 748-465-5AB, which the system showed as suitable to both ATR 42 and ATR 72 aircraft, and also interchangeable with FQI P/N 749-158.

Figure 5: Screen information provided by ®AMASIS.

In the section “APPLICABILITÉ” (bottom left of figure 5), the “Code” field indicates in fact the type or the family of aircraft on which the part can be installed, the “nb” field shows the quantity needed on each aircraft and the IPC code in the ®AMASIS video should give the chapter, page, section and figure of the IPC where the part is listed. In the section “INTERCHANGEABILITÉS”, at the bottom right of figure 5 are listed the P/N of other interchangeable parts, while the field “Code” shows any restrictions (“I” means full interchangeability, “R” means interchangeable but with restrictions imposed by the manufacturer).

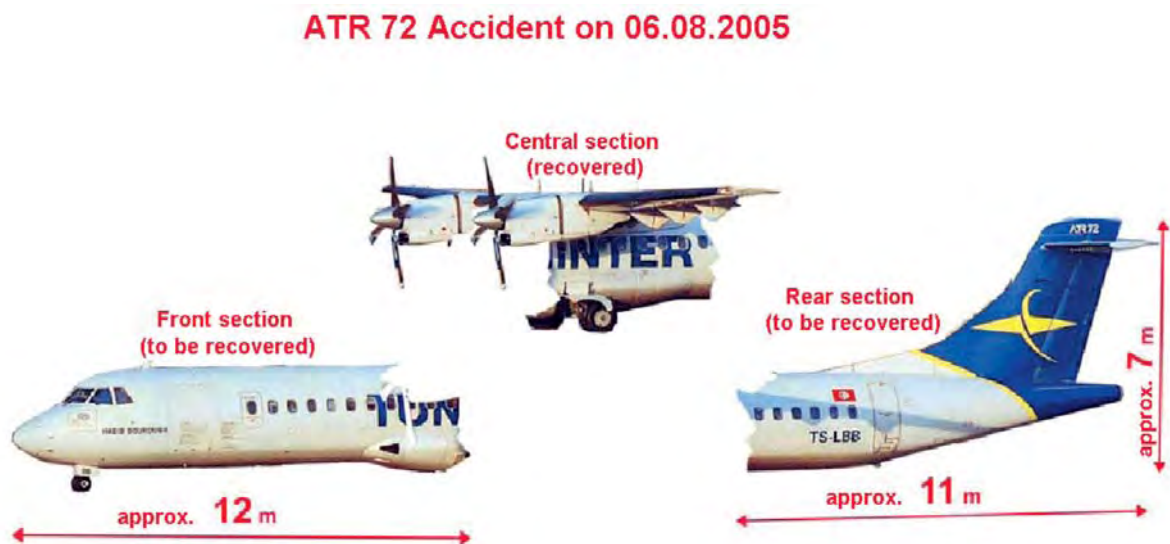
- LH and RH wings with nacelles and engines and part of the central fuselage;
- The rear, including the vertical and horizontal stabilizers and part of the fuselage;
- Front and central section of the fuselage, also including the cockpit.

The illustration in figure 6 shows the three parts of the aircraft discussed above, with indication of the parts which were recovered later on, as they had sunk shortly after the ditching. Such reconstruction of the wreckage was made immediately after the event, on the basis of the available information, and proved useful for carrying out the subsequent wreckage recovery operations.

Figure 6: Illustration showing the three sections the aircraft broke into, following impact with the sea surface (ANSV reconstruction). The indication “to be recovered” refers to the date of August 6th, 2005. These parts were later recovered.

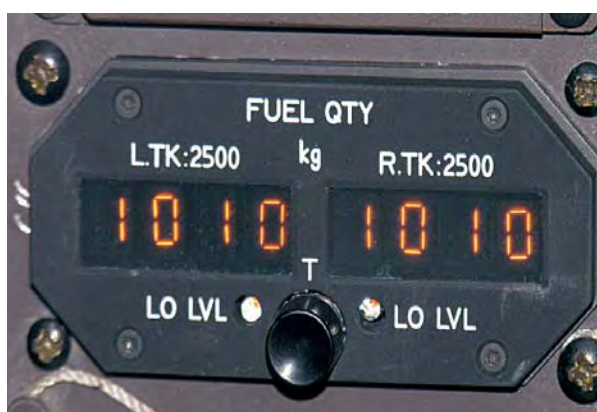
Photo 8: FQI ATR 72.

Difference between FQIs, when not installed on the aircraft, is also determined the P/N on data plate on top of it which is different between ATR 72 and ATR 42 type FQIs .

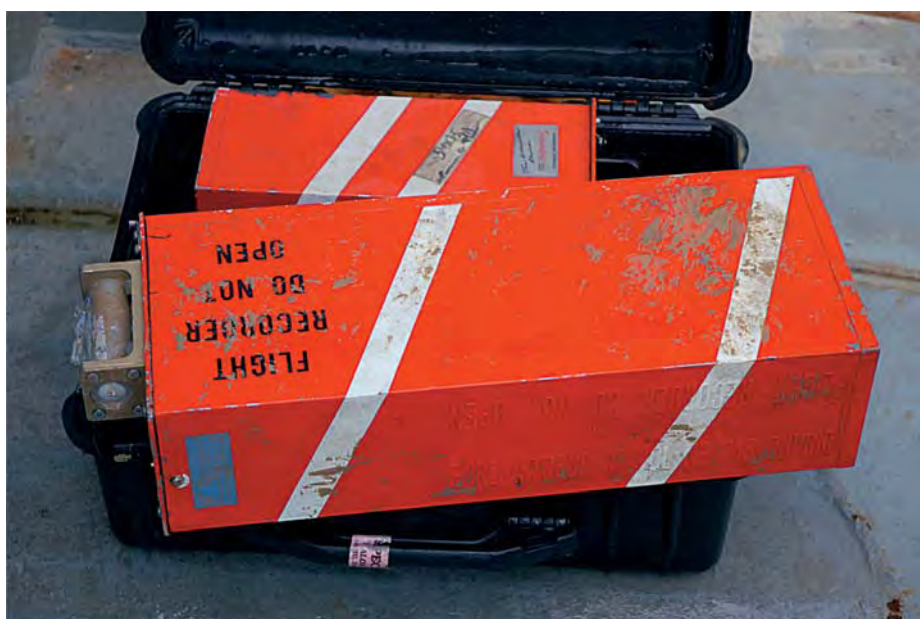
Photo 16: The recovered FDR (foreground) and CVR.

Both units were in reasonable general condition, without evidence of impact or fire damage.

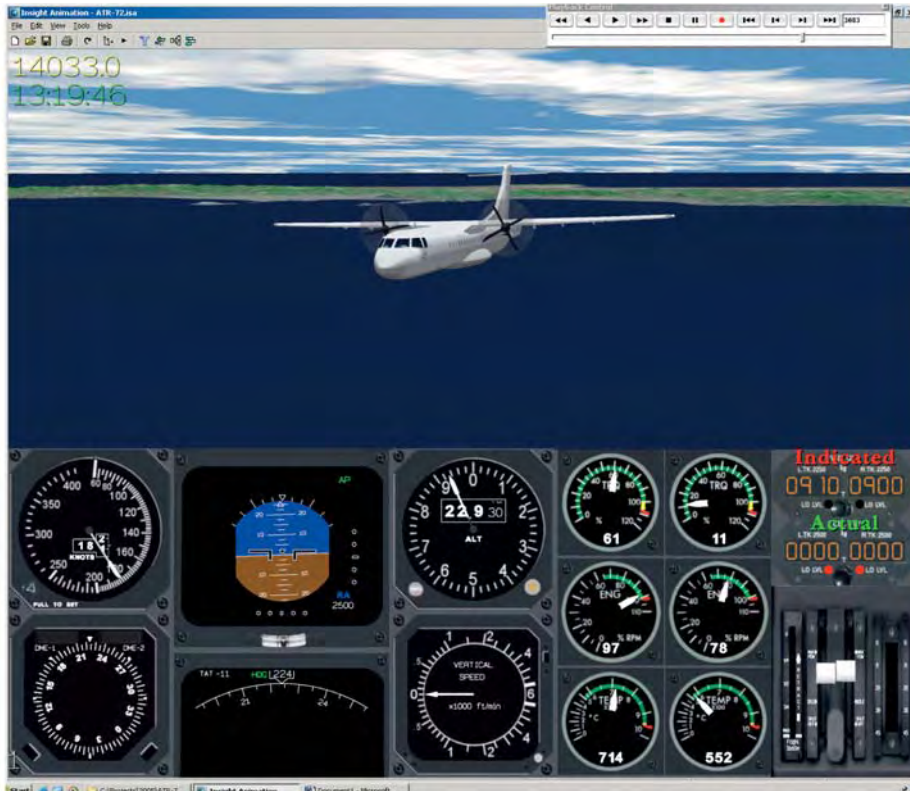
Figure 13: Right engine shut down.

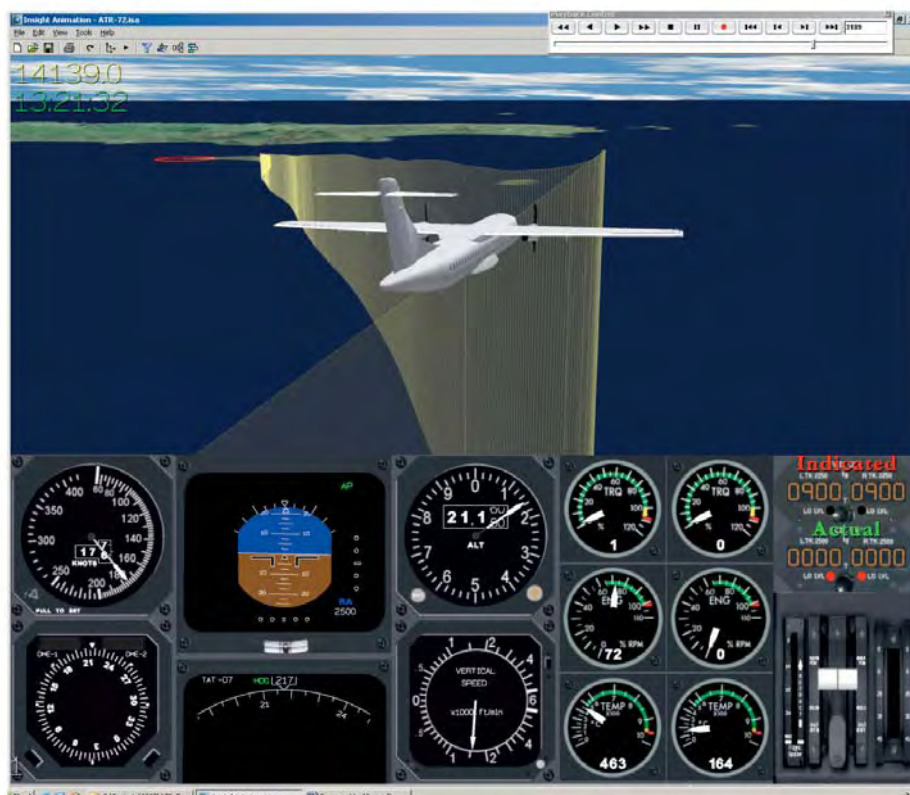
Figure 14: Aircraft during the descent with both engines shut down.

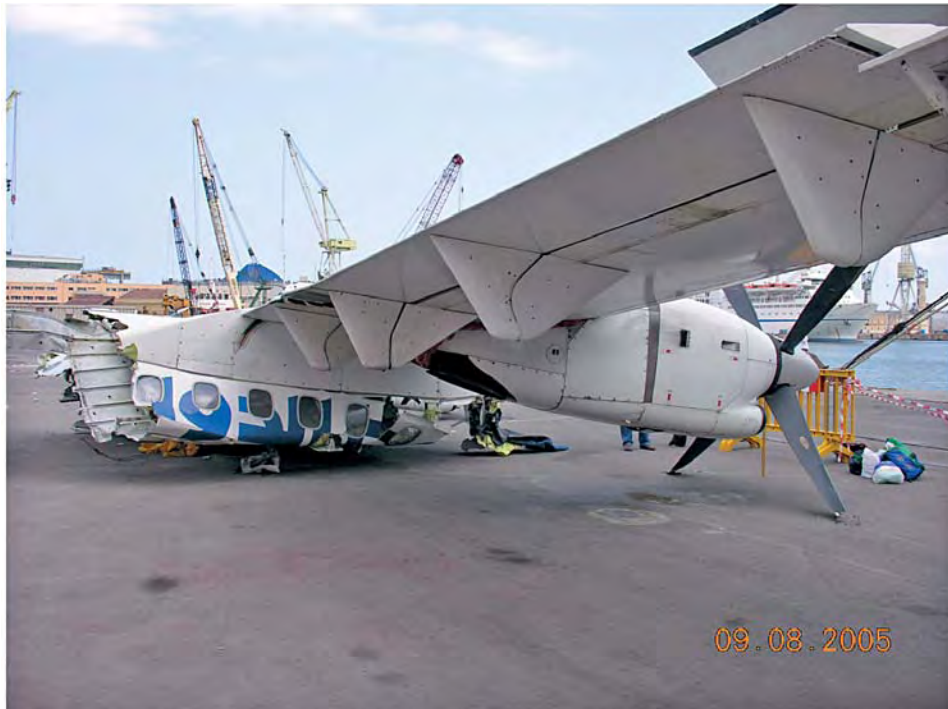
Photo 22: Part of the central fuselage with LH and RH wings at the Port of Palermo.

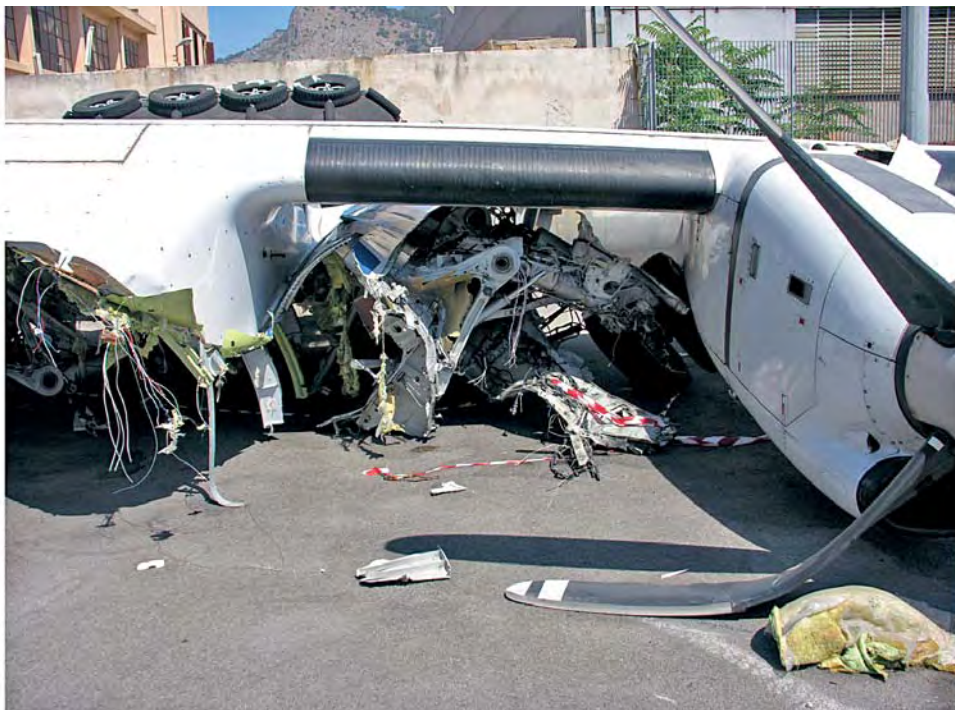
Photo 23: Part of the central fuselage with LH and RH wings at the Port of Palermo, the central section.

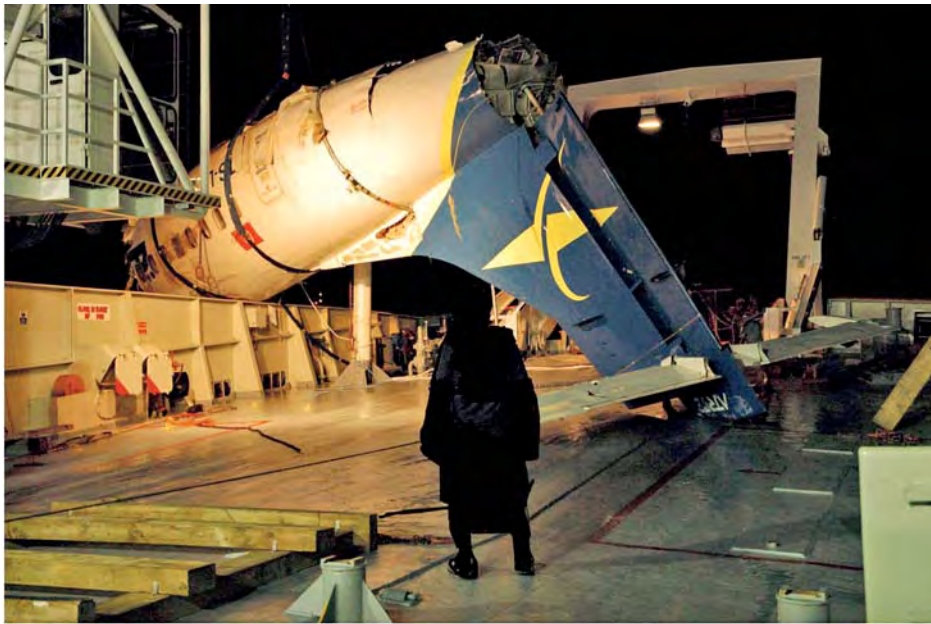
- a) Tail section, approximate length 11 metres, including horizontal and vertical tail assemblies. A large gash in the bottom section was clearly visible from the outside. The end part of the tail cone was missing. It had in fact already been recovered by the rescue team from the sea surface on the same day of the event.

Photo 24: Positioning of the wreckage on the ship's deck

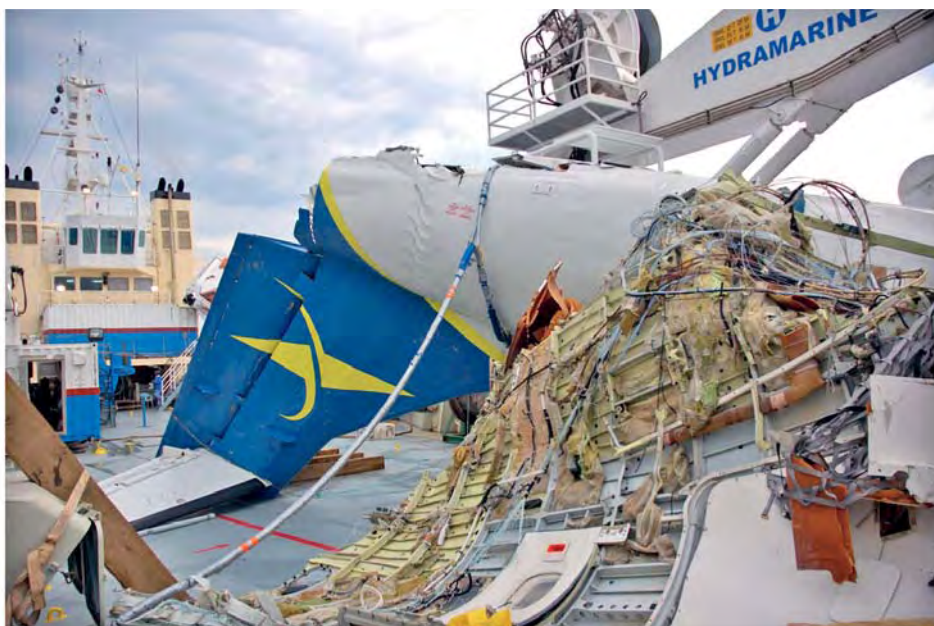
Photo 25: Remains of the wreckage on the ship's deck after recovery.

Considerable structural damage was found on the inside. The pressure bulkhead between the cabin pressurized zone and the tail had a large diagonal gash (see photo 34 and 61). The tail assemblies did not show any significant deformation. The CVR was removed from its housing. It was removed, immediately washed with fresh water and then placed in a container full of distilled water. The supports of the FDR housing appeared damaged and the device itself was missing (photo 61).

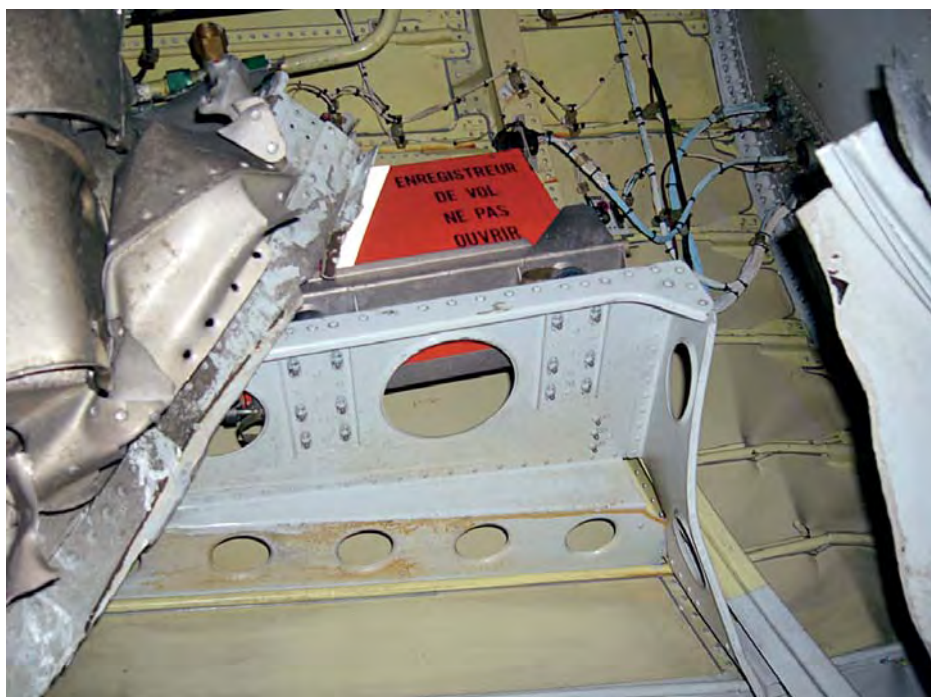
Photo 26: CVR in its housing inside the aircraft.

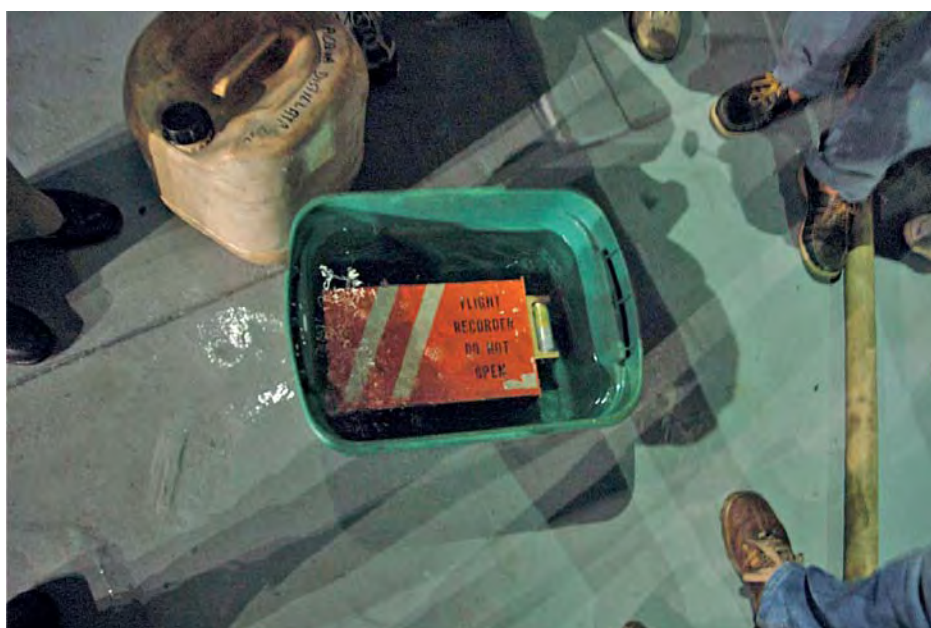
Photo 27: CVR in distilled water, after being recovered from the aircraft.

As described later, the FDR was located and recovered from the bottom of the sea. Also the FDR was washed and placed in distilled water immediately after being recovered, in order to prevent corrosion affecting the quality of the recorded data. Both recorders were then placed under sequestration by the competent judicial authority.

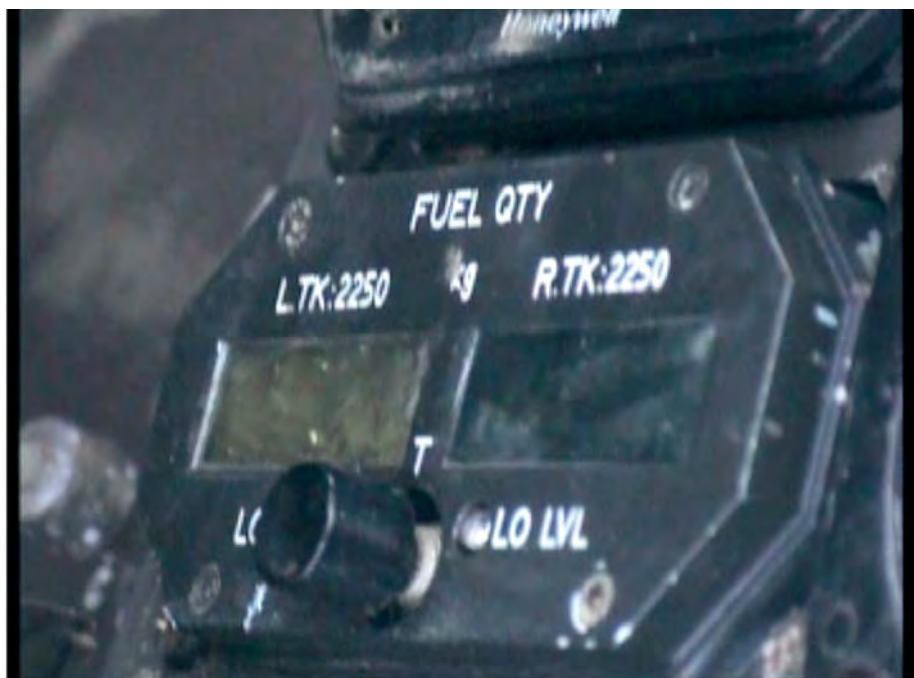
The Fuel Quantity Indicator was still in its housing inside the cockpit. Photo 29 shows the front part of the instrument with the writing 2250 kg, which indicates the maximum fuel capacity of each wing fuel tank. In effect the indication of 2250 kg relates to indicators used by the ATR 42 models. Subsequent checks did in fact confirm that the FQI installed was a model intended for ATR 42 aircraft.

Photo 29: The FQI installed on the TS-LBB - video still taken immediately after recovery.

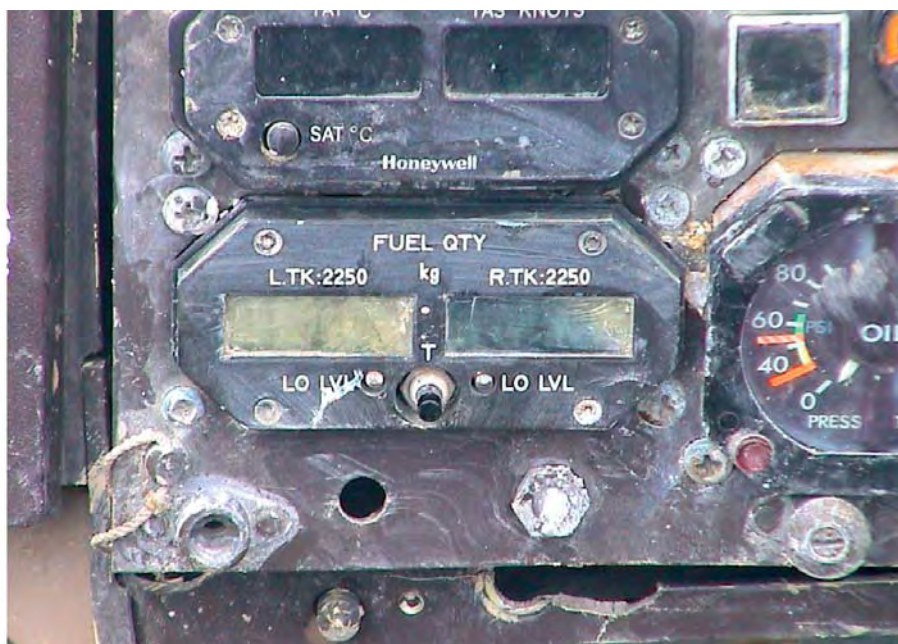
Photo 30: FQI front panel recovered from the wreckage. Note the inscription “2250” corresponding to an ATR 42 type FQI.

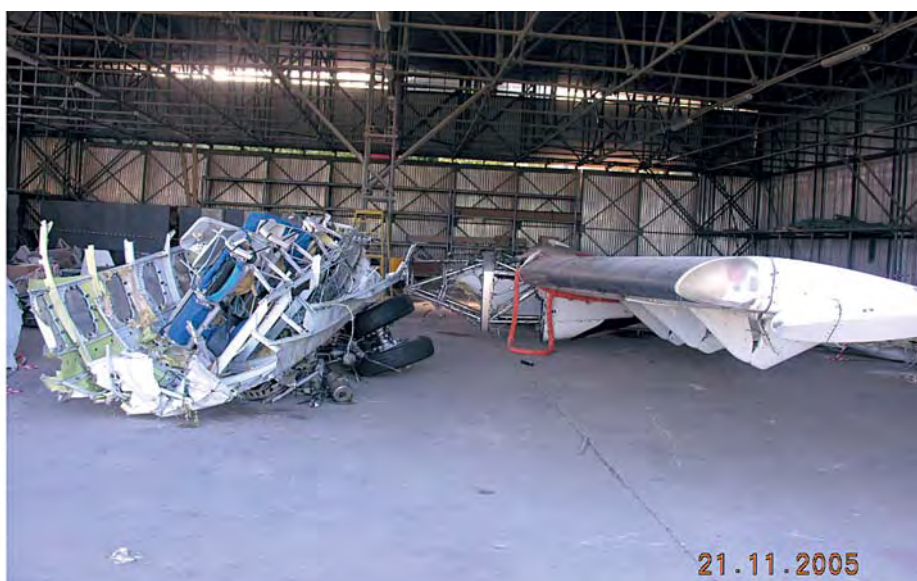
No specific tests have been carried out on the structural parts of the wreckage. Most of the break points showed the typical overload stress characteristics. No evidence of fatigue and corrosion was detected. As already indicated, as far as the rear section is concerned, breaks are localized by the severed section, connected to the remaining part of the aircraft fuselage. No signs of damage were detected in the tail section.

Photo 31: Part of the wreckage inside a hangar at Bocca di Falco.

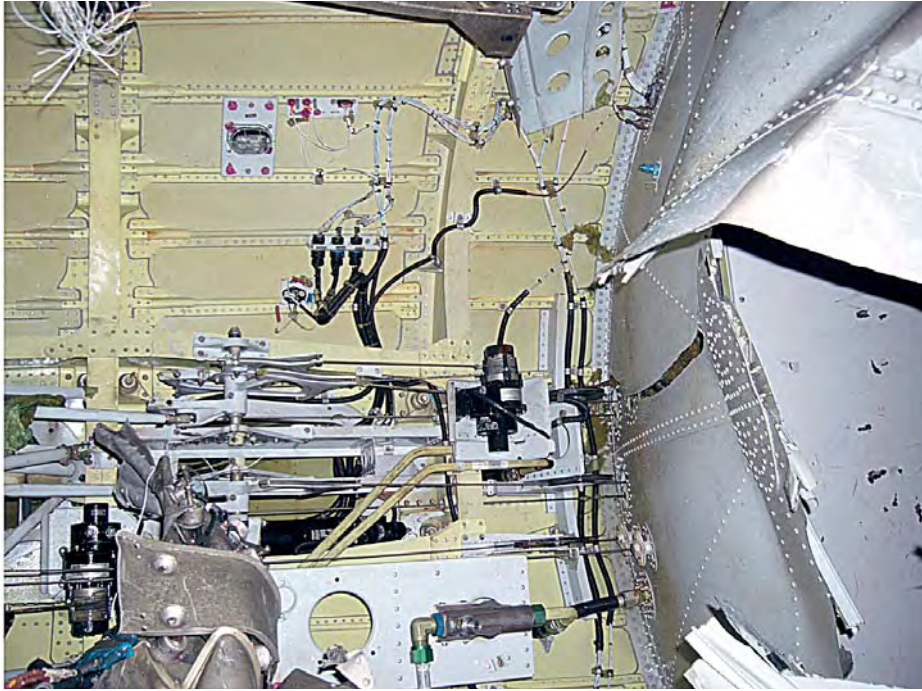
The rear of this section showed a great amount of damage and deformation, resulting in the breaking of the pressure bulkhead between the pressurised and the non pressurised zone. This indicates that the impact of the aircraft against the sea surface was very strong. The rear had in fact completely collapsed, while the seating area was virtually intact.

Photo 34: Rear of the aircraft, inside view. Note the deformation of the pressure bulkhead.

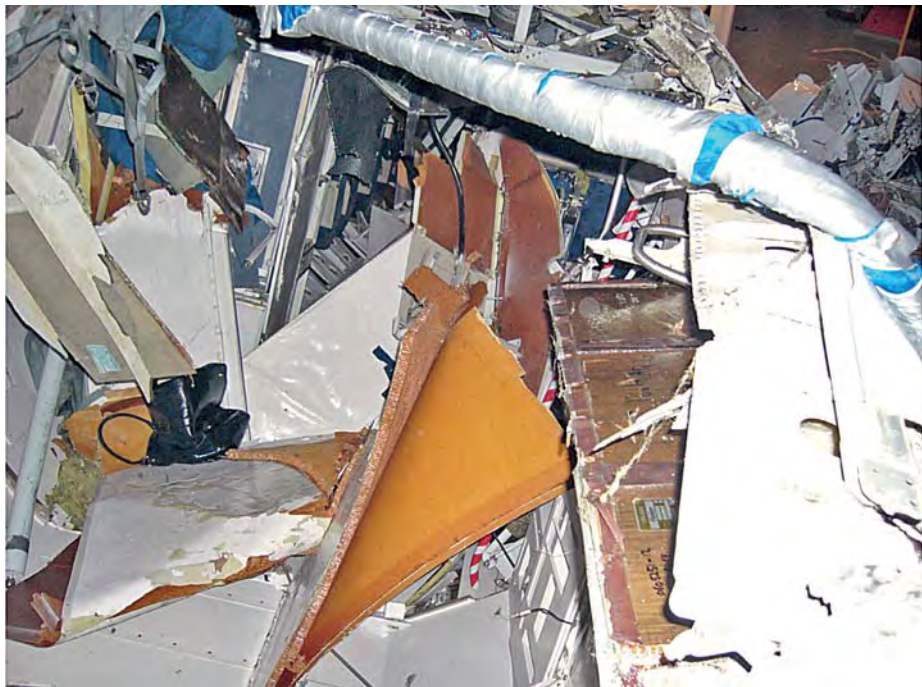
Photo 35: Interior of the passenger cabin.

Together with the evidence given by some passengers occupying the back rows, who remember hearing a loud impact and then being immediately surrounded by water, the scene encountered indicates that the rear of the aircraft might have been the first to impact against the water surface, separating from the rest of the structure due to the strong induced bending stress.

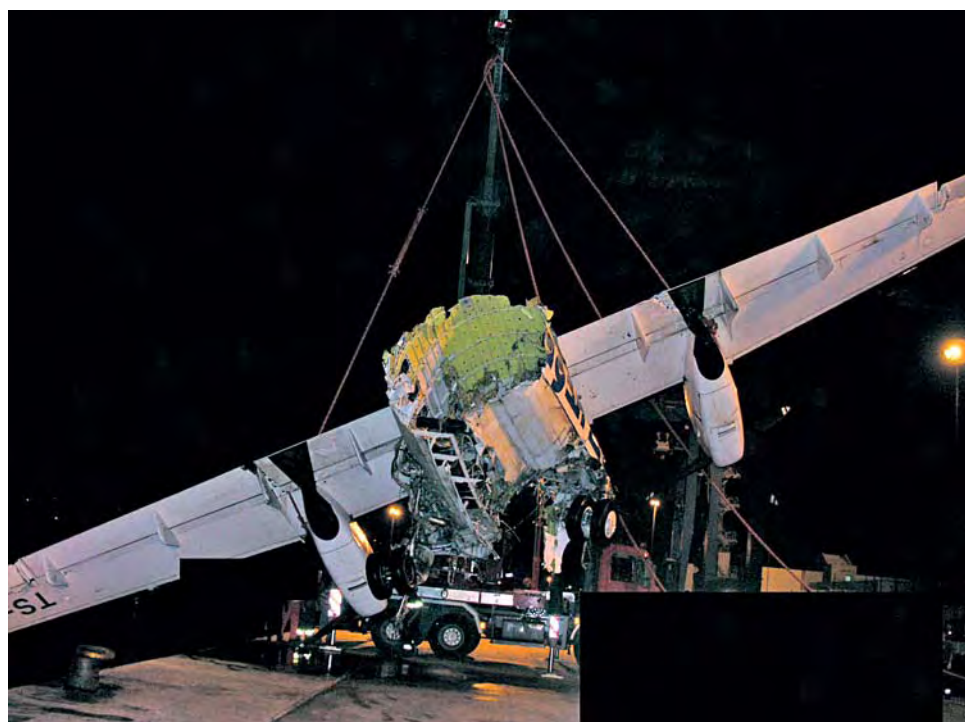
Also this section shows no evidence of breaks due to fatigue and/or any corrosion. All sections show breaks typical of overload.

Photo 36: Central section of the wreckage, with LH and RH wings, during recovery.

The right-hand appeared more deformed than the left-hand, indicating that the right-hand of the aircraft had suffered a stronger impact. The seats on this side were in fact no longer attached. From the evidence, it appears that the central section strongly impacted against the sea surface. The strong bending stresses caused by such impact caused the structure to separate from the rest of the aircraft at the point of the main landing gear and the wing structure.

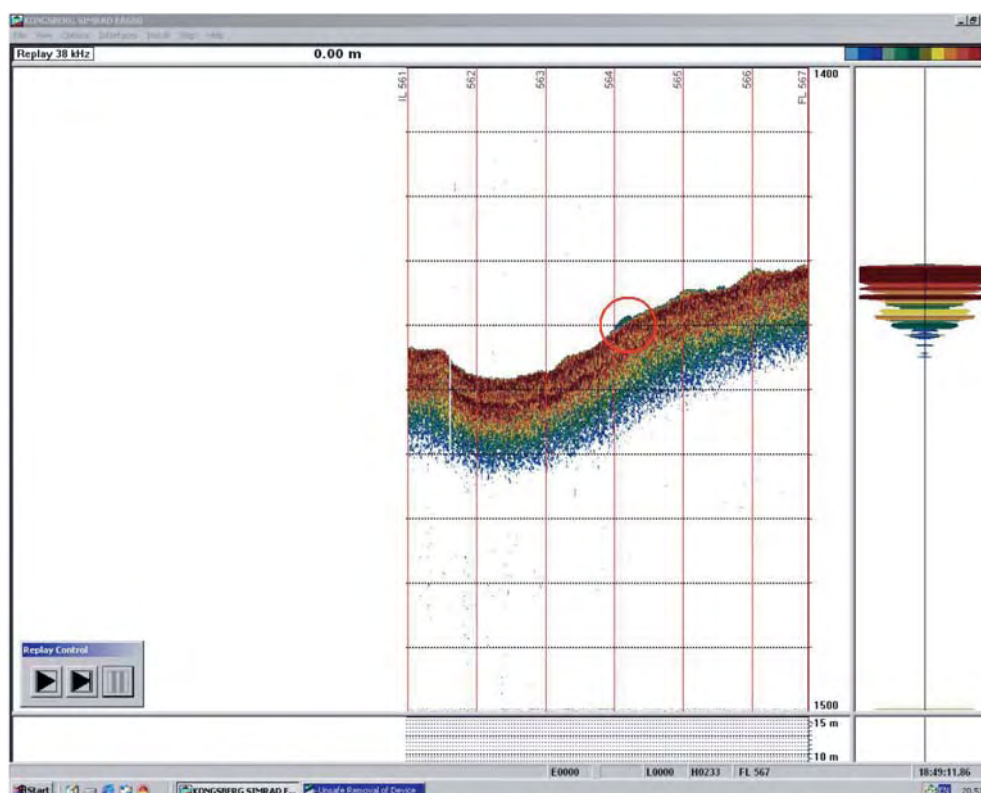
The scanning operations enabled to identify some abnormalities, particularly the presence of parts which were not compatible with the type of seabed. These were the starting point for the subsequent search stage, carried out using side scan sonar. These needed to be placed underwater and towed using underwater ROVs.

Figure 18: Abnormalities on the seabed.

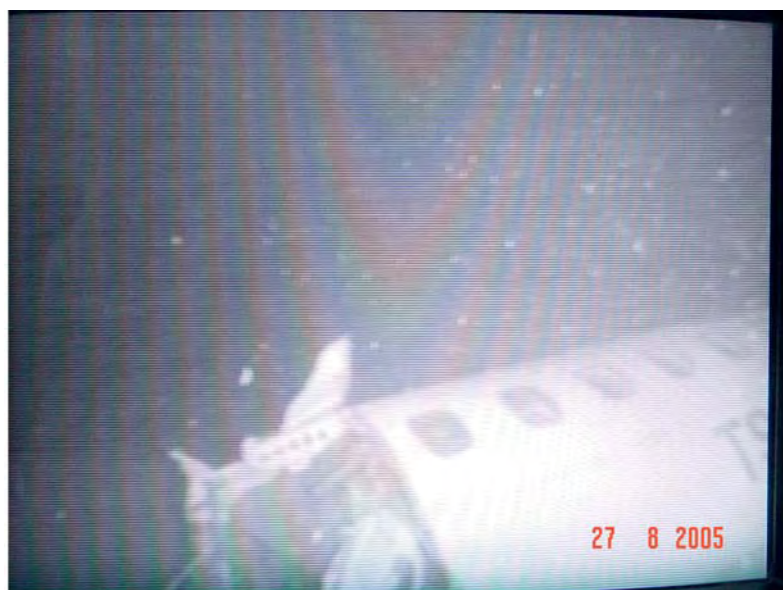
05.08: contact and visual inspection of some parts of the wreckage, particularly the tail assembly. The geographical coordinates were in accordance with those established by the Navy during the previous days. In order to check for any human remains, the inside was inspected. This operation was performed with difficulty (the roof of the cabin had collapsed). The results were negative.

Photo 53: The tail section at the bottom of the sea (approximate depth 1450 metres).

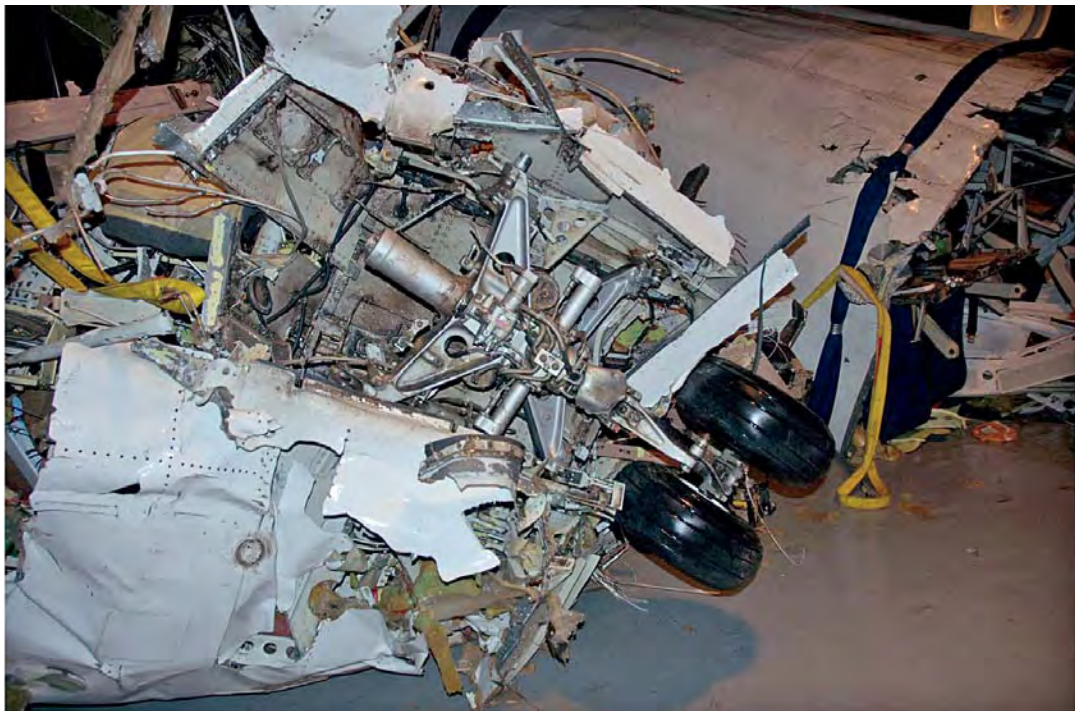
Photo 59: Front of the fuselage, nose landing gear.

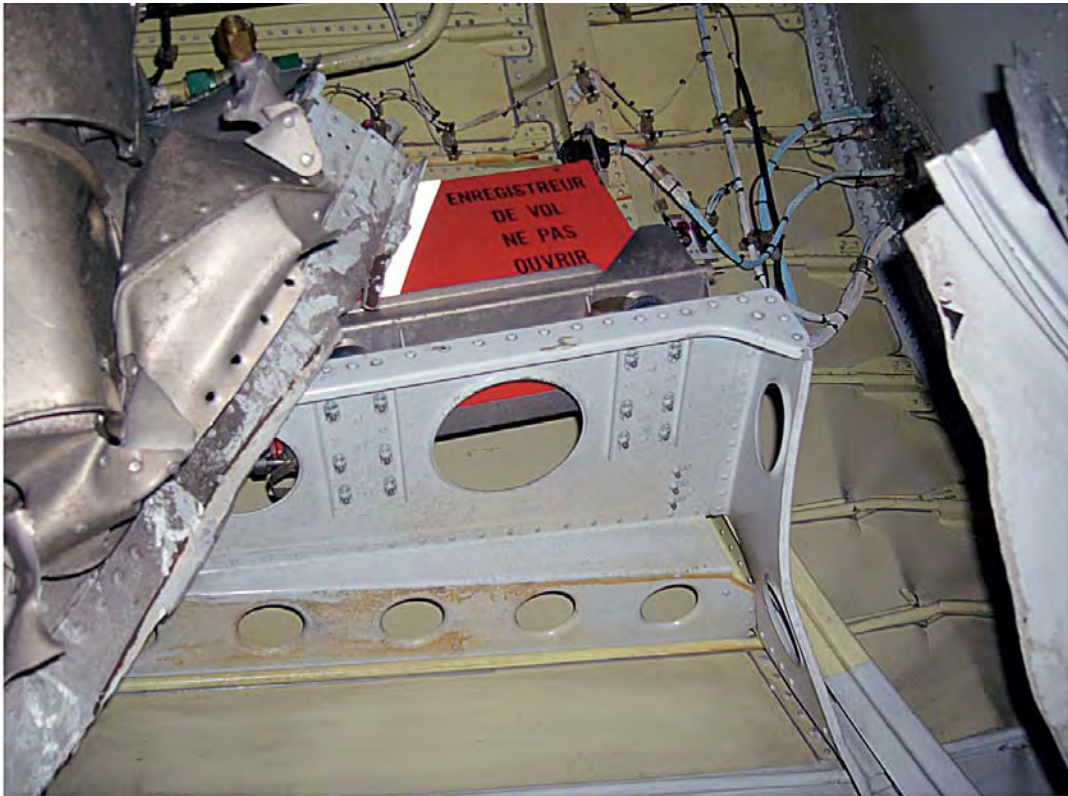
22.00: the recovery of the tail section was completed. This was positioned on the deck of the ship. The rear section was immediately inspected from ANSV personnel, looking for the flight recorders. The CVR was in its position, but the FDR was missing. The FDR housing showed

Photo 62: CVR in its housing.

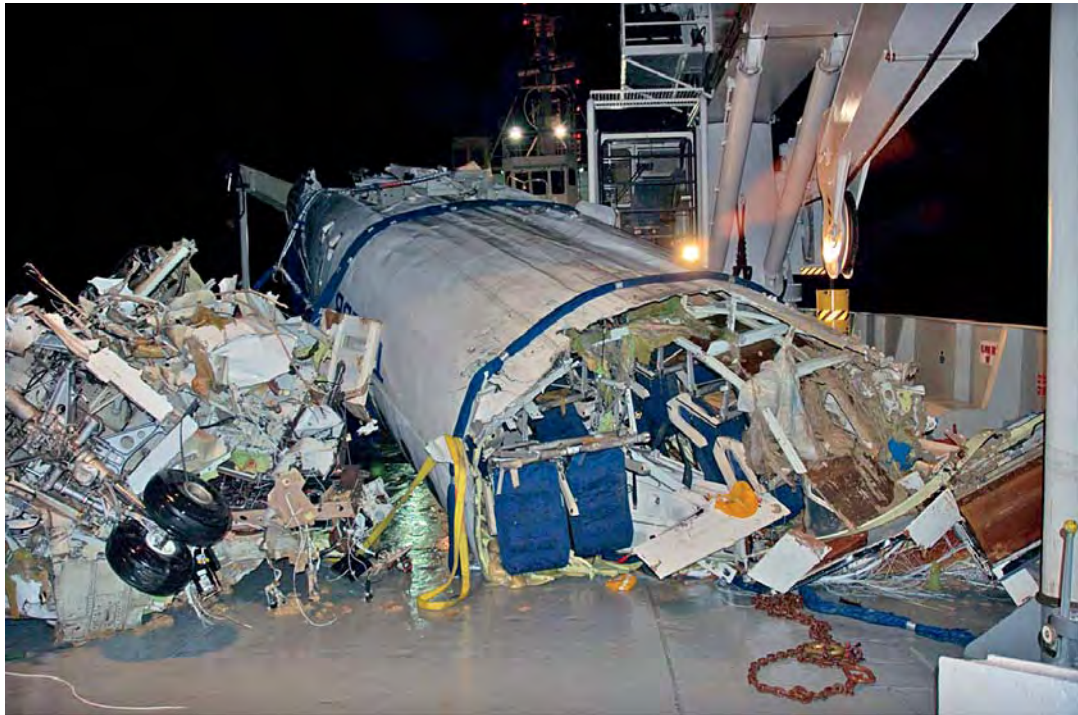
Once the tail section was positioned on the ship's deck, with lifting gear still attached, the recovery personnel realised that a large part of the fuselage remains were still attached to the tail. In fact, the remaining part of the aircraft, including the front of the fuselage and the cockpit, was still attached to it. This meant that approximately 70 to 80% of the wreckage had now been recovered.

Photo 63: Tail section on the ship's deck with front part of the fuselage

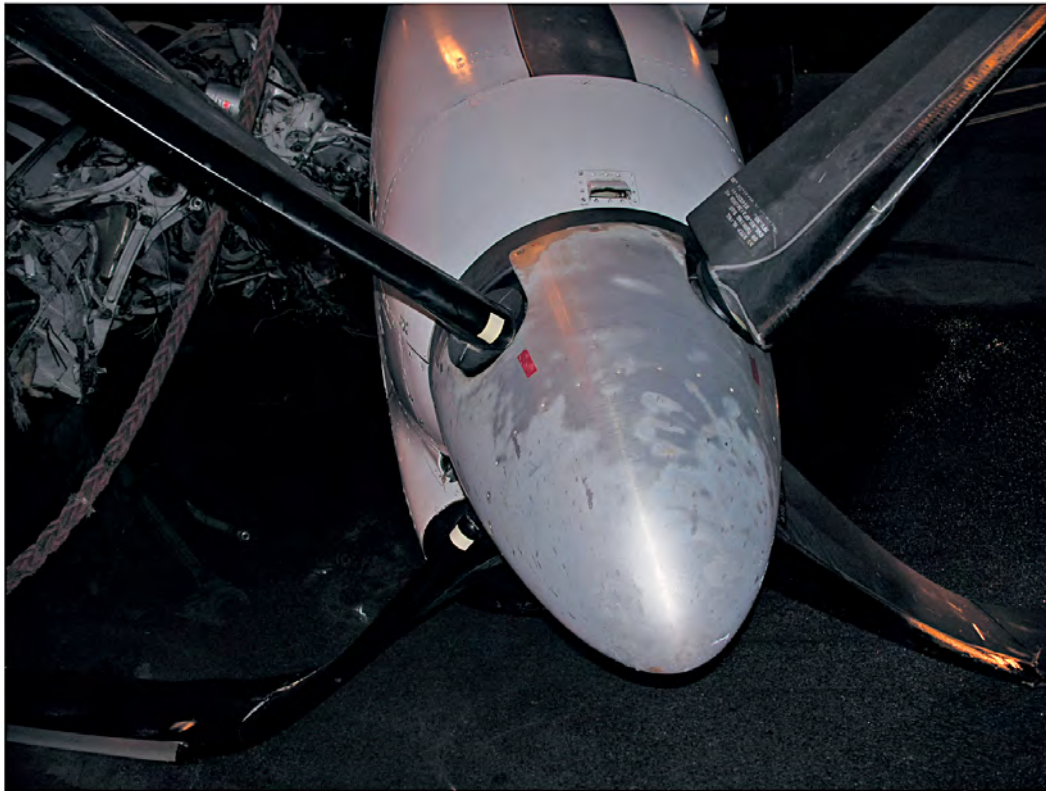
Photo 70: Note the feather position of the right engine propeller.

- The substantial integrity of the propeller blades, which were only damaged during the recovery operations and placement on the wharf of Palermo harbor (bending);
- Pitch of the blades in the fully feathered position (the position of minimum drag to forward motion);
- No evidence of fuel or lubricants leaks;
- No evidence of damage to the feed lines.

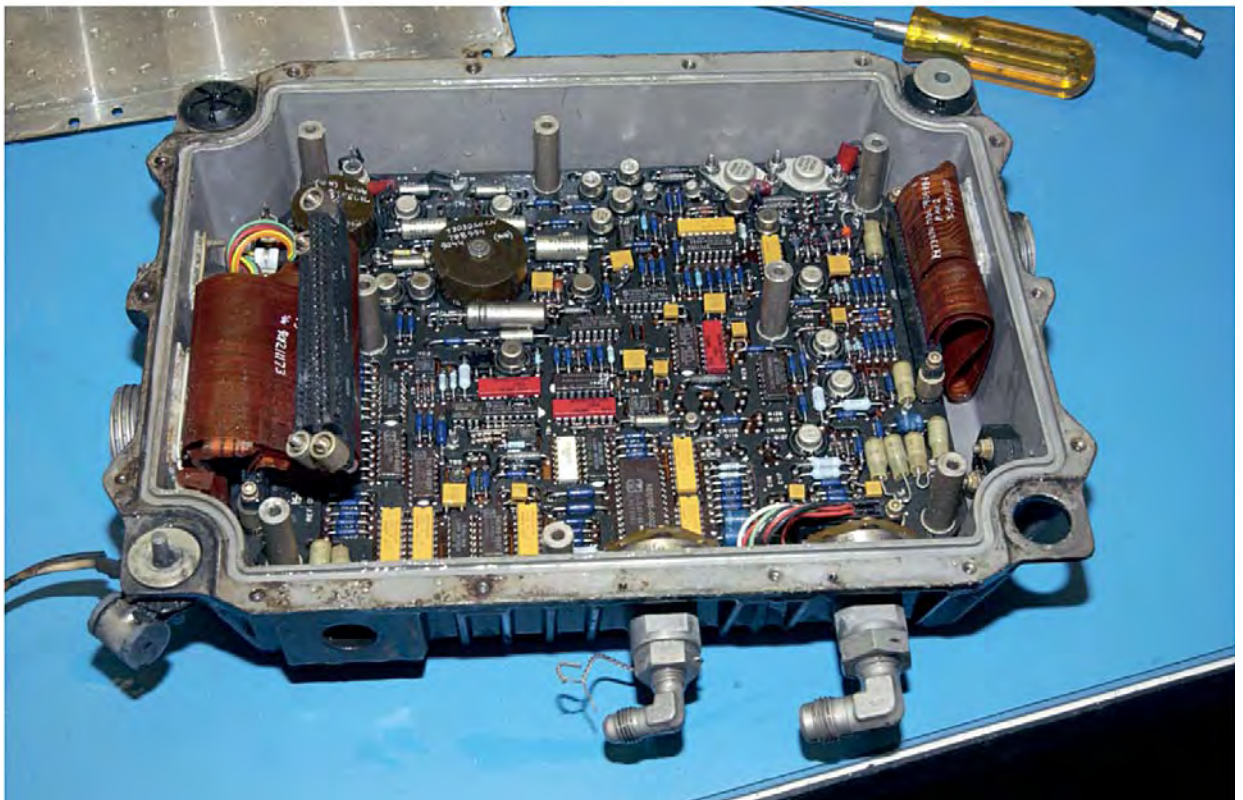
The information recovery operation gave positive results. This was also due to the good condition of the devices. The data recovered are in the form of a list of failure codes that have occurred from the date of the last reset, but they are not associated to a time parameter that could indicate when exactly they happened.

From the analysis of these data, it is possible to safely confirm that the engines did not suffer any notable failures, such as high turbine temperatures, compressor stall and/or malfunctioning of the internal components, which may have caused a spontaneous engine shutdown.

Photo 75: EEC internal circuits.

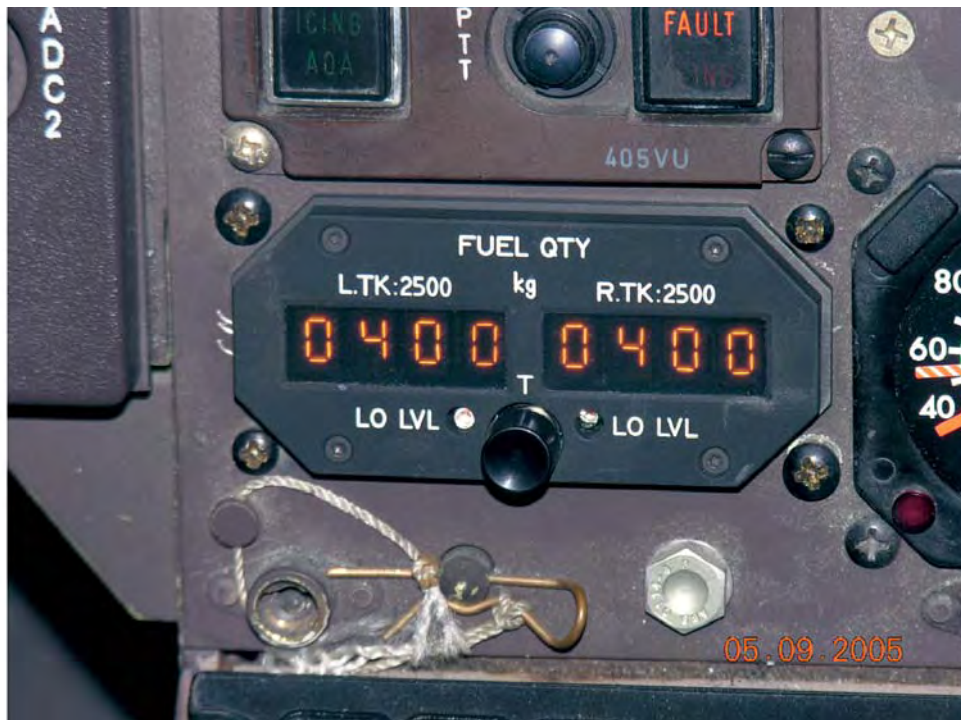
Photo 76: Indication given by ATR 72 FQI fitted on an ATR 72 with 400+400 kg of fuel in each tank.

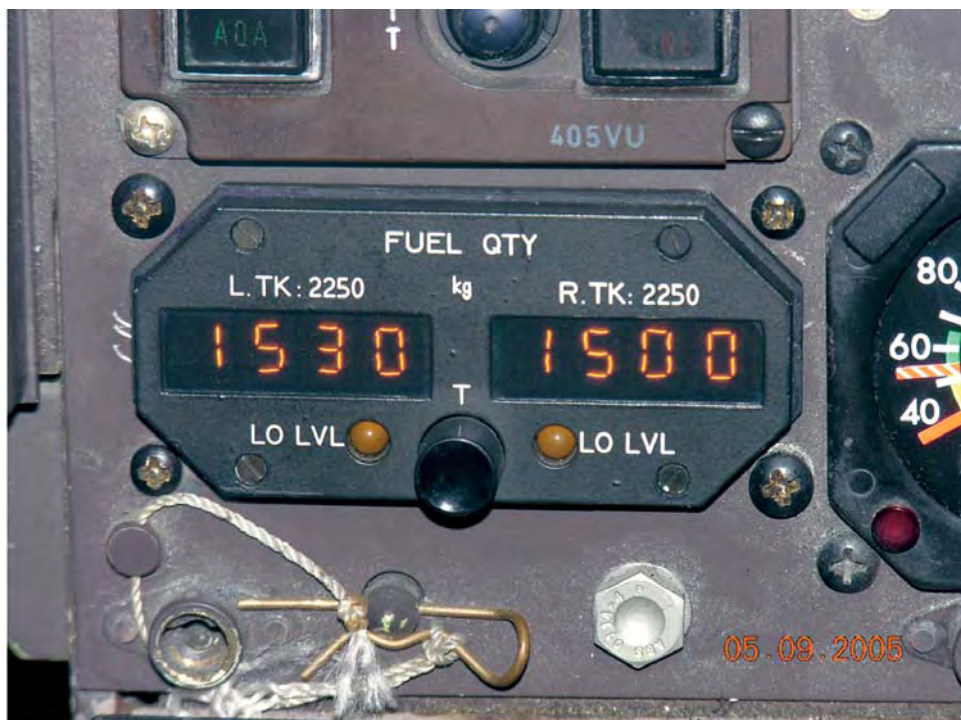
Photo 77: Indication given by an ATR 42 FQI fitted on an ATR 72 with 400+400 kg of fuel in each tank.

From the analysis of the results, it is therefore possible to state that the quantity indicated by an ATR 42 type FQI installed on an ATR 72 aircraft is higher than the quantity actually present in the fuel tanks and that it follows a linear variation curve, which is shown in the graph itself. In particular, by extrapolating the data based on the value of 0 kg, the indication of an ATR42 type FQI is equal to approximately 1800 kg. This is the quantity given by the TS-LBB crew to the air

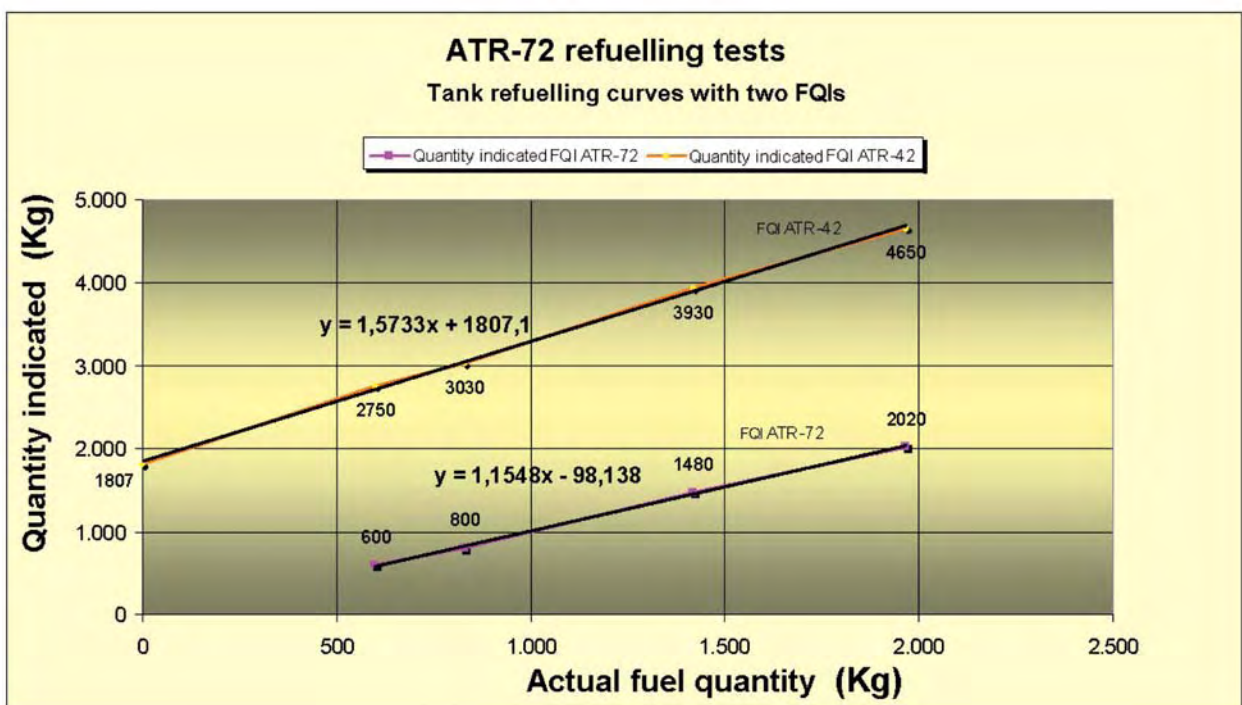
Figure 22: Tank refuelling experimental curves using two FQIs.

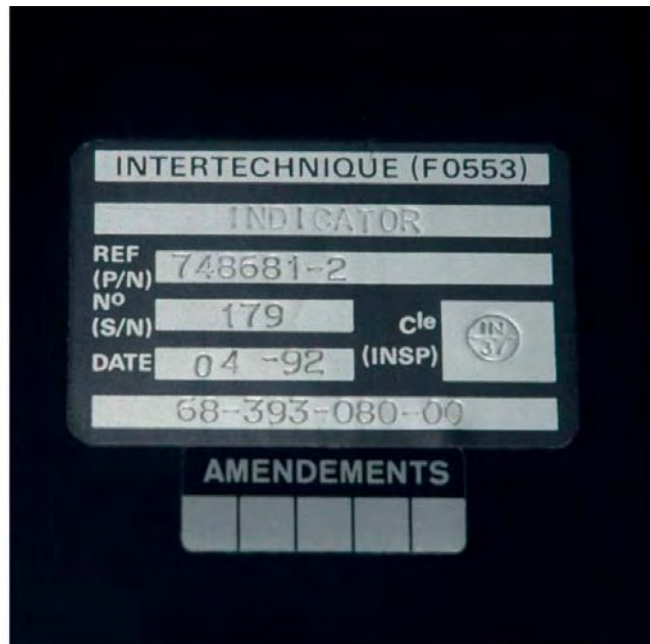
The same search was then performed by inserting P/N 748681-2, therefore omitting the dash between the first and second group of numbers. This is the P/N as printed (see photo 80) on FQI S/N 179, removed from the aircraft TS-LBB for replacement. In this case, the video monitor responded with the information relating to P/N 748681-2, called INDICATOR.

Photo 80: FQI S/N 179 nameplate (Data Plate).

- The ®AMASIS system also recognises dashes between alphanumeric groups as significant characters.
- The P/N number stamped by the manufacturer Intertechnique on the S/N 179 FQI, is different from the one listed in the IPC for the ATR 72 aircraft, with the dash after the digits 748 being missing. P/N 748681-2 is also listed on the document called "Authorised release certificate – Airworthiness approval tag" (subsequently replaced by JAA FORM ONE, now EASA FORM ONE); the P/N of ATR's IPC reflects the Intertechnique certification P/N as determined by Intertechnique itself.

On the contrary, the plate attached to instrument P/N 748681-2 S/N 179 (see Photo 80), which was removed from TS-LBB, has no hyphen after the first three figures.
