FINAL REPORT

**ACCIDENT
INVOLVING ATR 72 AIRCRAFT
REGISTRATION MARKS TS-LBB
ditching off the coast of Capo Gallo (Palermo - Sicily)
August 6th, 2005**

AGENZIA NAZIONALE
PER LA SICUREZZA DEL VOLO

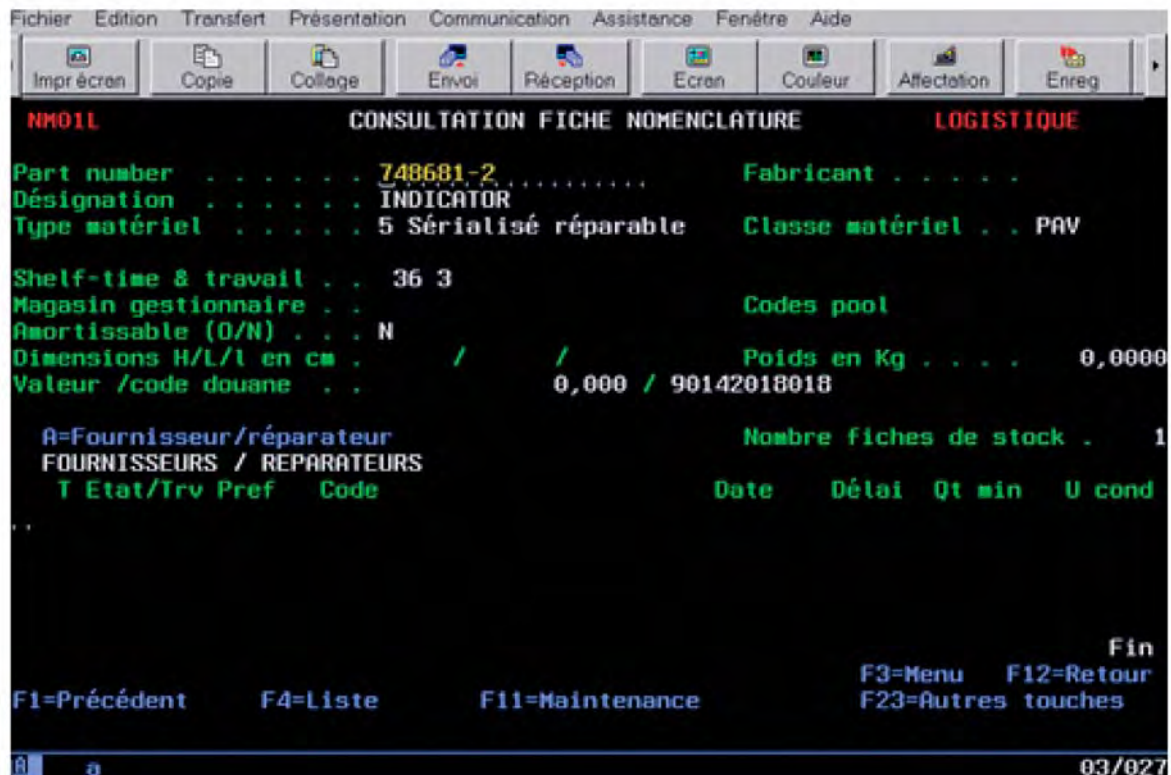
The same search was then performed by inserting P/N 748681-2, therefore omitting the dash between the first and second group of numbers. This is the P/N as printed (see photo 80) on FQI S/N 179, removed from the aircraft TS-LBB for replacement. In this case, the video monitor responded with the information relating to P/N 748681-2, called INDICATOR.

Photo 81: Information supplied for P/N 748681-2.

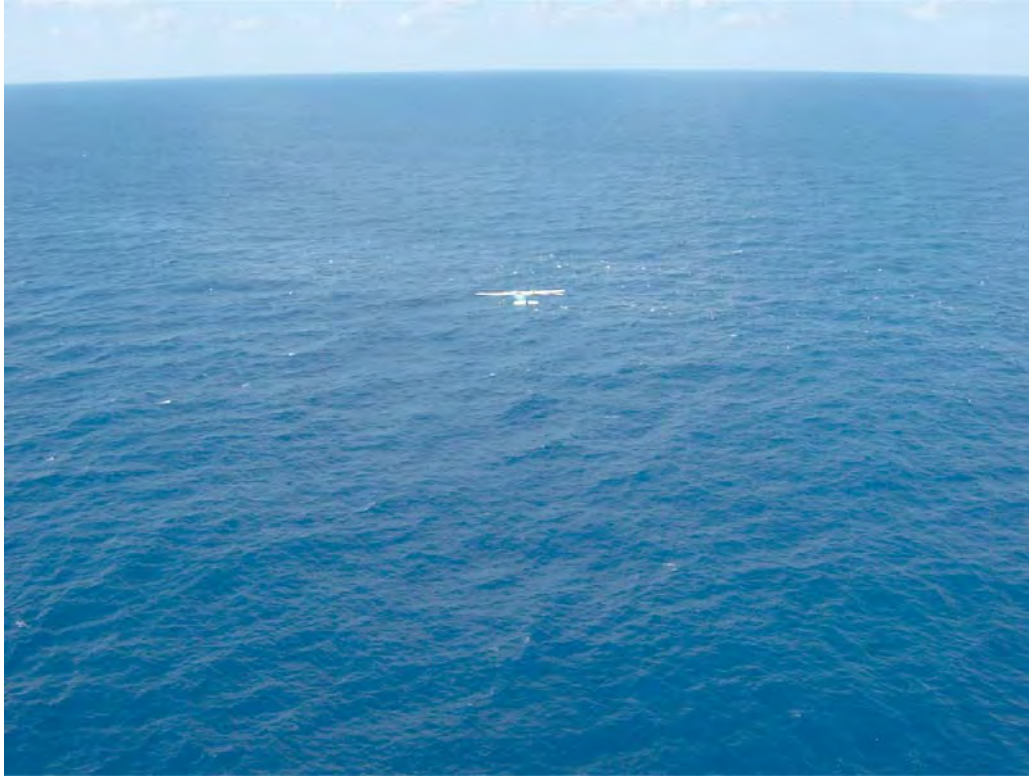
Photo 82, taken about 40-45 minutes after the aircraft ditched from the rescue helicopter that was the first to arrive on the scene, shows that the conditions at sea did not make it possible to distinguish the swell direction for certain at low altitude (approximately 500-1000 ft).

Photo 82: The TS-LBB wreckage shortly after ditching.

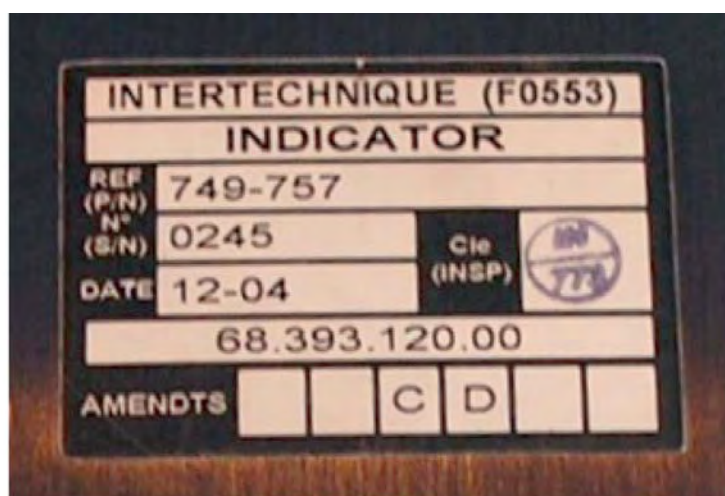
It is pointed out that only in the latest CMM, 28-42-83, is the hyphen dropped after the first three figures of the Part Number (P/N); however, during a visit to FQI's manufacturer premises and from the observation of some FQI's produced in December 2004 (photo 83) and April 2005 (photo 84), it has been noted that the identification plates attached to the instruments continue to feature it.

Photo 83: FQI Identification Plate.

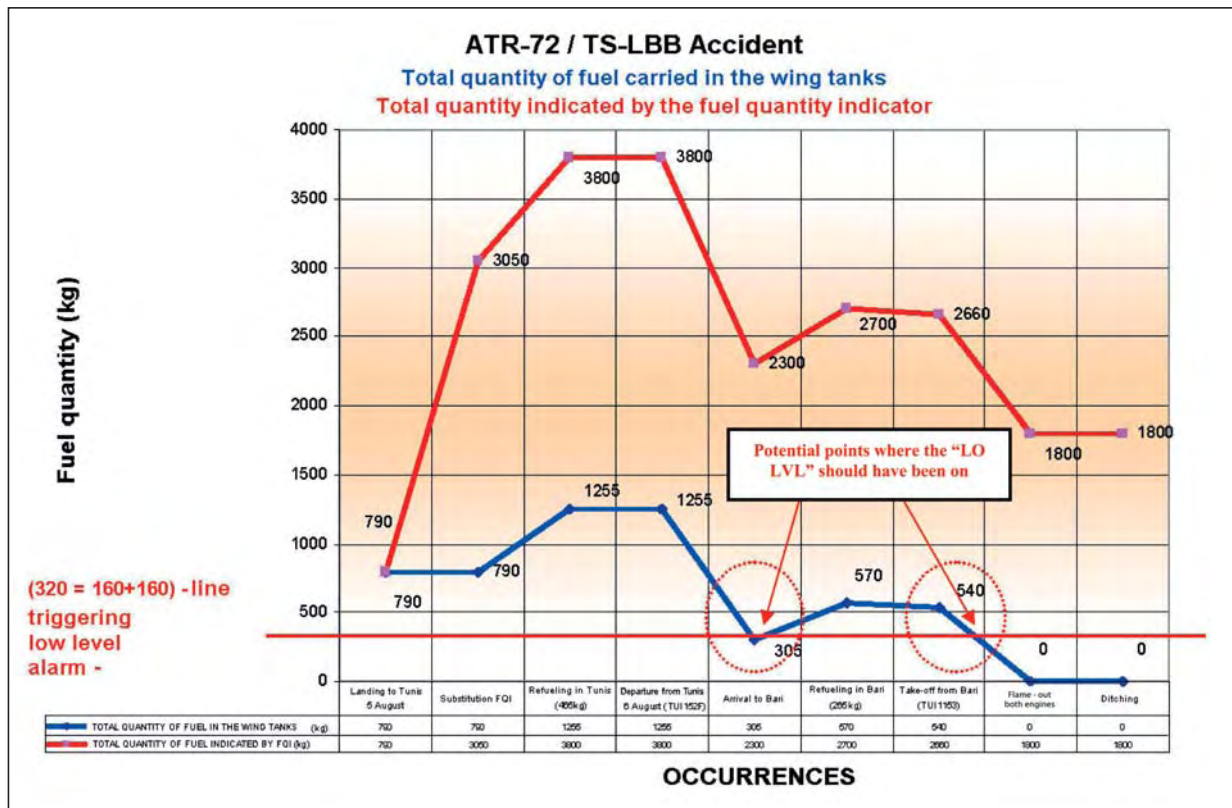
²³ With an ATR 42 type Fuel Quantity Indicator installed on board an ATR 72, the fuel quantity indicated obeys the following law of variation, determined experimentally: $Y = 1,572 X + 1807,8$ (in which X is the quantity of fuel actually carried on board). For example, with 600 kg fuel actually on board, the quantity indicated by the ATR 42 type FQI will be about 2750 kg.

Figure 27: Quantity of fuel indicated (red line) and actually on board (blue line). Note: a margin of error of approximately $\pm 2-3\%$ should be considered for the figures stated.

By indicating a fuel quantity on board over 900 kg higher per tank than the quantity actually carried, the ATR 42 type FQI mounted on TS-LBB thus failed to trigger the amber warning light and the associated single chime in the cockpit.

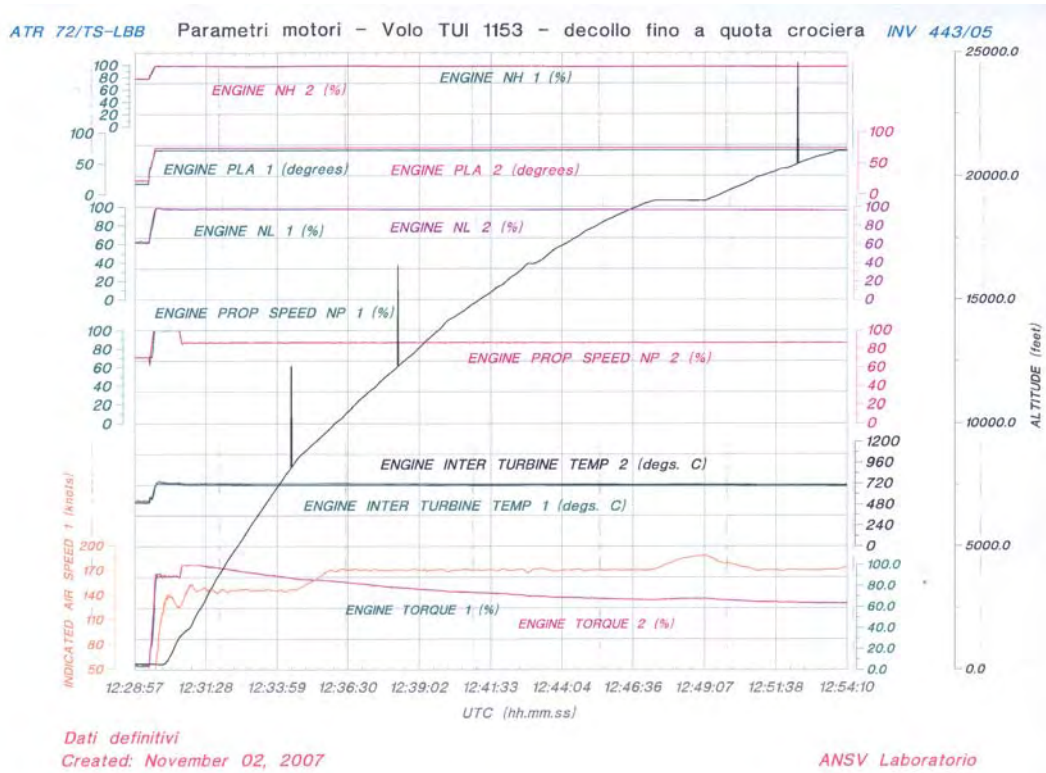
It will be noted from the graphs shown in Figure 28 that the engine parameters were normal and within the prescribed limits in the takeoff and climb to initial cruising altitude phase. The flight thus went off normally, without any aspect of particular note, from takeoff from Bari airport until the first engine flame out (right engine). The data extracted from the FDR regarding the working of the two engines suggest nothing out of the ordinary throughout the whole of the phase preceding the RH engine shut down.

The temperature, engine speed and fuel flow readings were, in fact, within normal values, as

illustrated in the graphs in Figure 28. Fuel consumption was normal and settled at a rate of about 10 kg/min in the cruising phase (graphs in Figure 29).

Figure 28: Pertinent engine parameters from takeoff to initial cruising altitude.

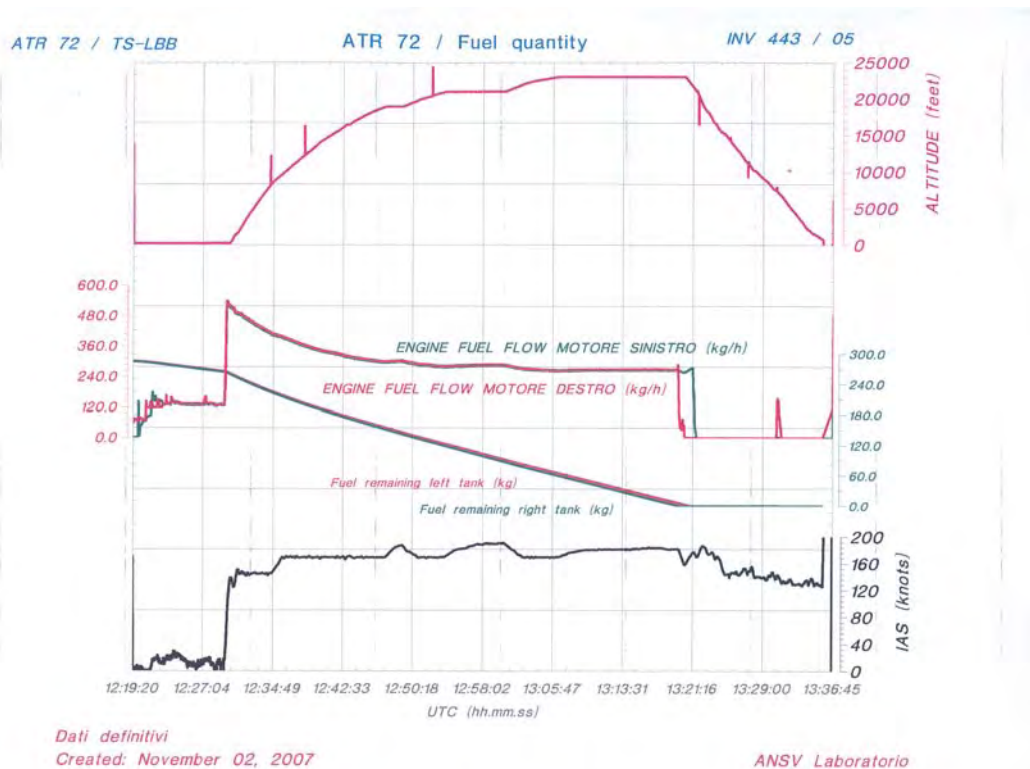
Figure 29: Fuel quantity and consumption status. “Fuel remaining” parameter is determined from the fuel flow data and it is not directly recorded by the FDR

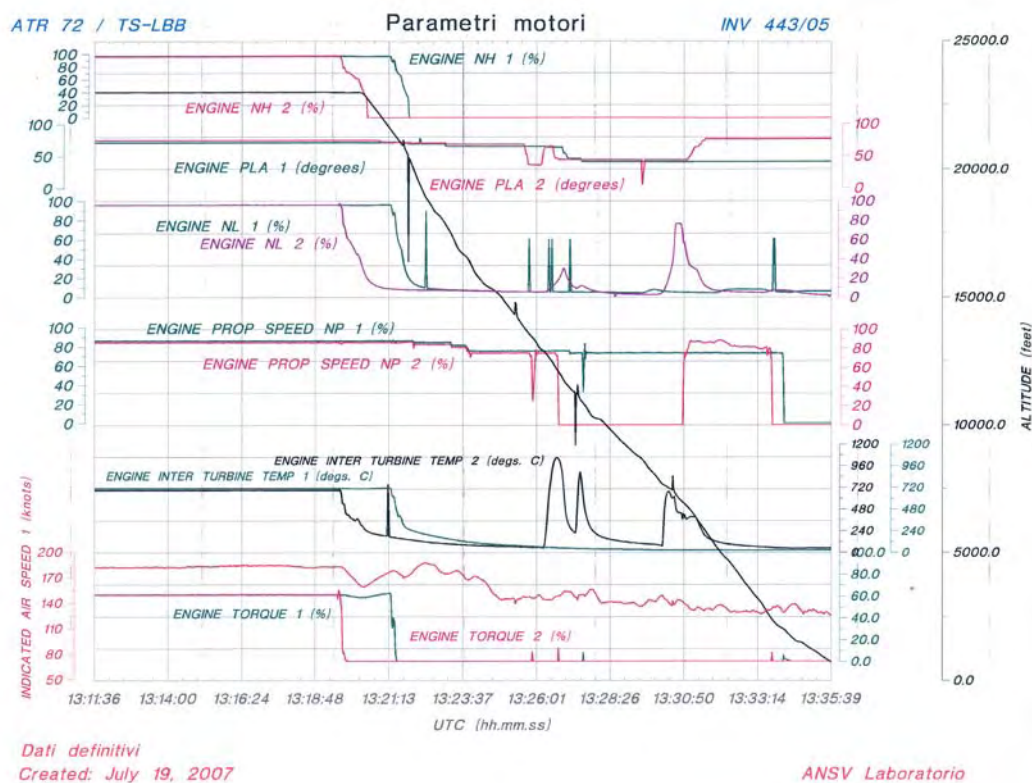
An analysis of the cockpit conversations that emerge from the CVR, plus the FDR data regarding aircraft altitude and speed parameters and the information supplied by the flight crew, have made it possible to reconstruct the action taken by the crew at the time when the first failures occurred. Figure 30 illustrates the main engine operation parameters; it may be seen that both engines shut down in linear fashion, without increases in internal temperature or an abrupt increase/decrease in speed in either engine.

Figure 30: Pertinent engine parameters.

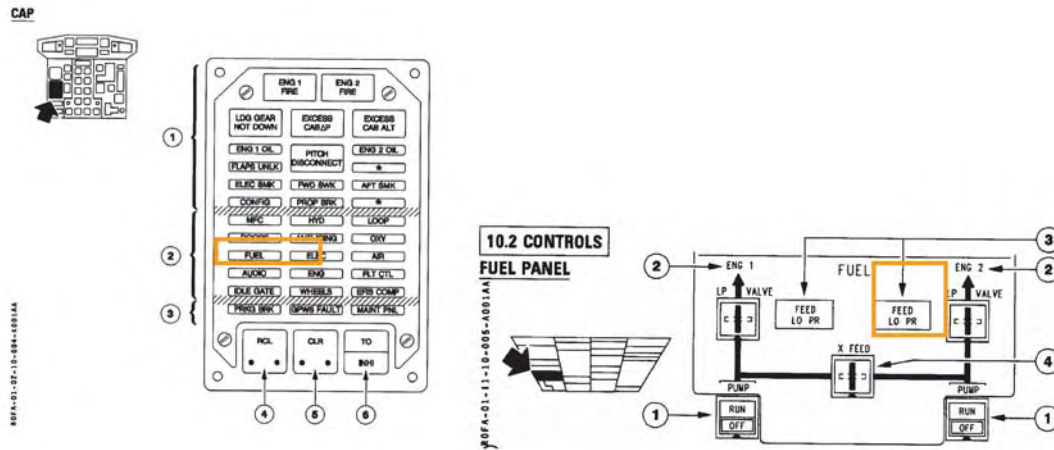
The first indications of malfunctioning to reach the cockpit were the amber “FEED LO PR” and “FUEL” lights illuminating on, respectively, the fuel panel and the Crew Alerting Panel (CAP), accompanied by the associated single chime.

Figure 31: CAP and Fuel Panel.

The “FUEL” warning light on the CAP lighting up alerts the crew to an abnormal situation requiring corrective action, and the “FEED LO PR” warning light illuminates whenever the pressure of the fuel flow into the engine concerned falls below 350 mbar (5 psi). This is a sign of a possible fuel pump failure, a suspected fuel leak in the fuel ducts, or shortage of fuel. In the case in point, it was a sign of shortage of fuel.

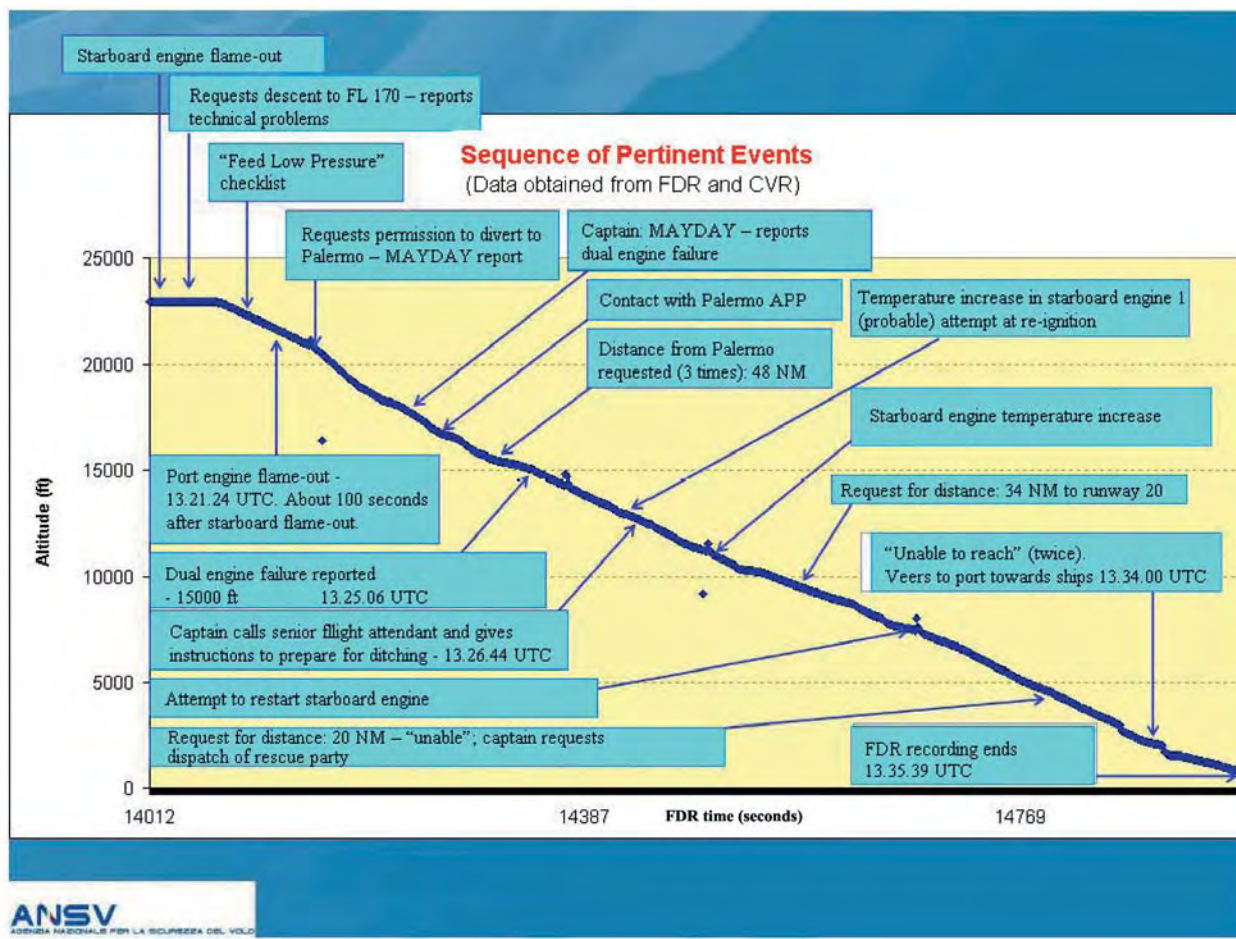
Whereas Figure 33 shows the same sequence in diagram form, taking aircraft altitude as the base parameter.

Figure 33: Sequence of pertinent events.

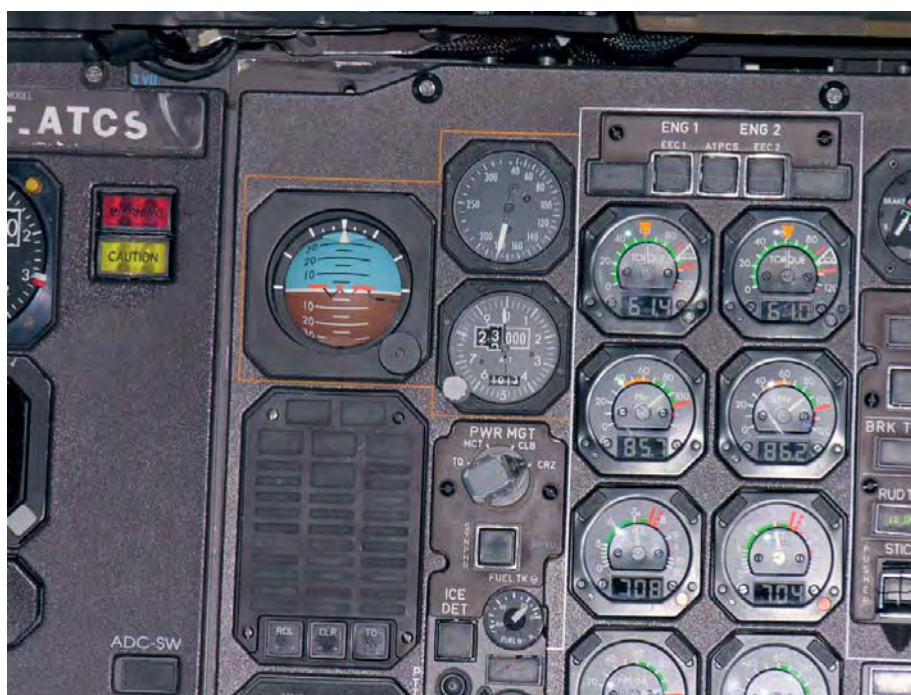
After identifying the first failure and starting to apply the relevant check list, the crew detected a loss of thrust in the RH engine followed, shortly after, by the other (LH) engine failure. This emergency situation was not handled correctly, as the checks prescribed in the applicable “BOTH ENGINES FLAME OUT” check list were not performed. However, the particular operating conditions in which the crew found itself must be borne in mind: without information in the cockpit on the distance from Palermo (with the second engine out of action, the DME values are not available), with reduced flight instruments, with a misleading fuel quantity reading, dual engine failure and the prospect of ditching. With dual engine failure, and hence with the electrical generators inoperative, flight instrument availability is limited and the crew has only the stand-by instruments to rely on for the purposes of handling the aircraft.

Photo 85: Detail of stand-by instruments.

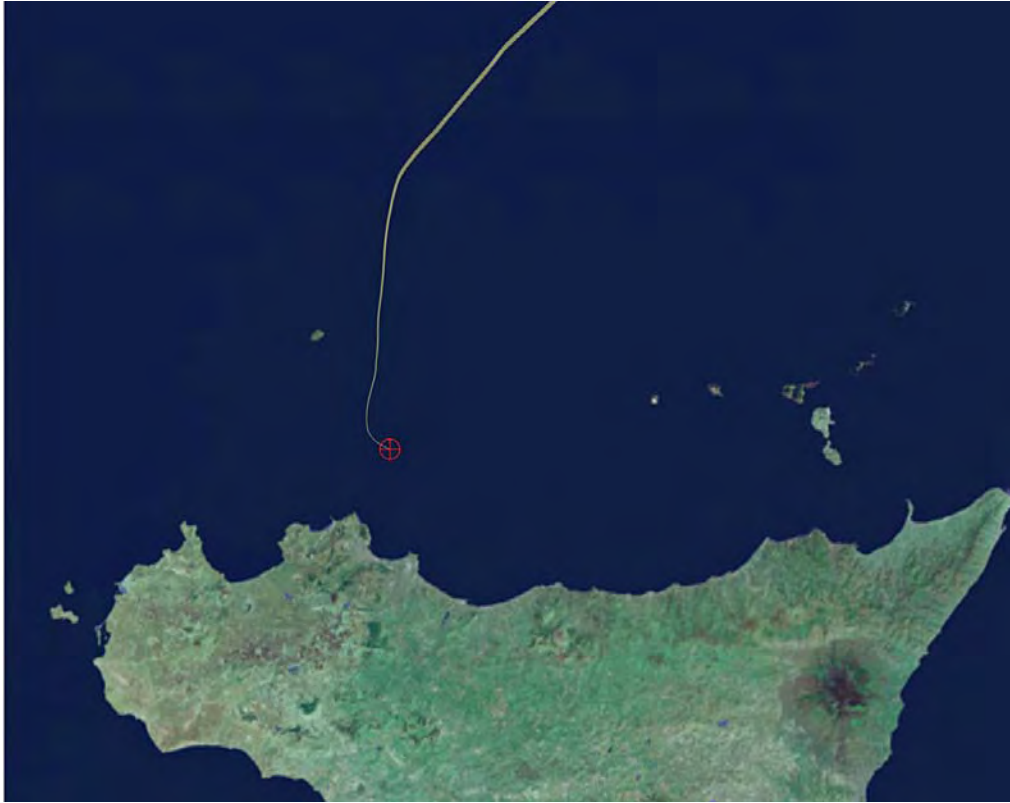
In flight conditions of this kind, the captain in any case had the presence of mind, once he had actually realised that it was impossible to land at Palermo (Palermo APP reported at the altitude of about 4000 ft that the distance was 20 NM), to steer the aircraft in the direction of two vessels, veering away from the previous heading to left and requesting that the vessels in question be alerted so as to facilitate the pinpointing of the aircraft for subsequent rescue purposes.

Figure 34: Final phase of the TS-LBB flight path (FDR data).

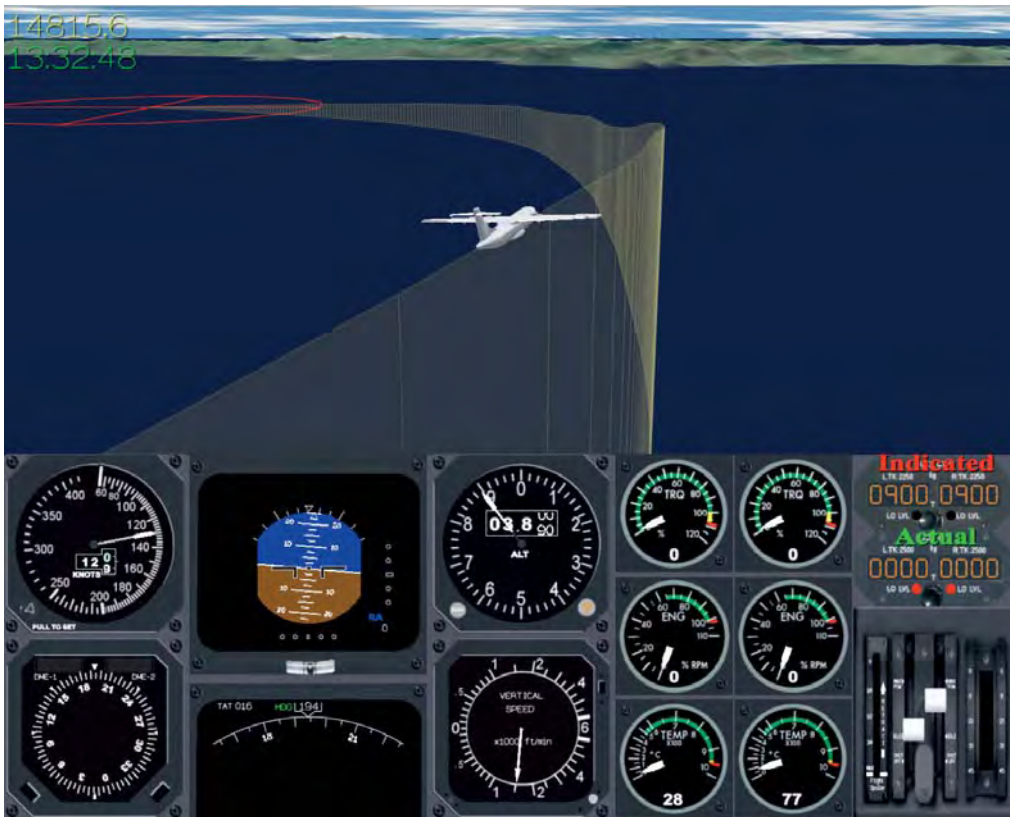
Figure 35: Final phase of the TS-LBB flight path (FDR data).

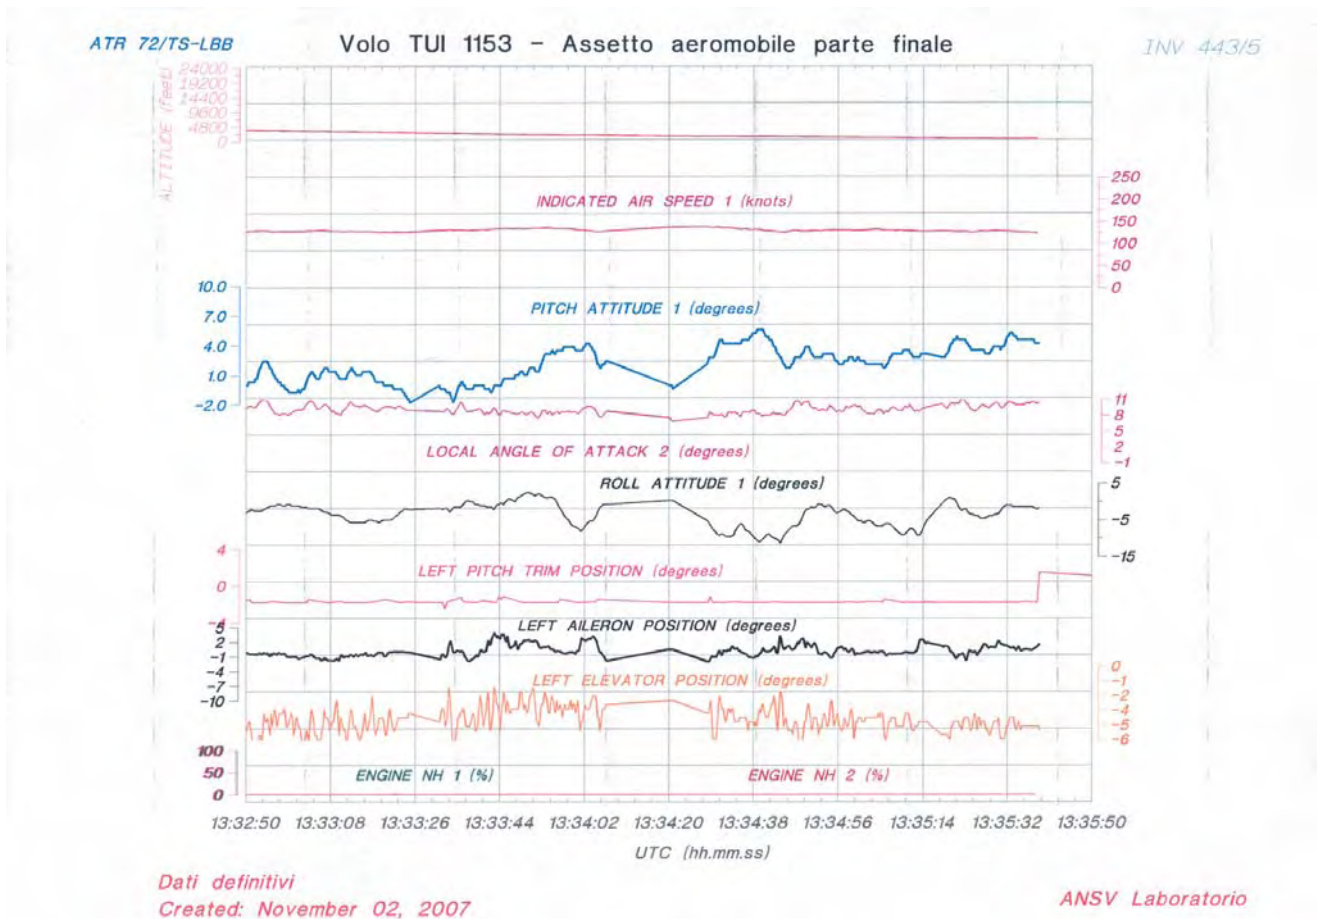
The FDR stopped recording with the aircraft at an altitude of 728 ft and Indicated Air Speed of 125 kts. From analysis of relevant data recorded during the previous minute, it has been determined that the aircraft had a descent rate of approximately 700 to 800 ft/min. Therefore in the hypothesis, highly probable, that the pilot maintained the same descent rate until impact, it can be reasonably assumed that approximately one minute has elapsed between FDR recording interruption and the impact with the sea surface. Such hypothesis is verifiable with the comparative analysis of FDR and CVR end of recording timing, with ATC timing (see paragraph 1.11.4.). Regarding the evaluation of parameters needed for determining the dynamics during the final part and that regarding the ditching, it has been necessary to use the results from wreck analysis, CVR data and available witness statements.

Figure 36: Relevant parameters during final phase.

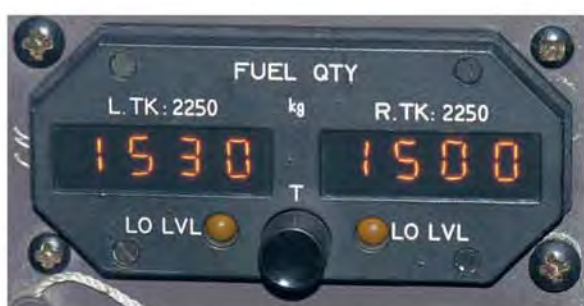
Fuel Quantity Indicator ATR-42

The wing tanks of the ATR-72 and ATR-42 differ in terms of maximum fuel capacity and shape, as well as number of the probes; as a consequence FQIs for the ATR-72 and for the ATR-42 utilize different algorithms to process the input capacitance signals coming from the tank probes and therefore they are not interchangeable (see manufacturer curves in Annex).

Nevertheless the FQIs for the ATR-72 and ATR-42 have the same dimensions and installation interface; this means that an FQI for the ATR-42 could erroneously be installed on a ATR-72 model and viceversa. The only visible difference between the two FQIs is the indication in small white digits of the maximum fuel quantity per tank, which is “2500” for the ATR-72 and “2250” for the ATR-42.

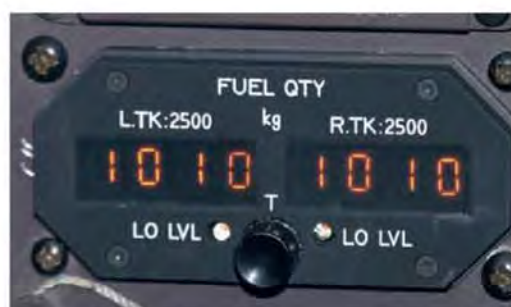
Fuel Quantity Indicator ATR -72

ANSV conducted extensive refuelling tests in order to quantify and assess the effect of an erroneous FQI installation in terms of fuel quantity indication.

One can easily replace or interchange the FQI of the two aircraft types (ATR 72 and 42) because they are identical in construction. The only difference lies in the imprinted fuel quantities of the left and right fuel tanks: ATR 42 – 2250 kg, ATR 72 – 2500 kg. This imprint does not really catch the eye and is easily overlooked.

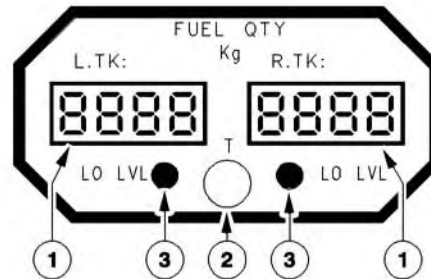
FUEL QTY PANEL

- ① **FUEL QTY indications**
Fuel quantity in each tank is displayed in kg.
- ② **Test pb**
Pressing the test button will check both measurement channels and, if the functioning is normal, display all 8's.
At the same time, CCAS is activated, MC flashes amber, SC is heard.
- ③ **LO LVL amber lights**
Each light illuminates amber and the CCAS is activated when quantity of the concerned display becomes lower than 160 kg ; in addition, the corresponding electrical pump is automatically actuated.

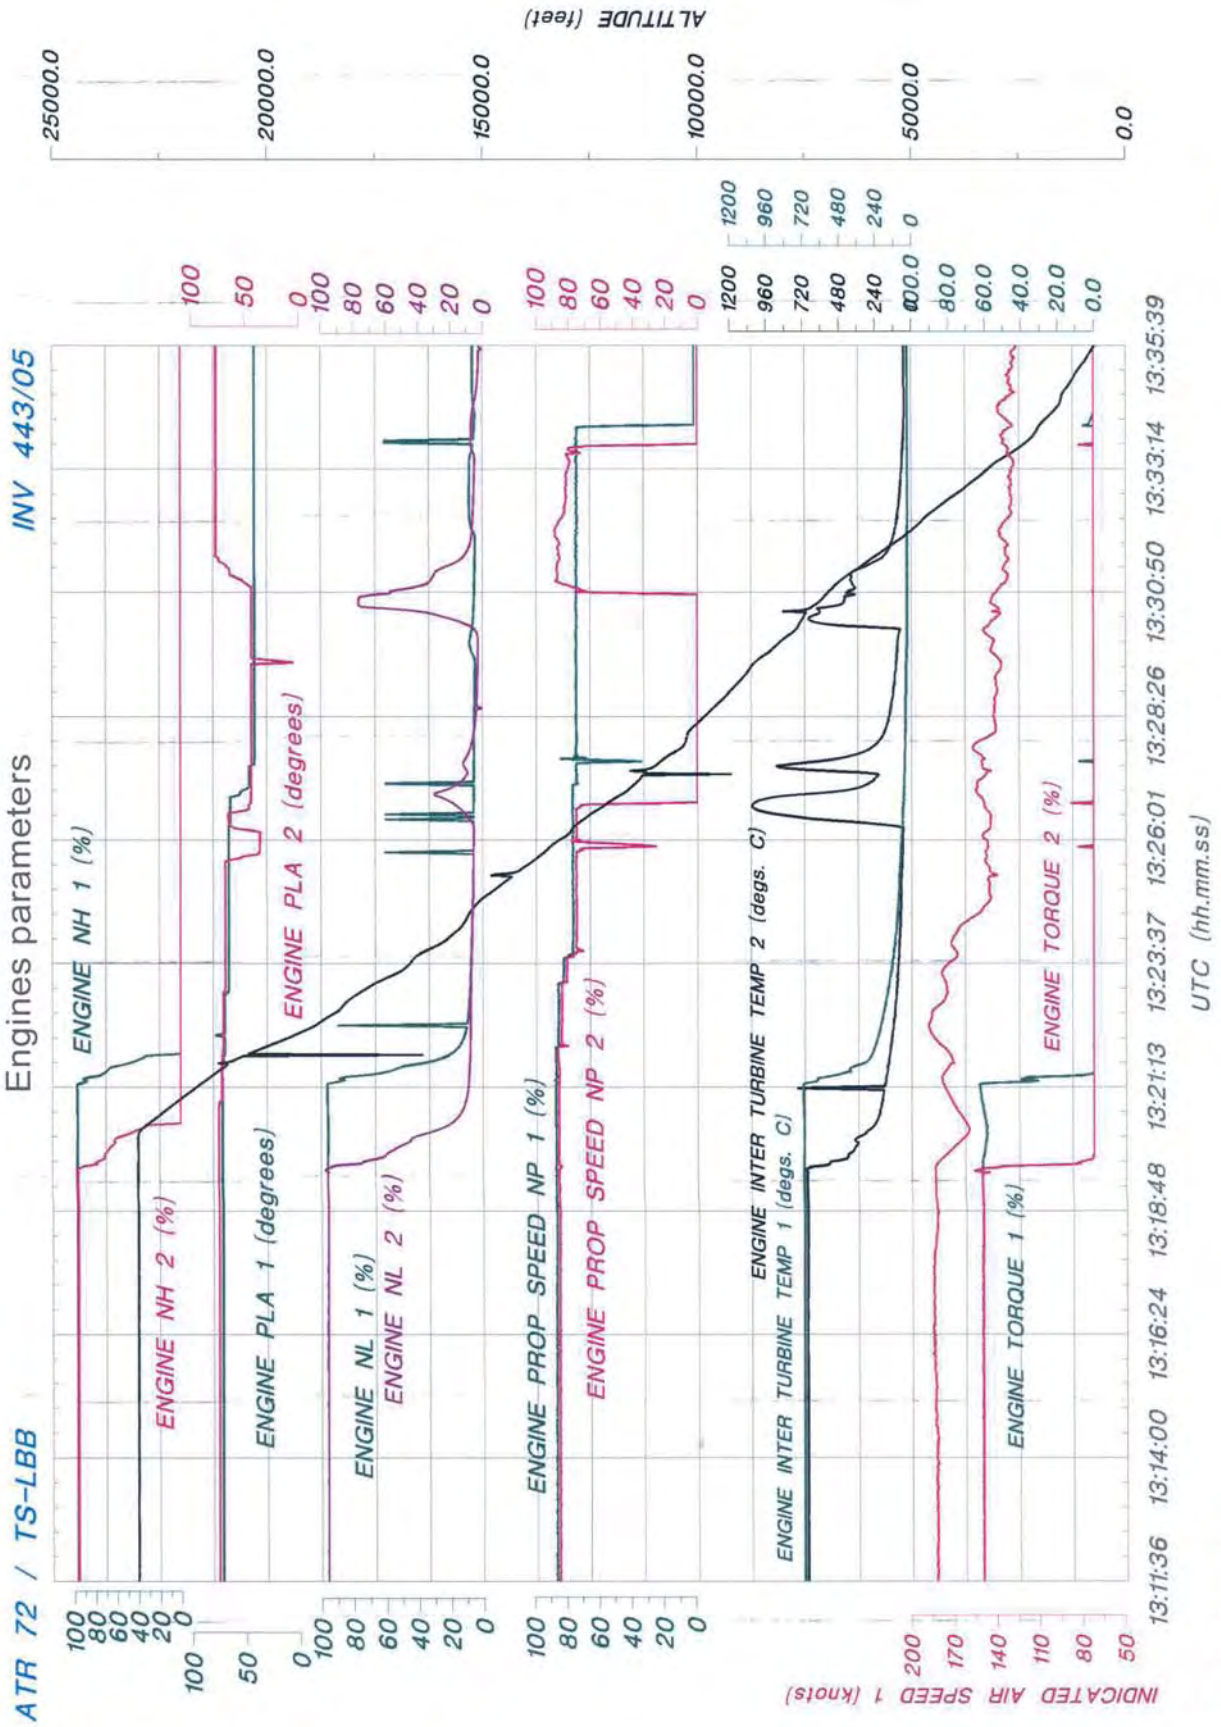
Engines parameters - Flight TUI 1153 - engines shut - down

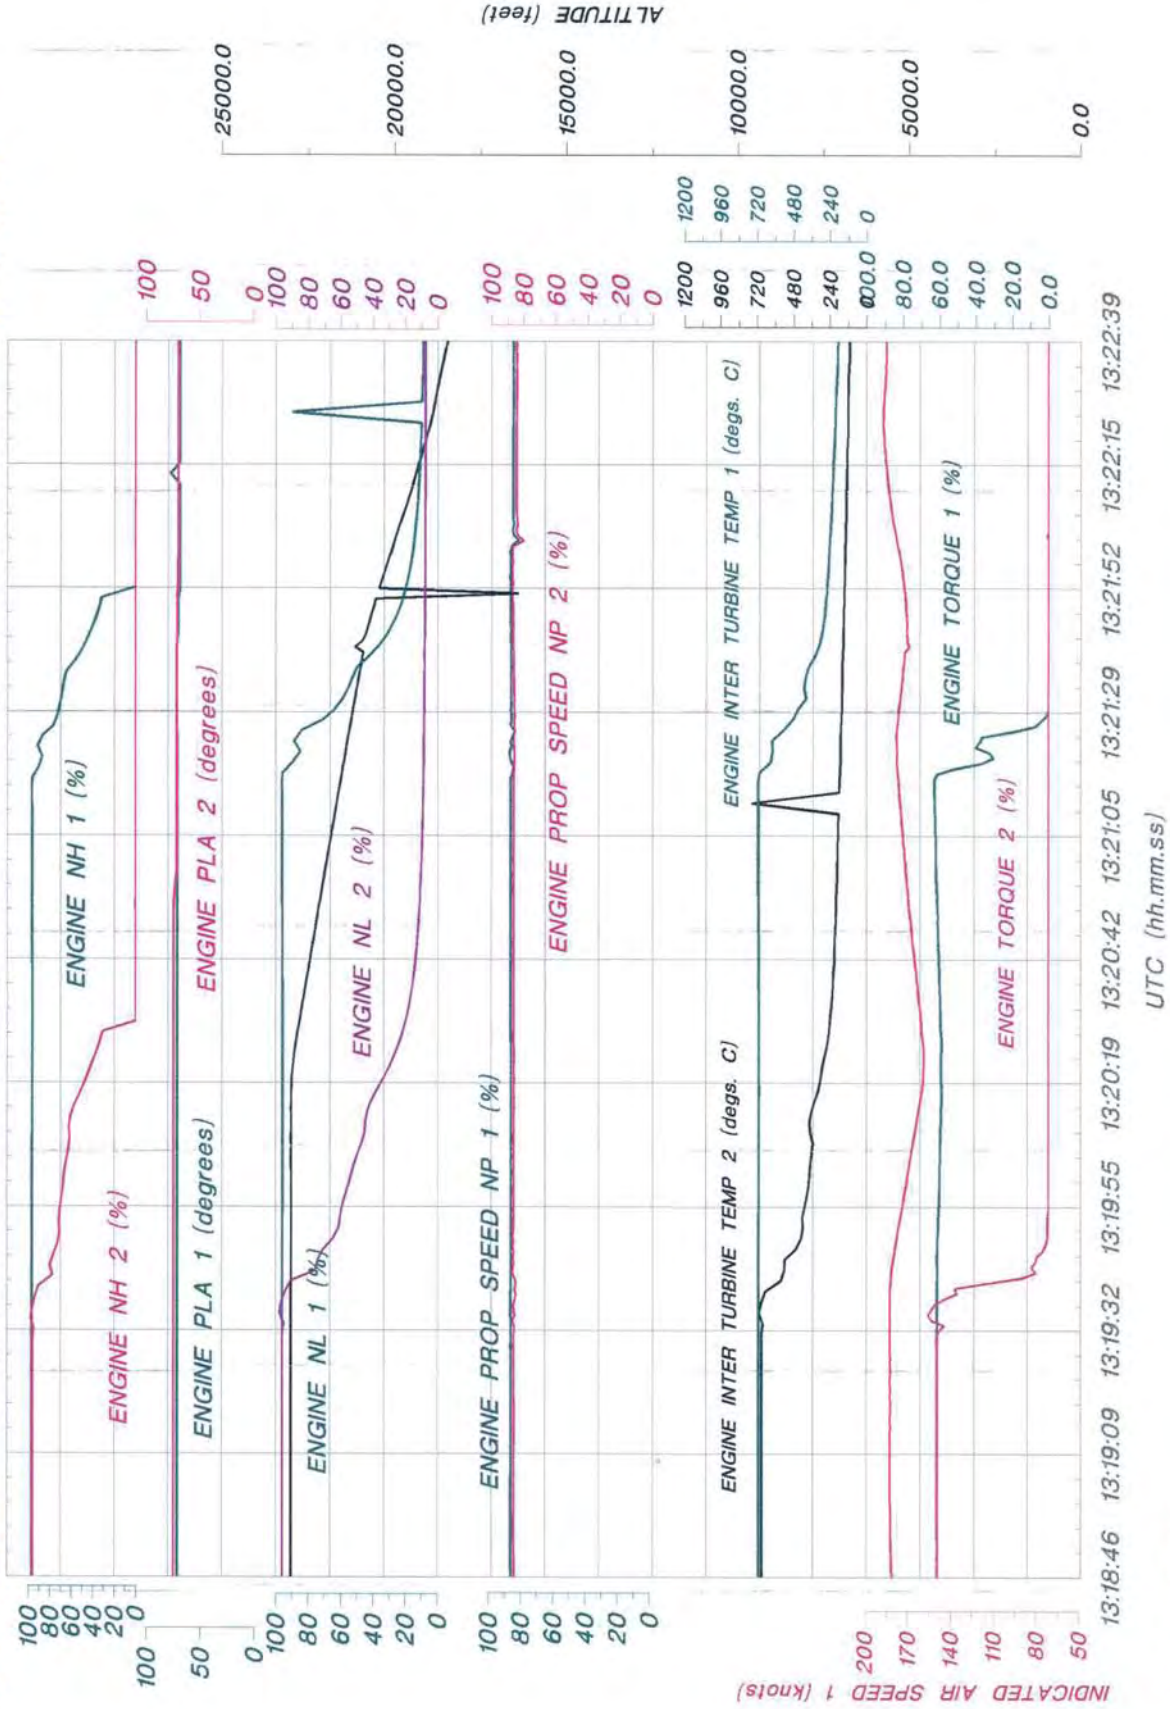
ATR 72 / TS-LBB Engines parameters - Flight TUI 1153 - engines shut - down INV 443/05
