FINAL
KNKT.12.05.09.04

Aircraft Accident Investigation Report

**Sukhoi Civil Aircraft Company
Sukhoi RRJ-95B; 97004
Mount Salak, West Java
Republic of Indonesia
9 May 2012**

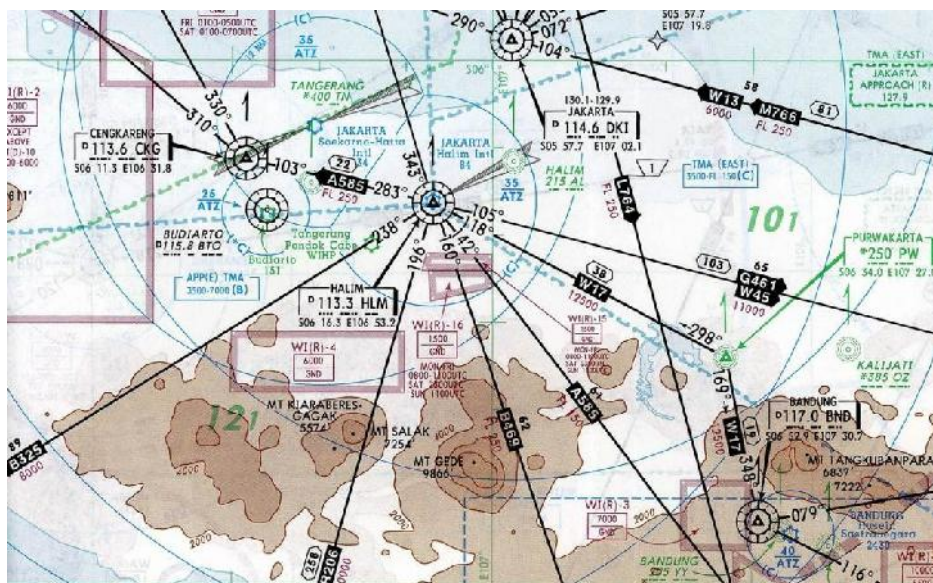
Figure 9: Navigation chart contains information of Atang Sanjaya Training Area and terrain contour

Figure 9 shows a sample of instrument navigation chart that provides information includes the Atang Sanjaya Training Area / WI(R)-4 and the terrain contour. This chart was not carried on the aircraft.

The instrument chart, shown as figure 9, contained terrain contour and "Bogor Area", and the visual chart, shown as figure 10, may have provided a better understanding to the pilot that the point they intended to fly to was close to a mountainous area. These charts were not carried on board the aircraft.

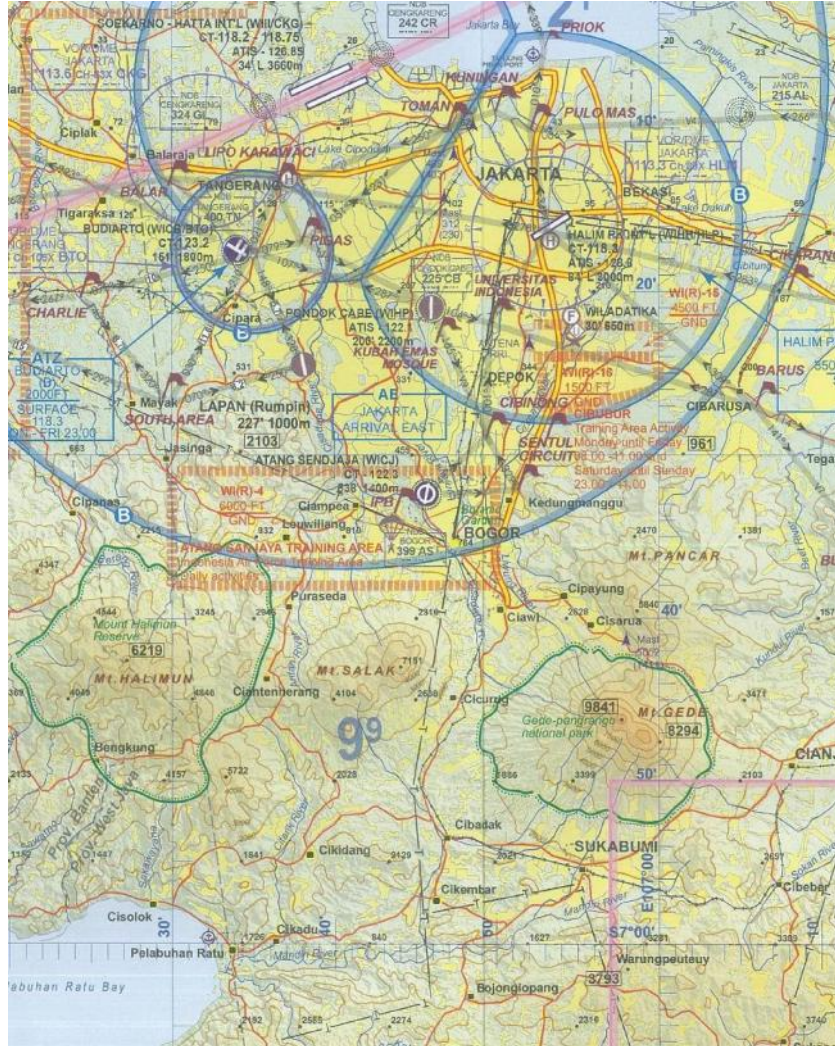
Figure 10: Visual chart

This typical visual chart (figure 10) contains information of the Atang Sanjaya Training Area / WI(R)-4 and the terrain contour which is normally provided by the local government. The investigation was unable to determine if this chart was carried on the aircraft.

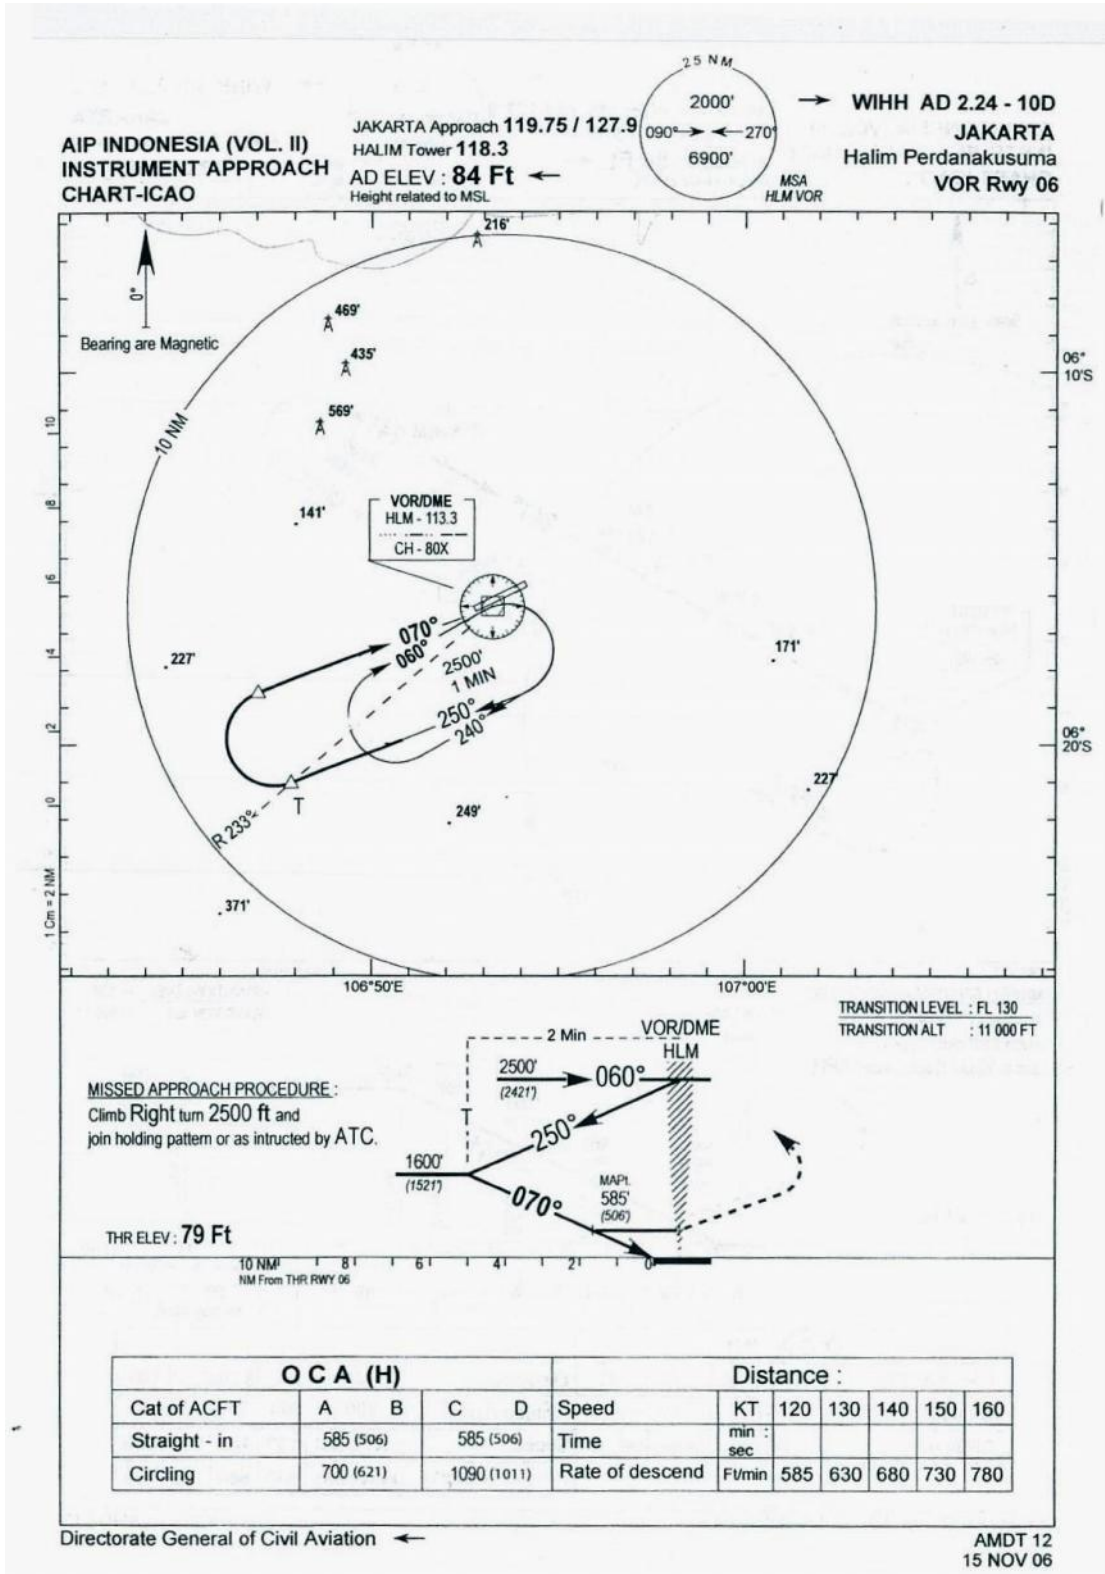
Figure 11: VOR approach procedure for runway 06 Halim

The VOR Approach procedure for runway 06 stated that the turn altitude was 1,600 feet and the Minimum Sector Altitude (MSA) in the area from 090 degrees clockwise to 270 degrees of HLM VOR was 6,900 feet.

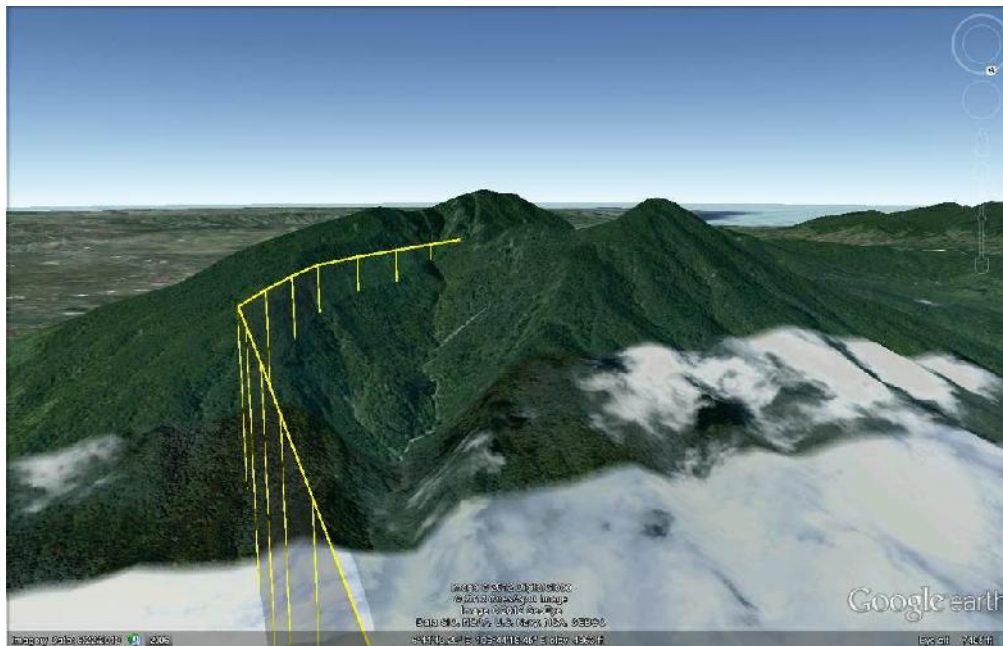
Figure 16: FDR flight path and altitude on the final phase of the flight

Several pertinent excerpts from the CVR were superimposed with the flight path derived from the FDR as shown in figure 16.
