Investigation Report

5X004-0/01
April 2003

Kind of occurrence: Serious Incident
Date: 20. March 2001
Location: Frankfurt / Main
Type of aircraft: Transport category aeroplane
Manufacturer / Model: Airbus Industrie / A 320-200
Injuries to persons: no Injuries
Damage to aircraft: A/C not damaged
Other damage: none
Source of Information: BFU Investigation

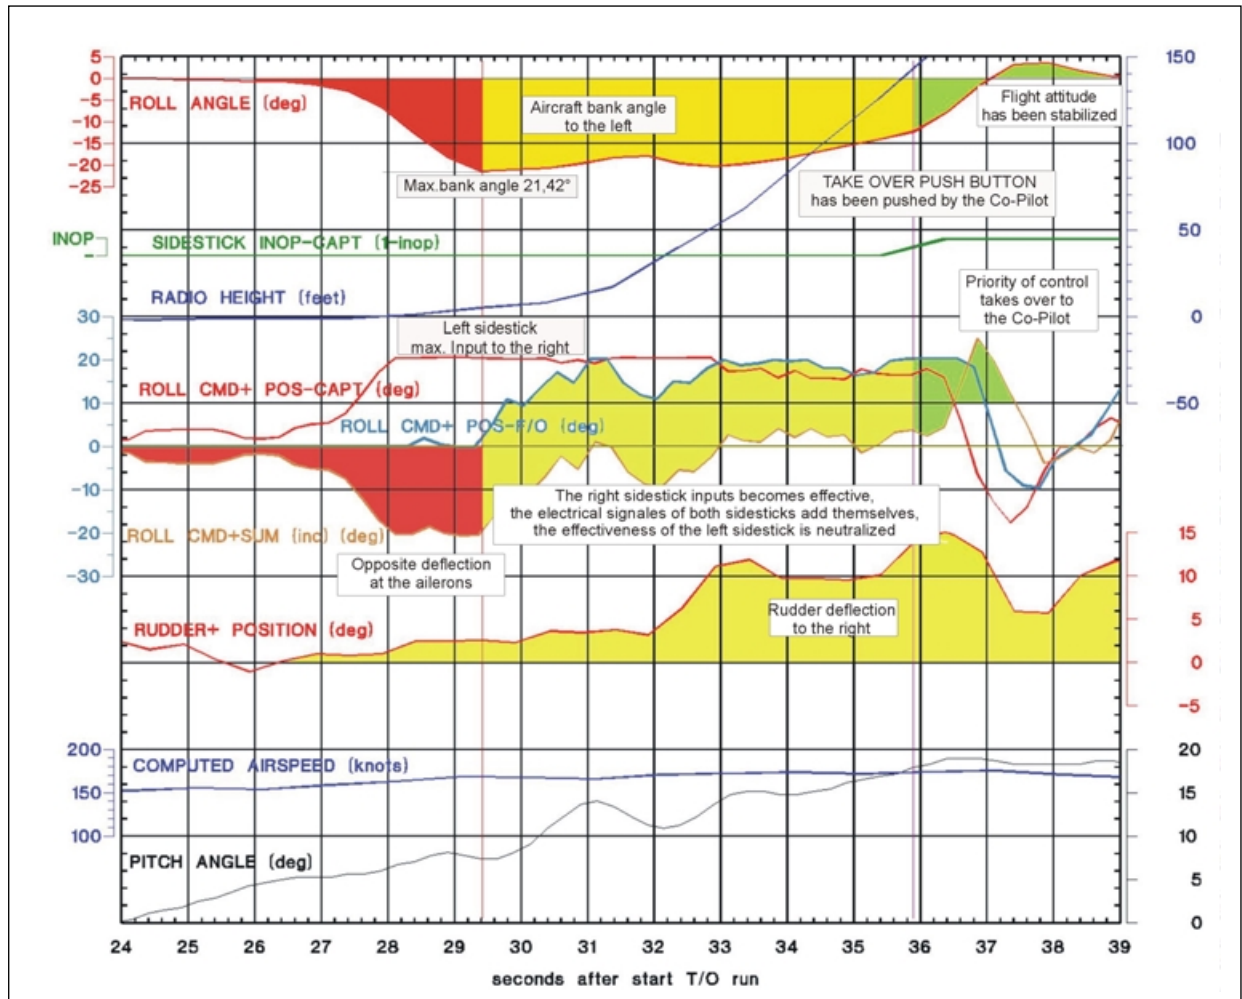
The flight data recorder concerned is a solid state flight data recorder (SSFDR) made by Loral-Aviation-Recorders in Sarasota/Florida. Approx. 470 parameters had been recorded. The flight data recordings were stored on a CD and sent to Braunschweig to the BFU for the purpose of evaluation.
