Investigation Report

AX001-1-2/02
May 2004

Kind of occurrence: Accident
Date: 1 July 2002
Location: (near) Ueberlingen/Lake of
Constance/Germany
Type of aircraft: Transport Aircraft
Manufacturer/Model: 1. Boeing B757-200
2. Tupolev TU154M
Injuries to persons: 71 fatalities
Damage to aircraft: Both aircraft destroyed
Other damage: Damage to open field and forest
Source of Information: BFU Investigation

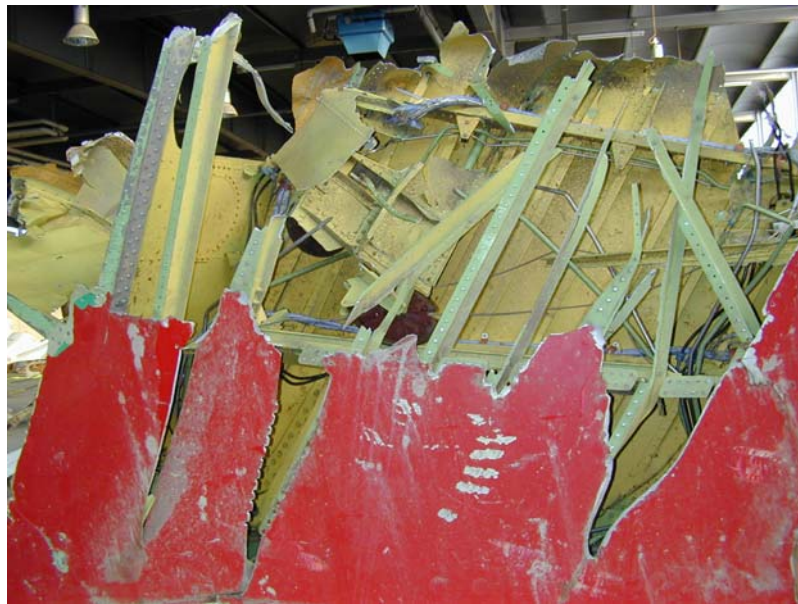
The top of the right side was bent to the rear left.

direction of flight

The top section of the vertical fin with a length of about 2,30 m was found south-east of the main wreckage at a distance of 4 to 5 km from the village of Altheim. The centre part of the vertical tail with a height of about 4 m and a length of about 5 m was not found.

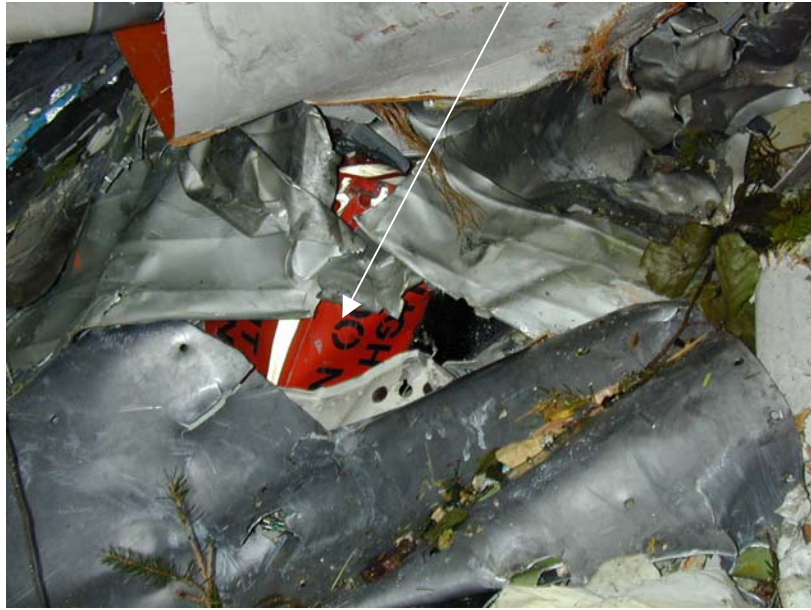
exhaust of APU

The FDR and the CVR were recovered from the aft part of the fuselage.
