MH17 Crash

Crash of Malaysia Airlines flight MH17

Hrabove, Ukraine, 17 July 2014

The Hague, October 2015

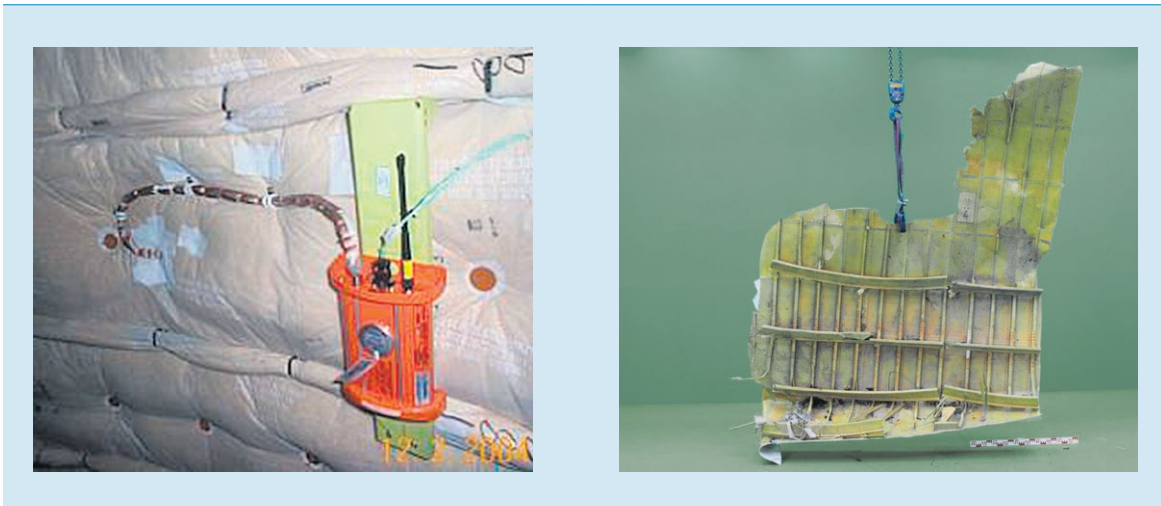
Figure 11: Fixed ELT location installed in a Boeing 777 (left), panel recovered from 9M-MRD with no insulation material or ELT attached (right). (Source: Dutch Safety Board)

The fixed Emergency Locator Transmitter was not recovered by the investigation team, although the fuselage structure at the rear of the aeroplane onto which the fixed Emergency Locator Transmitter was mounted was recovered. Figure 11 shows the typical installation of a fixed Emergency Locator Transmitter in a Boeing 777 (left) and the panel recovered from the wreckage of flight MH17 where the fixed Emergency Locator Transmitter was mounted (right).

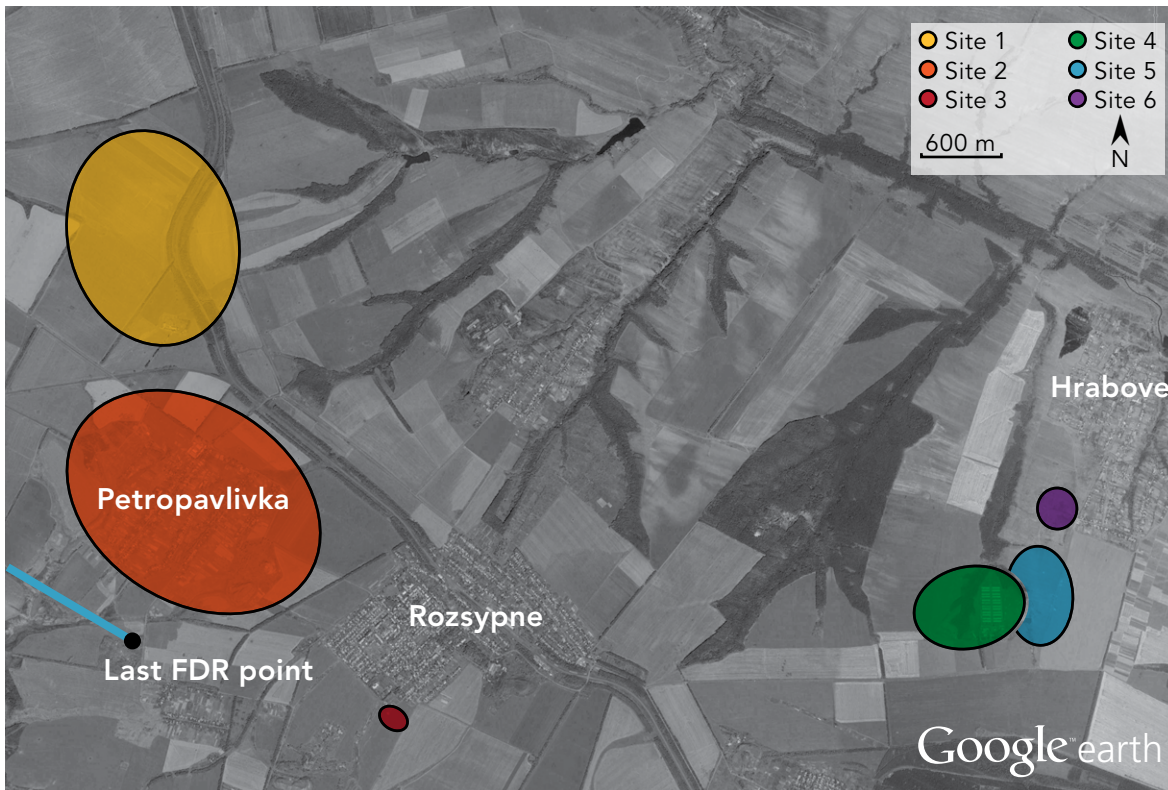
Figure 12: Overview of wreckage area showing the six smaller sites. (Source of satellite images: Google Earth/ Digital Globe)

The wreckage parts of the aeroplane were identified within an area of approximately 50 km². Most of the wreckage was located on six sites within this area. The majority of the wreckage was located in three of these sites to the south-west of the village of Hrabove. Figure 12 shows the geographic location of the six wreckage sites. Each wreckage site has an associated colour. The distribution of wreckage pieces over a large area indicates an in-flight break-up.

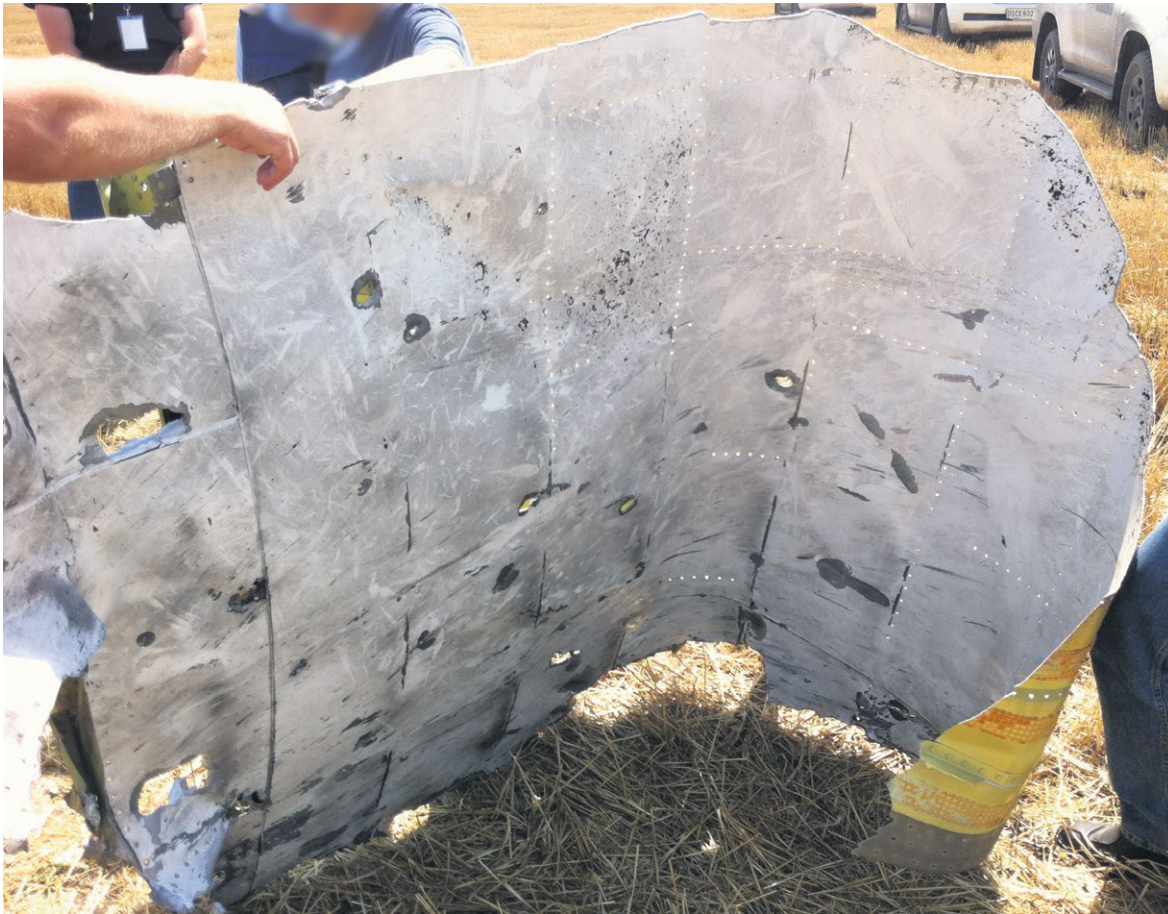
Figure 15: Upper left hand cockpit fuselage. (Source: DCA Malaysia)

A portion of the cockpit fuselage's top section (STA236.5 to STA332.5) was located in the south-western region of site 1 (Figure 15). This part was not recovered. The fuselage skin

showed evidence of perforation from the outside. The aft side of the fuselage skin was bent upwards and a number of formers and stringers were missing from the fuselage. The upper side of the fuselage showed traces of soot.

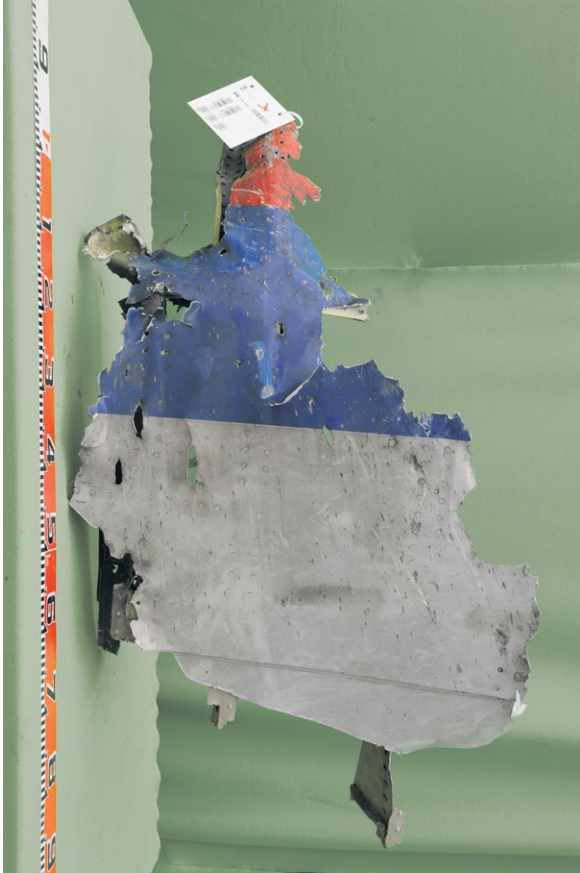
Figure 18: Part of fuselage left hand side showing holes and pitting. (Source: Dutch Safety Board)

Part of the fuselage, originating from the left hand side of the cockpit was identified in a garden in the central region of site 2. This part contained numerous puncture holes and pitting. It also showed traces of soot. The formers on the inner side of the fuselage had been sheared off. See Figure 18.

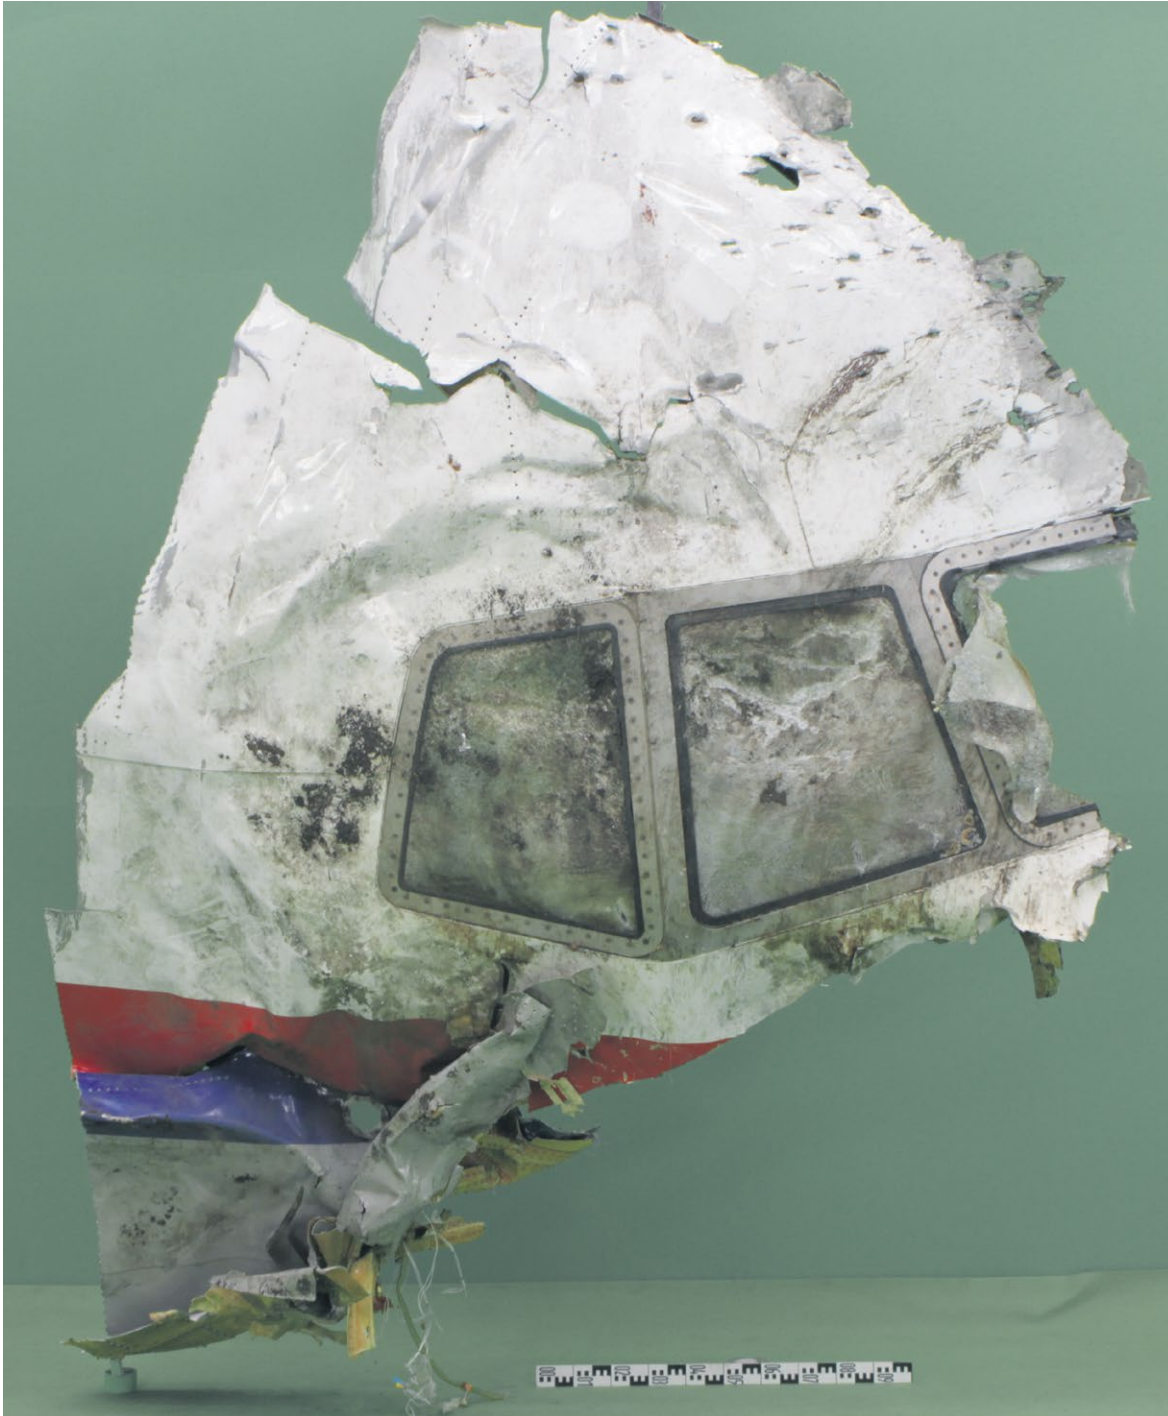
Figure 19: Part of the right hand side of the cockpit. (Source: Dutch Safety Board)

The right hand side of the cockpit remained fairly intact. The window panes of the right cockpit windows were still in place. The presence of soot is noted on the inside of the right cockpit windows 2 and 3. The upper portion of the right hand side of the fuselage showed evidence of both perforation and ricochet marks. In contrast to the left hand side of the cockpit (see paragraph 2.12.2.7), the lower right hand side did not show similar signs of perforation from the outside (see Figure 19). The size of the perforation holes is detailed in paragraph 2.6 of Appendix X.

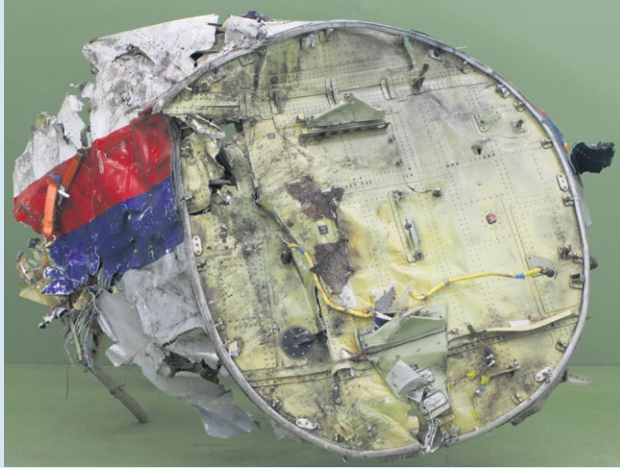
There was perforation damage on the forward pressure bulkhead. Three holes were visible. Parts of the cockpit fuselage were still attached to the left hand and right hand side of the forward bulkhead (Figure 20). The left hand side of the fuselage attached to the forward pressure bulkhead contained numerous puncture holes and pitting was observed (Figure 21). The right hand side of the fuselage attached to the forward pressure bulkhead had no perforation damage.

Figure 20: Forward pressure bulkhead and right hand fuselage. (Source: Dutch Safety Board)

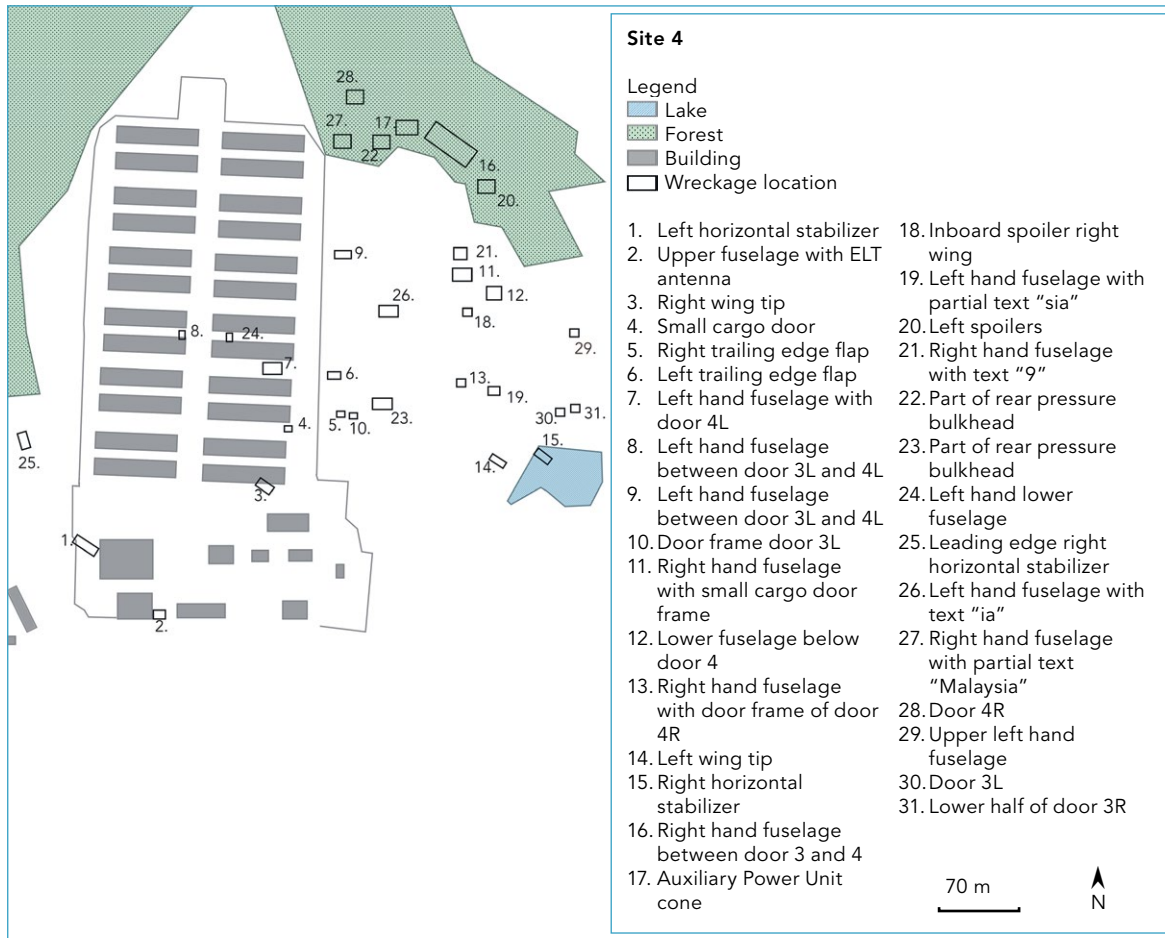
The fuselage of the aeroplane between the wing and the tail section (section 46 to section 48) was primarily located in site 4, approximately 2 kilometres south, south-west of Hrabove. Pieces of wreckage, including both horizontal stabilizers and both wing tips were distributed over this site of approximately 540 x 650 metres. The site contains a number of farm buildings surrounded by a fence and it was partially surrounded by a forest which was located in a gully. The right stabilizer was found in a small lake in the south-easterly part of the site. An overview of the wreckage site and the location of the wreckage pieces is depicted in Figure 28. A total of about 50 oxygen generators were recovered from sites 4 and 5.

Figure 28: Overview of wreckage site 4 and the location of the wreckage pieces. (Source: Dutch Safety Board)

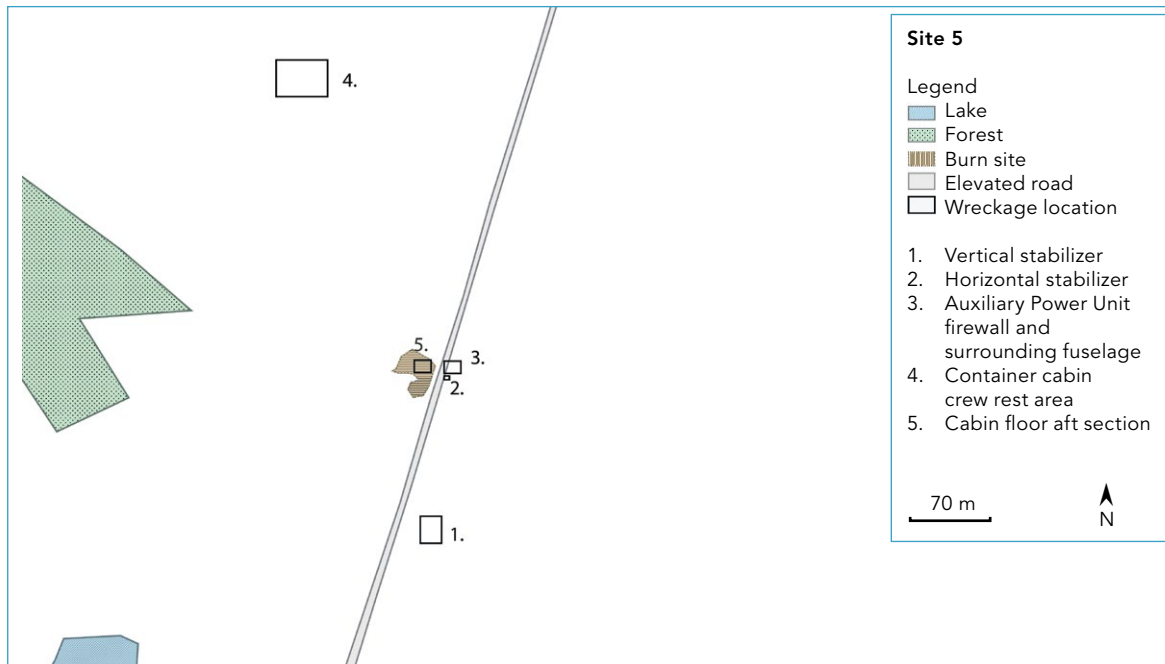
A part of the aft section of the aeroplane, including the vertical stabilizer and the surrounding fuselage was located in site 5, situated approximately 750 metres south-west of Hrabove. Within this site, pieces of wreckage were distributed over approximately 600 x 800 metres. Parallel to the elevated road on the west side, there were power lines. It was noted that one of these power lines on the west side of the elevated road had been clipped. An overview of the wreckage site and the location of the wreckage pieces is depicted in Figure 30.

Figure 30: Overview of wreckage site 5 and the location of the wreckage pieces. (Source: Dutch Safety Board)

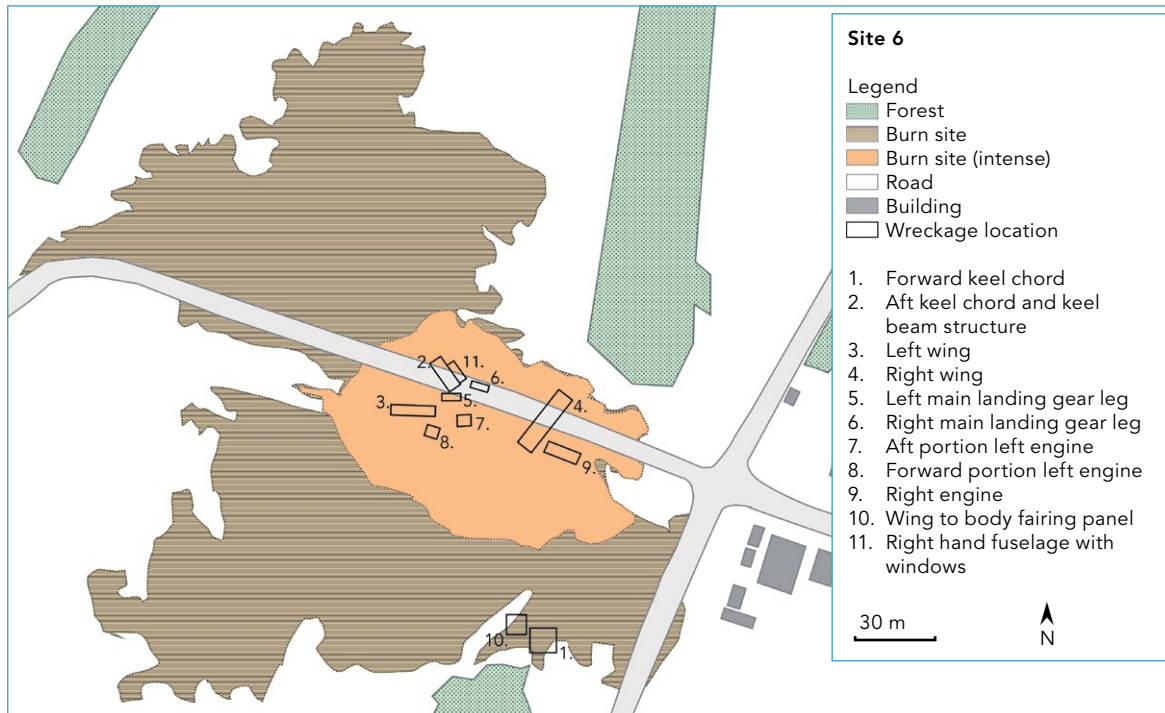
Wreckage site 6, situated in the south-western corner of the village of Hrabove, measured approximately 250 x 200 metres. Within this site, a smaller region, where a high intensity fire had occurred, measured approximately 100 x 60 metres. An overview of the wreckage site and the location of the wreckage pieces is depicted in Figure 31.

Figure 31: Overview of wreckage site 6 and the location of the wreckage pieces. (Source: Dutch Safety Board)

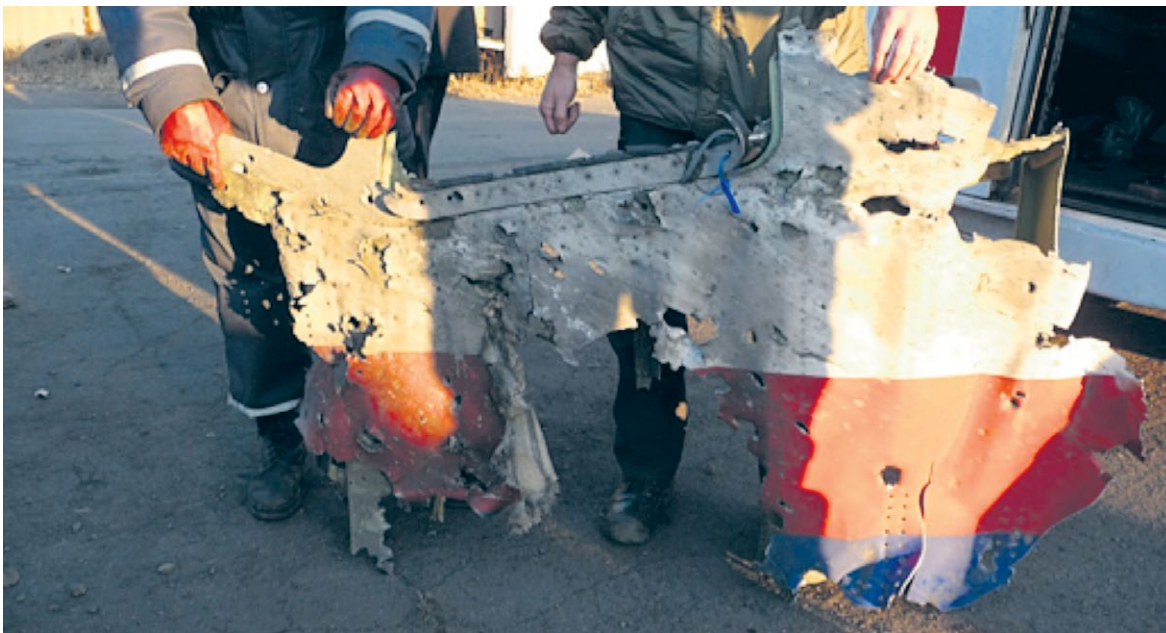
Figure 32: Handover of the left cockpit window frame to the Dutch Safety Board by members of the SES. This is the same part as is shown in Figure 33. (Source: Dutch Safety Board)

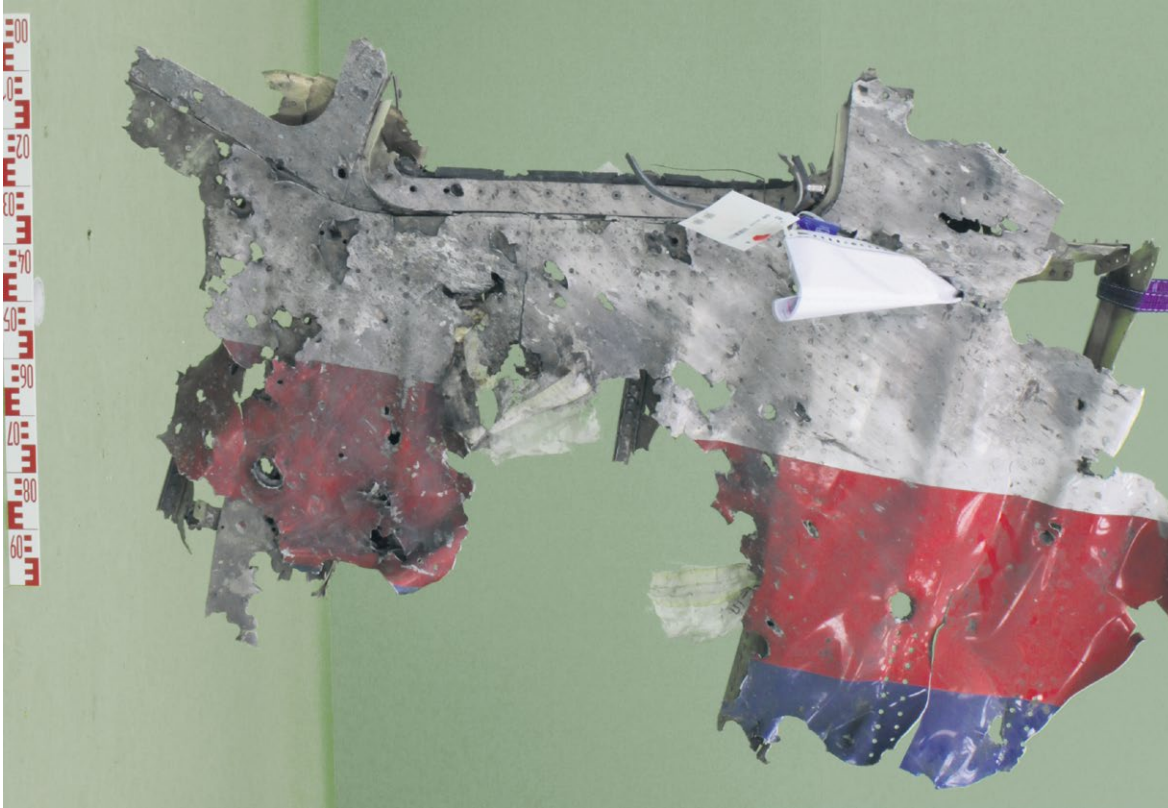
Part of the fuselage (STA180.5 to STA228.5), originating from the left hand side of the cockpit, was located at the side of the road, in the central region of site 2, near the village of Petropavlivka. Residents of the village reported that the wreckage piece had been moved to expedite the search and recovery mission. The fuselage skin was punctured from the outside in a number of places and the outside fuselage skin was pitted and showed traces of soot. Frames on the inner side of the fuselage had been sheared off.

Figure 33: Part of the left cockpit window frame. (Source: Dutch Safety Board)

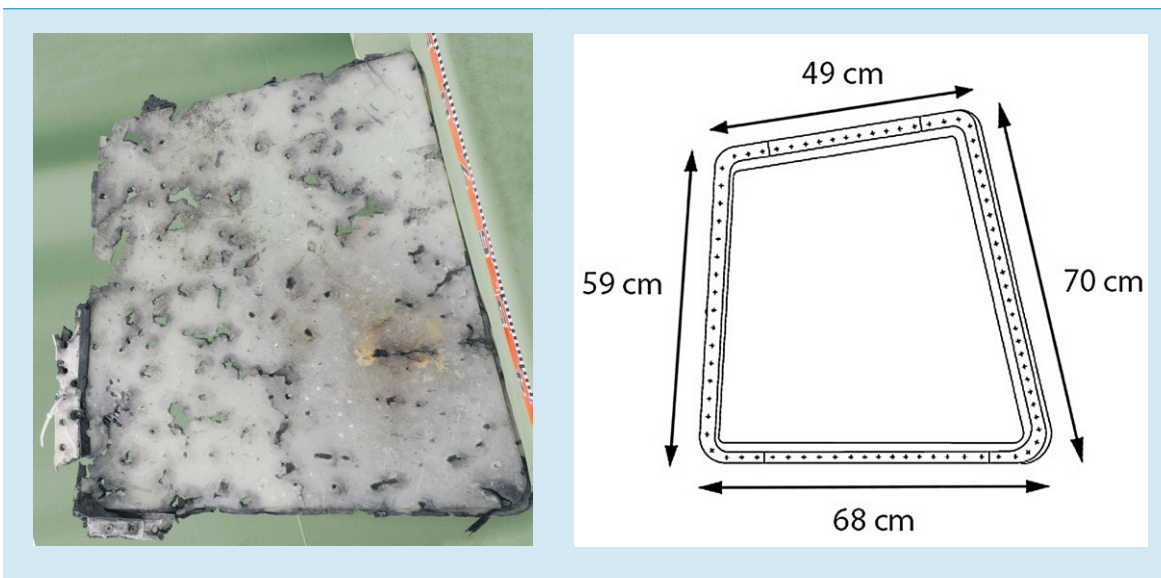
One of the layers of the window (window number 2) on the left hand side of the cockpit was collected by local residents. Cockpit windows are made of multiple layers of glass and plastic. The window had a total of 102 puncture holes and marks, varying in size and shape, as seen in Figure 34. Parts of the window frame were still attached to the window.

Figure 34: Left cockpit window 2. (Source: Dutch Safety Board)

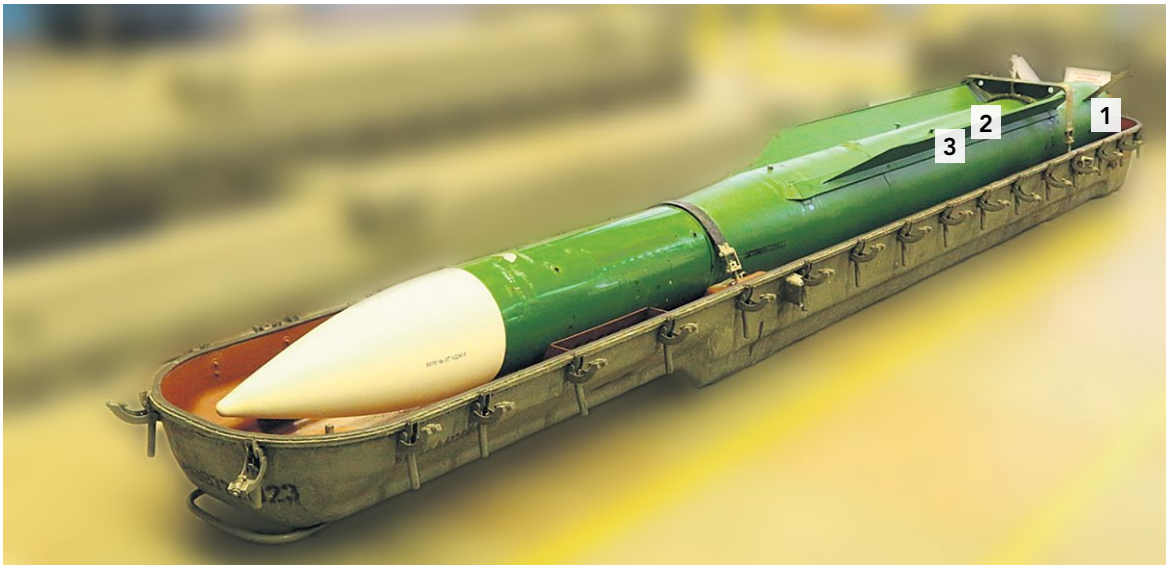
Figure 35: Image of 9M38M1 surface-to-air missile showing the approximate location of three of the parts recovered. (Source: NBAAI)

The shape and form of the parts recovered is consistent with a 9M38 series surface-to-air missile. Images of three of the recovered parts are shown in Figure 36 together with an indication of origin on a 9M38 series surface-to-air missile; namely an engine nozzle (1), part of one of the four stabilizer fins (2) and a data cable (3).

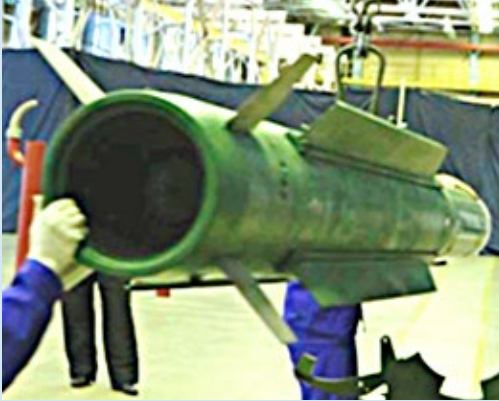
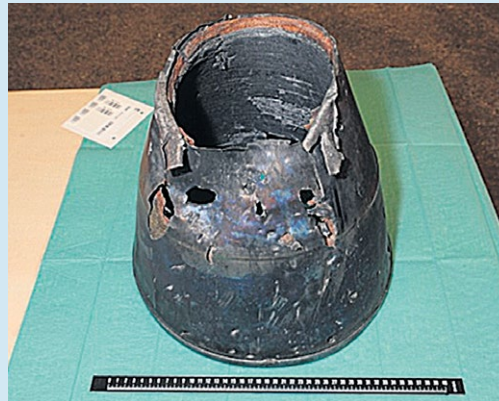
1. Rear nozzle of the missile's engine. (Source: NBAAI)

Missile engine nozzle as found in Ukraine. (Source: Dutch Safety Board/Dutch National Police)

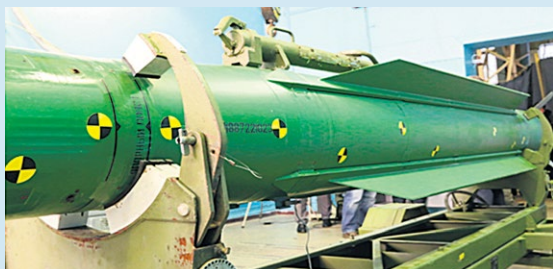
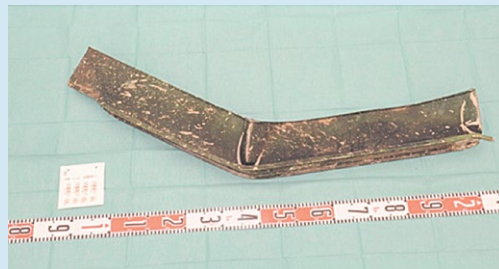
2. Stabilizing fins. (Source: NBAAI)

Part of stabilizing fin during identification at Gilze-Rijen Air Force Base. (Source: Dutch Safety Board/Dutch National Police)

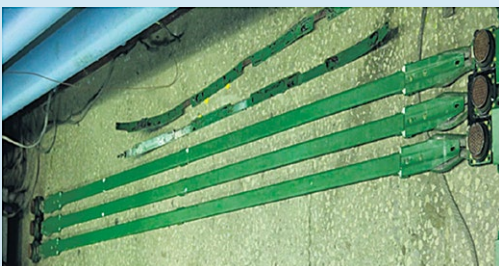
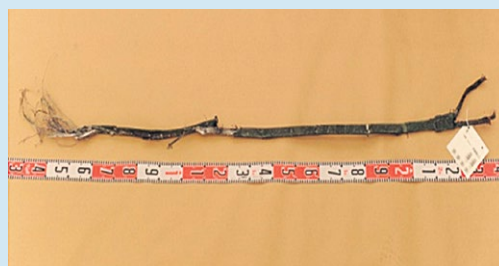
3. Data cables as mounted under the stabilizing fins. (Source: NBAAI)

Data cable during identification at Gilze-Rijen Air Force Base. (Source: Dutch Safety Board/Dutch National Police)

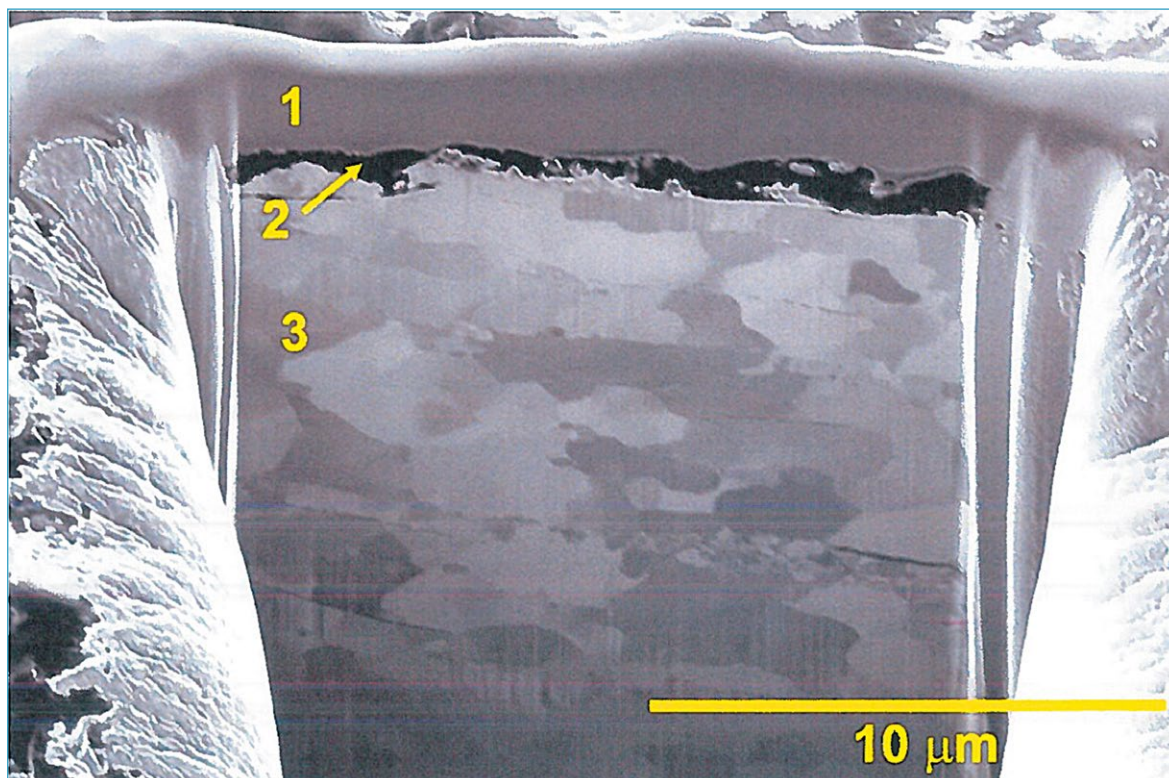
Cross-sections were made using the FIB technique on fragments recovered from the remains of the crew members, that had a glass and/or aluminium deposit. Scanning electron microscope examinations of the cross-sections created showed that both the aluminium and glass deposits were present in the form of thin layers of re-solidified material. These layers have a thickness ranging from tenths micrometres to tens of micrometres (Figure 38). On a small number of fragments thin layers containing traces of copper and plastic were found.

Figure 38: Example of SEM examination on a cross-section made using FIB. Note: 1) Layer of platina deposited by NFI, 2) layer of re-solidified molten cockpit glass, 3) unalloyed steel. (Source NFI)

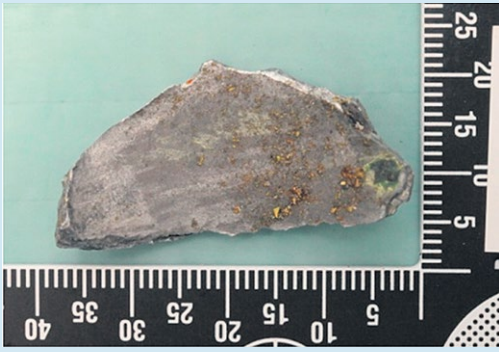
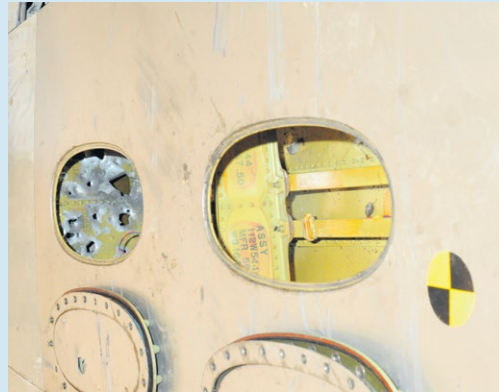
One of the fragments that was recovered from the wreckage of the aeroplane, was found in the left wing tip and a second one was found lodged in the left cockpit window frame. Figure 40 shows images of both of these fragments.

Metal fragment recovered from inside the left wing tip. (Source: Dutch Safety Board/Dutch National Police)

Location of the fragment inside the left wing tip, seen from below. (Source: Dutch Safety Board)

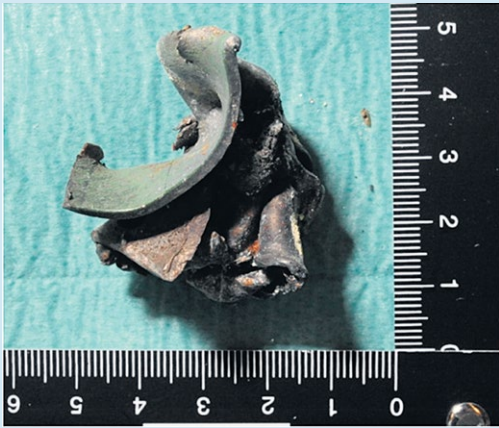
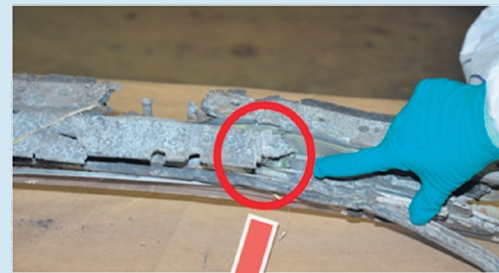
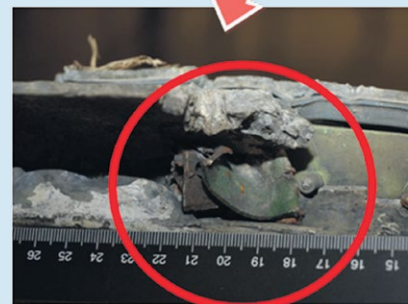
Metal fragment recovered from the left cockpit window frame. (Source: Dutch Safety Board/Dutch National Police)

Location of the fragment in the left cockpit window frame. (Source: Dutch Safety Board)

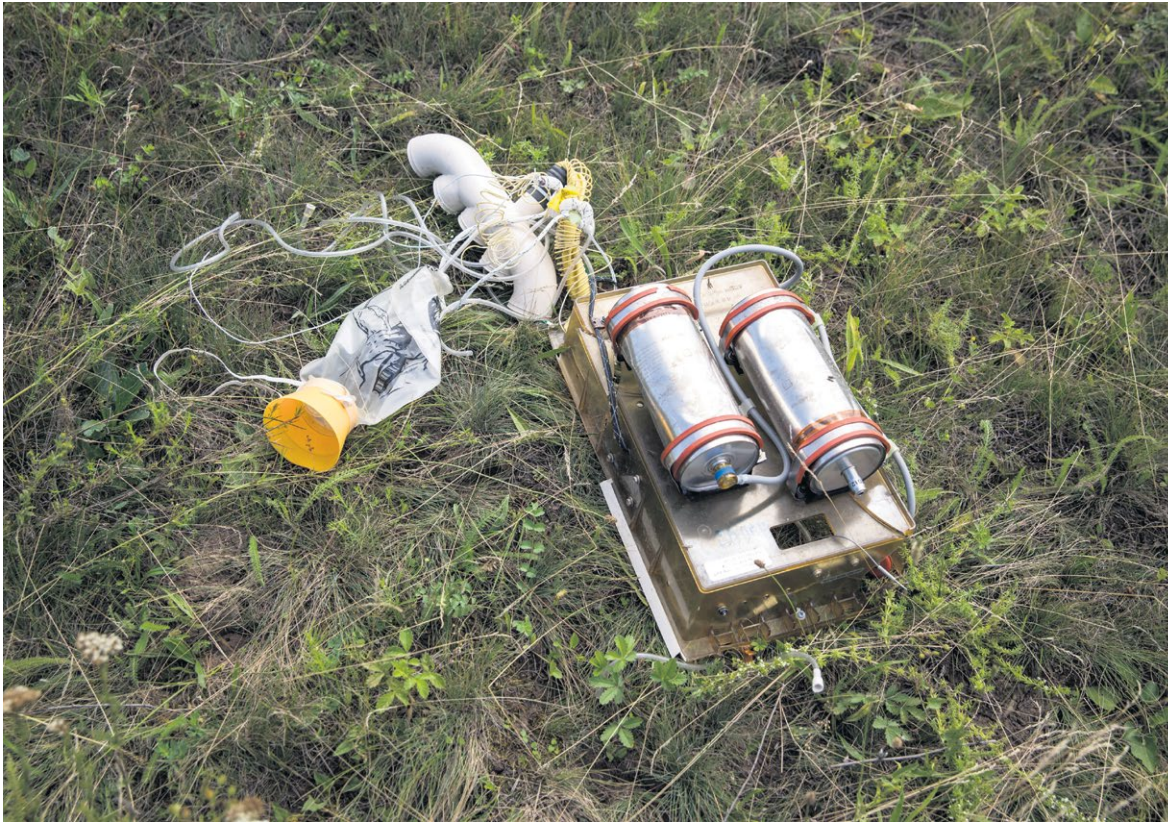
During the investigation about fifty chemical oxygen generators were recovered from the wreckage sites. With the exception of one, none of the chemical oxygen generators had its firing pin in place and all displayed a black coloured stripe; an indication that the

Figure 41: Chemical oxygen generators and part of the passenger service unit. (Source: Dutch Safety Board)

Some chemical oxygen generators were attached to their passenger service unit; others were found separated. All of the chemical oxygen generators were damaged and most of them were heavily distorted. About a dozen of the plastic PSU containers, or a part of them, which normally contain the emergency oxygen masks, were found. The containers are relatively rigid, but may nevertheless be deformed. The containers were heavily damaged, incomplete or cracked. All the latches, which cover the masks and keep them stored in the container, were missing. All of the solenoid switches were found in the 'unlatched' position. A few switches were damaged and could not be reset in the 'latched' position. For most of the chemical oxygen generators recovered, the masks and oxygen supply tubes were missing.

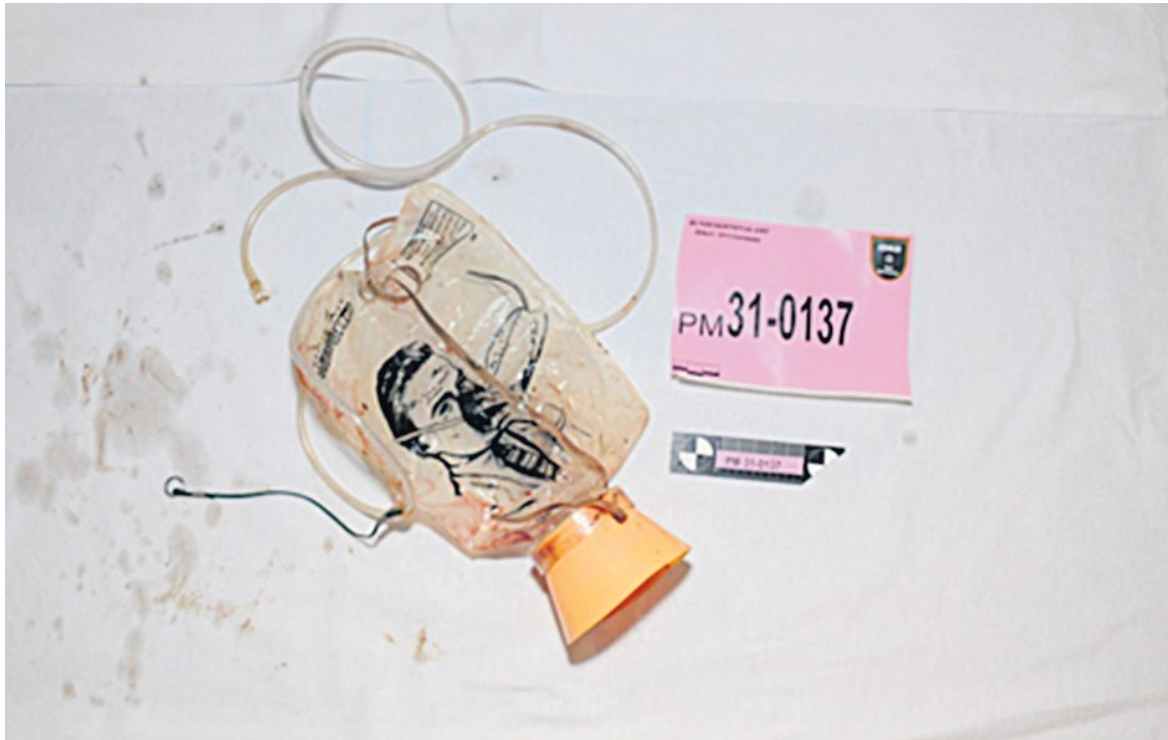
Figure 42: Emergency oxygen mask found on passenger. (Source: Dutch Safety Board)

During the victim identification process in the Netherlands, one passenger was found with an emergency oxygen mask, see Figure 42. The strap was around the passenger's neck and the mask was around the throat. No information was available about how this passenger was found at the wreckage site. The NFI examined the mask for biological traces and performed DNA tests. No DNA profiles could be obtained from the five samples taken. Therefore, DNA analysis was not possible. The lack of DNA material can be explained by the mask having been left outside for a long time at high temperatures.

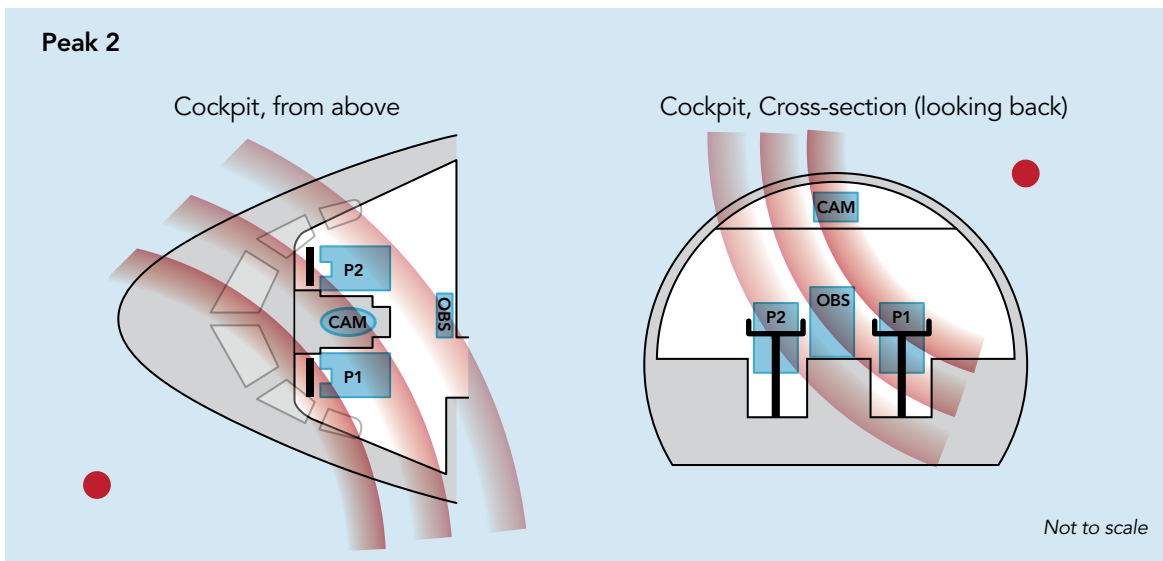
The time difference between the first and the second sound peak was determined to be 2.3 milliseconds. The second peak had a duration of 2.3 milliseconds and was recorded by all four channels. However, the recordings of the second peak were not simultaneous on all channels; some of the recordings had a different timestamp. The wave spectrum is representative for a sound wave. The time difference between the channels showed that the sound was recorded by the cockpit area microphone (CAM) and pilot 1 (P1) microphones first, followed by the pilot 2 (P2) microphone and, lastly, the observer (OBS) microphone. This difference in time showed that the sound wave originated outside the aeroplane starting from a position above the left hand side of the cockpit, propagating from front to aft (see Figure 43). It is concluded that the event was highly energetic in nature based on the short time duration of the event.

Figure 43: Second sound peak - graphic representation. (Source: Dutch Safety Board)

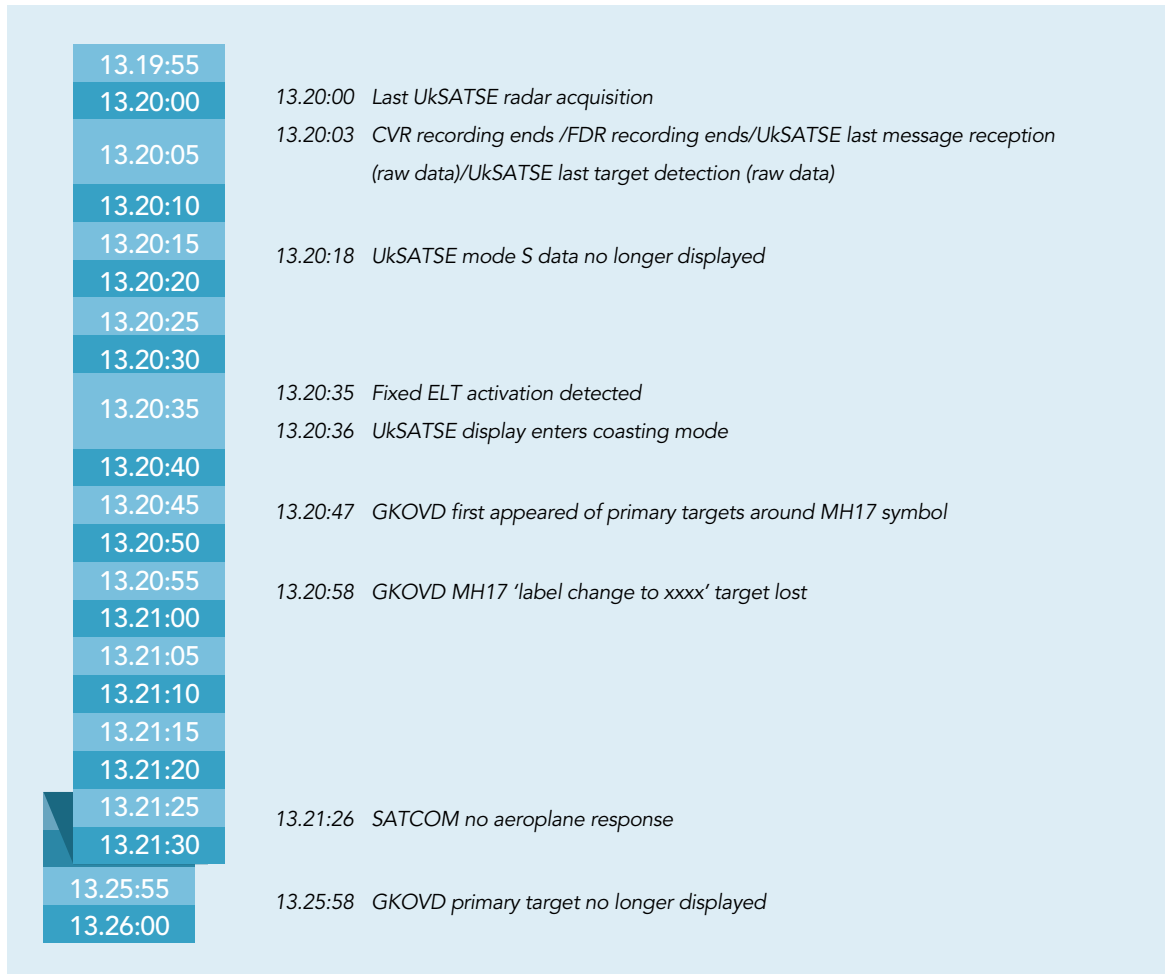
The loss of the two recorders and the radar data at 13.20:03 (15.20:03 CET) indicated that the electrical power was lost at this moment. The automatic activation of the fixed ELT between 13.20:05 - 13.20:06 (15.20:05 - 15.20:06 CET), caused by a deceleration, supported this. Finally, no other recorded data (e.g. SATCOM transmissions) contradicted the hypothesis.

Figure 44: Diagram showing a number of key moments in the recorded data. (Source: Dutch Safety Board)

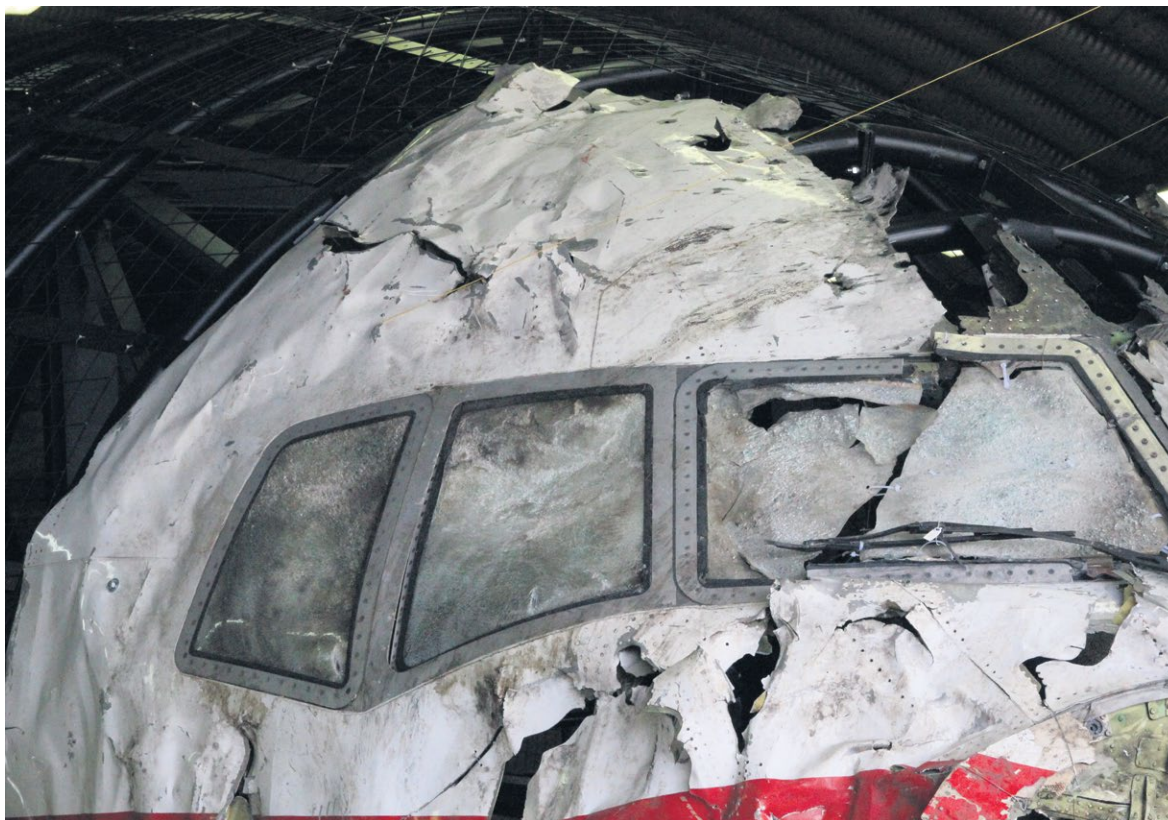
The main location of the damage of high-energy objects was on the left hand and upper side of the cockpit. The right hand side of the cockpit showed no high-energy object damage. As is shown in Figure 45 the two cockpit windows on the right hand side and the surrounding structure were unaffected by high-energy object impact.

Figure 45: Right hand side of cockpit. (Source: Dutch Safety Board)

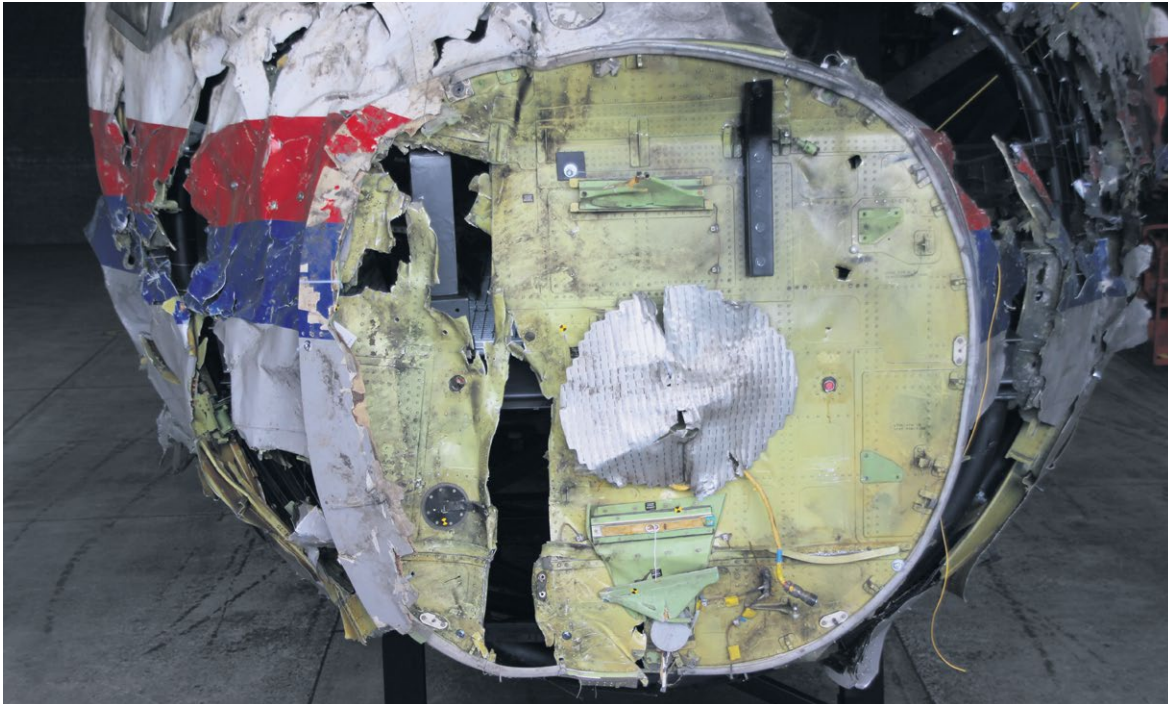
Figure 48: Cockpit bulkhead at junction with radome. (Source: Dutch Safety Board)

There was no perforation damage found in the cockpit bulkhead (Figure 48) that can be identified, with any certainty, as being from the perforation of high-energy objects. The perforation in the bulkhead was the result of other parts of the cockpit's structure having pushed through the plating.
