MH17 Crash

Crash of Malaysia Airlines flight MH17

Hrabove, Ukraine, 17 July 2014

The Hague, October 2015

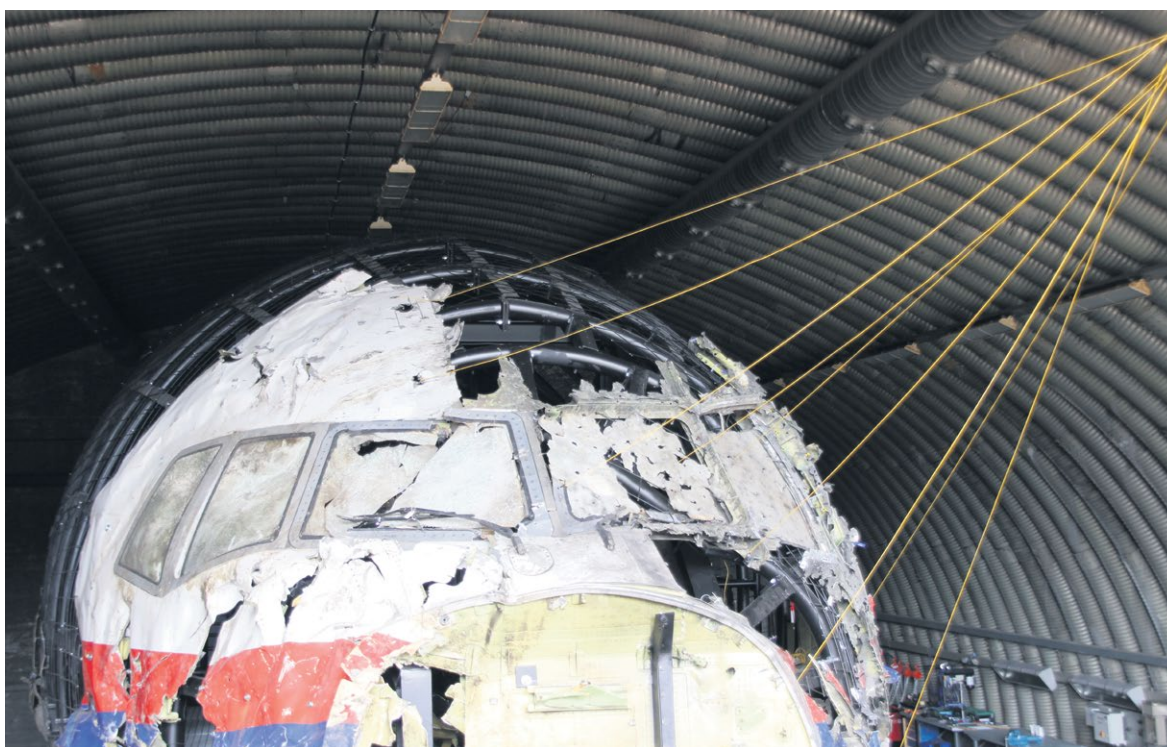
To determine the trajectory of the high-energy objects, the direction of the impact damage was analysed on several parts of the cockpit area. Using fibreglass rods and three-dimensional scans of the structure the direction of high-energy objects penetrating multiple layers of material was determined. A network of lines of string passed through straight lines of damage was set up. This is known as 'stringing' and is used to analyse the general direction of impact damage as shown in Figure 50. The results show trajectories of perforating damage converging to a general area to the left of, and above, the cockpit.

Figure 50: Impression of stringing of the cockpit. (Source: Dutch Safety Board)

It should be noted that although the 'stringing' is brought to a single point in Figure 50, it is not suggested that the point of detonation was actually a small single point. The lines are brought together to illustrate the divergent nature of the spray pattern of the high-energy objects. Stringing is only used to generate an indication of the detonation's position and is not intended to identify a specific point in space.

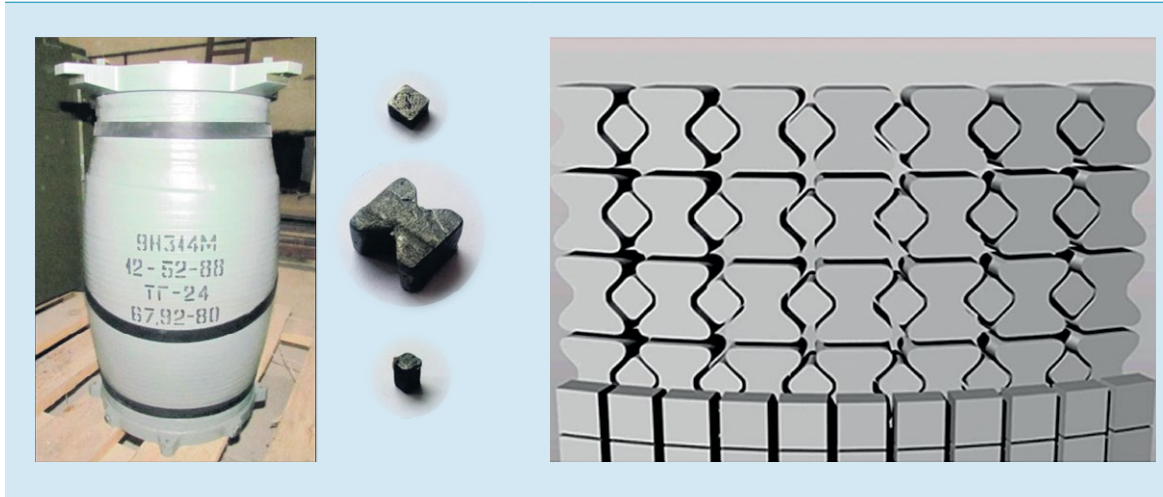
It is noted that the shapes of the pre-formed fragments found in the wreckage and the bodies of crew members in the cockpit; bow-tie and cubes, are only found in the 9N314M warhead (see Figure 56). The 9N314M warhead can be fitted to the 9M38M1 missile. These missiles are launched from a Buk surface-to-air missile system (see Figure 57).

Figure 56: Left: Sample 9N314M warhead. (Source: JSC Concern Almaz-Antey). Centre: from top to bottom, square, bow-tie and filler fragments. (Source: JSC Concern Almaz-Antey). Right: 3D print of the pre-formed fragment arrangement. (Source: AAIB). Note: the model name for the 9N314M warhead is shown on the left hand image in Cyrillic text, '9H314M'.

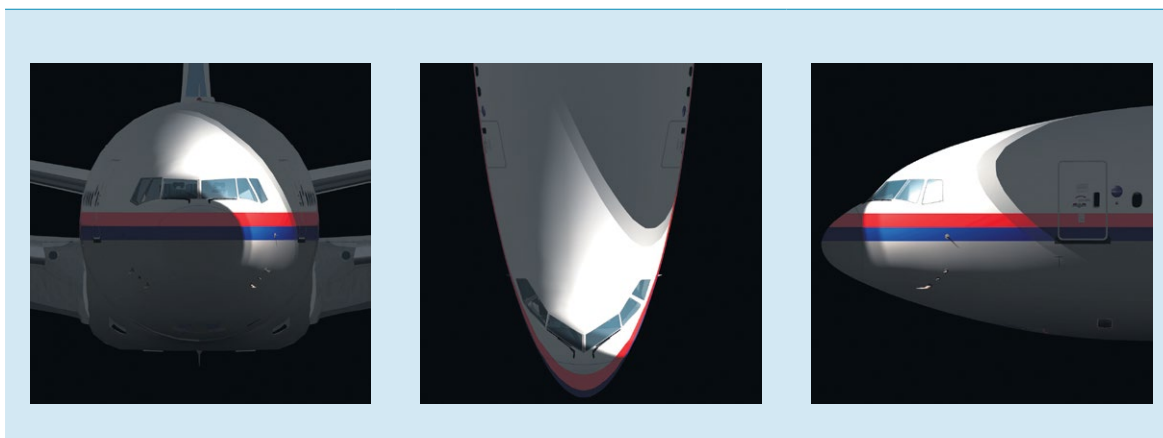
The simulation model resulted in a detonation location of the warhead that was to the left of and above the cockpit, whereby the missile was travelling at a speed of approximately 700 metres per second (approximately 1,360 knots or 2,520 kilometres per hour) in the opposite direction to the direction of flight of the aeroplane, coming slightly from below and from the right with respect to the aeroplane's longitudinal axis, seen from the cockpit.

Figure 58: Expected damage pattern caused by a 9N314M-model warhead. Lit areas show where damage was expected. (Source: NLR)

Using the modelled warhead's detonation point with the aeroplane's last known location, speed and attitude (see paragraph 3.4.1), the fragmentation visualisation model matched the damage observed on the wreckage of the aeroplane. The estimated position of the detonation was 0.25 metres ahead of the aeroplane's nose, 3 metres to the left of, and 3.7 metres above the tip of the nose.

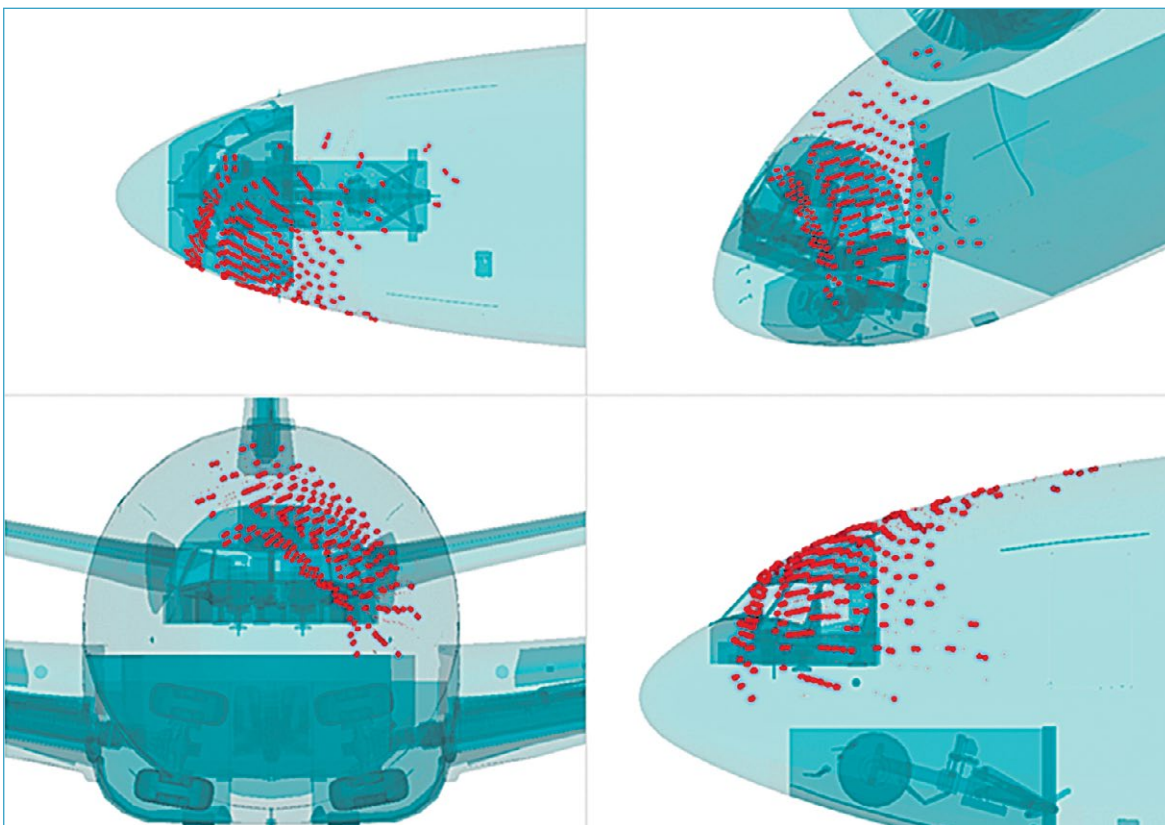
The best-match (green band in Table 19) between the simulation and the damage observed on the aeroplane was obtained with a 70 kg warhead flying at 730 metres per second and passing left of the aeroplane with an angle of 27 degrees to the aeroplane's x-axis and with a nose up attitude of 10 degrees (model IIb).

Figure 59: Image of the damage pattern produced by the model IIb in the warhead simulation model. (Source: TNO)

Based on its calculations, TNO concluded that a 70 kg warhead detonated 0.0 metres ahead and 2.0 metres to the left of, and 3.7 metres above the aeroplane's nose.

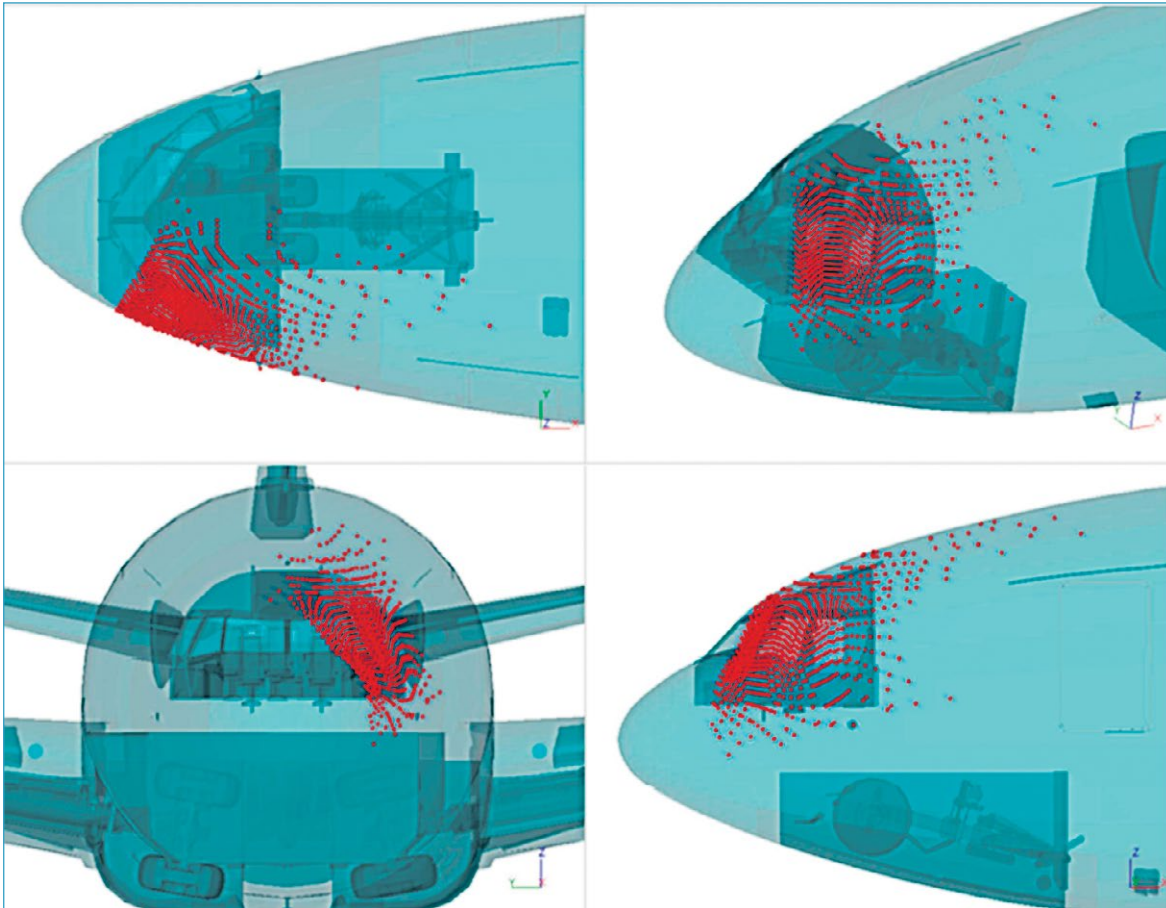
TNO's simulation also showed that there is no match obtained between the observed damage on the aeroplane and the simulated damage patterns when a smaller and lighter, 40 kg, warhead was applied. Figure 60 shows the simulated damage patterns for the set of simulations with a 40 kg warhead which were closest to the actual observed damage. This pattern gave a poorer match than was obtained with a heavier warhead (Model IIb).

Figure 60: Image of the damage pattern produced by the model of a 40 kg warhead in the warhead simulation model. (Source: TNO)

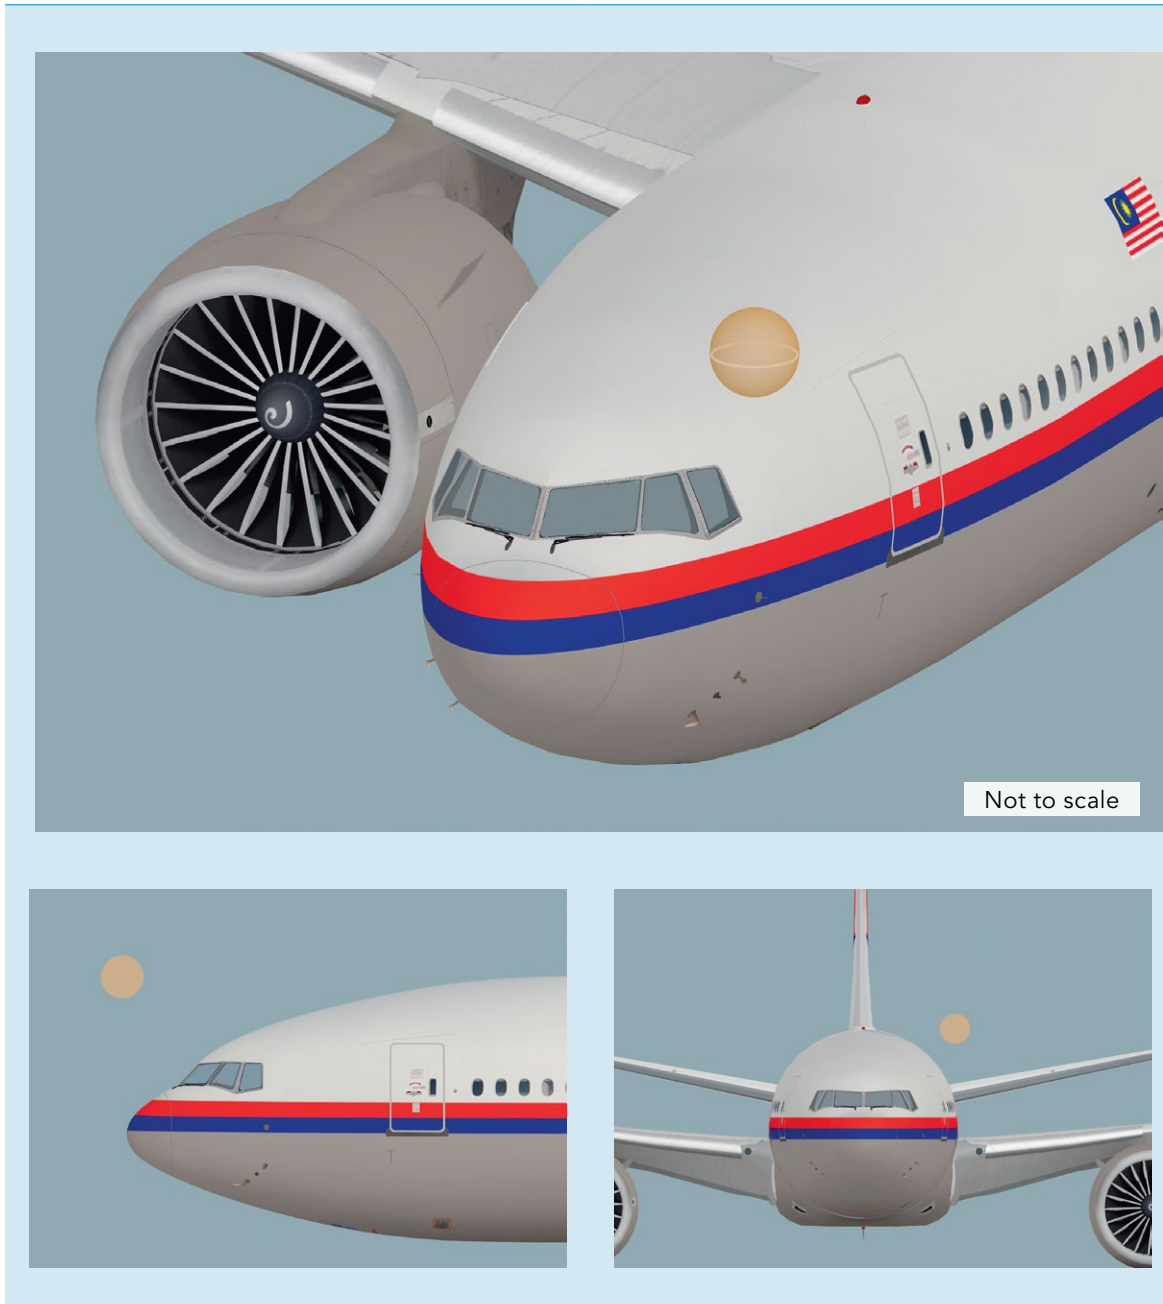
The Dutch Safety Board took account of uncertainties in the models by defining a volume of space that enclosed the results of the different simulations instead of a finite point in space. The volume of space of the warhead's detonation locations shown in Figure 61 is less than one cubic metre and is located at approximately 4 metres above the tip of the aeroplane's nose on the left side of the cockpit.

Figure 61: Simplified representation of the volume of space of the warhead detonation location according to three independent simulations. (Source: Dutch Safety Board)

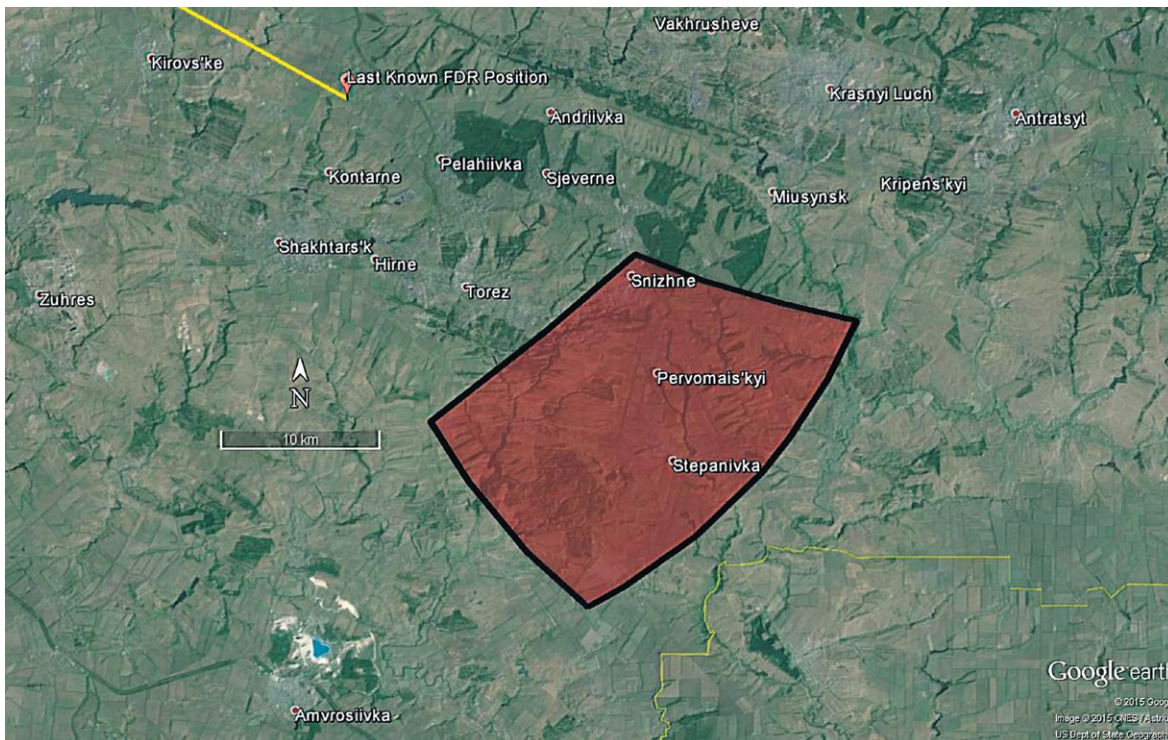
All of the possible points from where these flight paths could have commenced are visualised in Figure 62. Outside the calculated area of about 320 square kilometres, a 9N314M warhead carried on a 9M38-series missile as installed on the Buk surface-to-air missile system cannot create the damage pattern observed on the aeroplane.

Figure 62: Visualisation of NLR fly out simulation results. (Source: NLR)

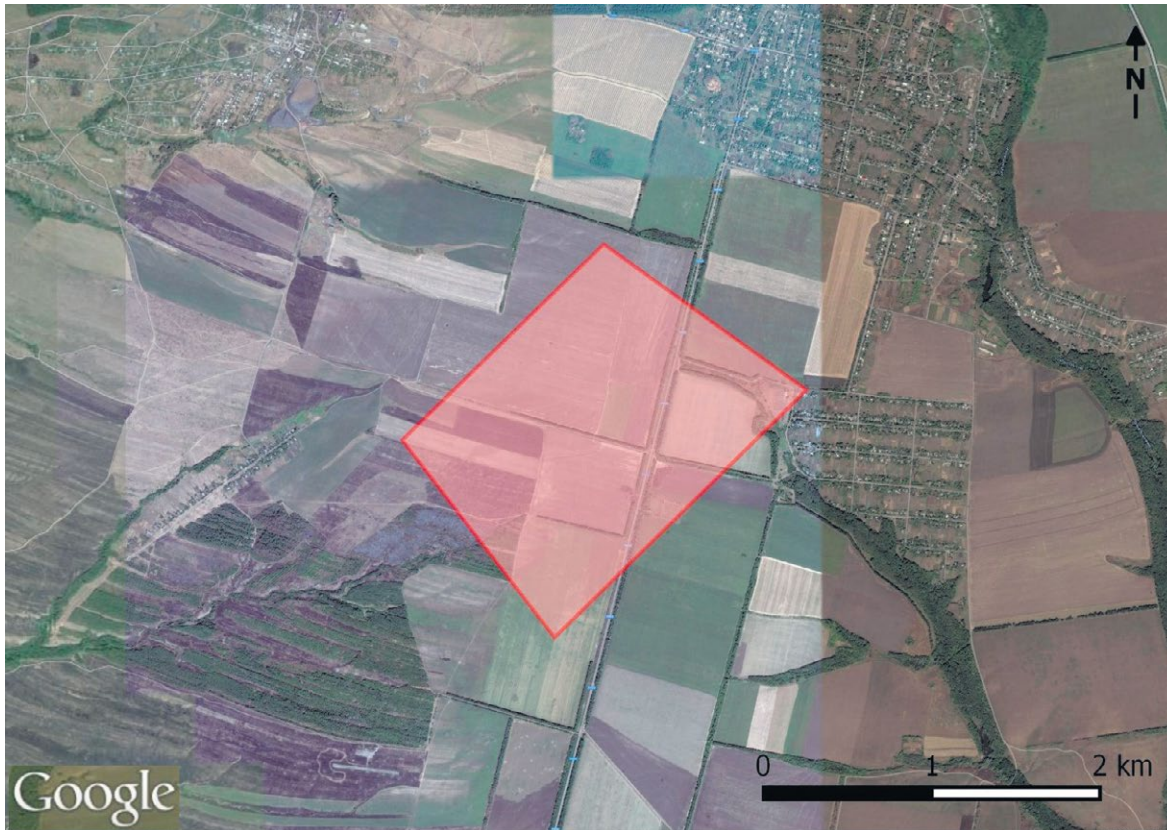
In a simulation performed by the Kyiv Research Institute for Forensic Expertise, an area of 4 square kilometres was calculated using the 9M38M1 missile and 9N314M warhead. This is shown in Figure 63.

Figure 63: Visualisation of Kyiv Research Institute for Forensic Expertise fly out simulation results. (Source: Kyiv Research Institute for Forensic Expertise)

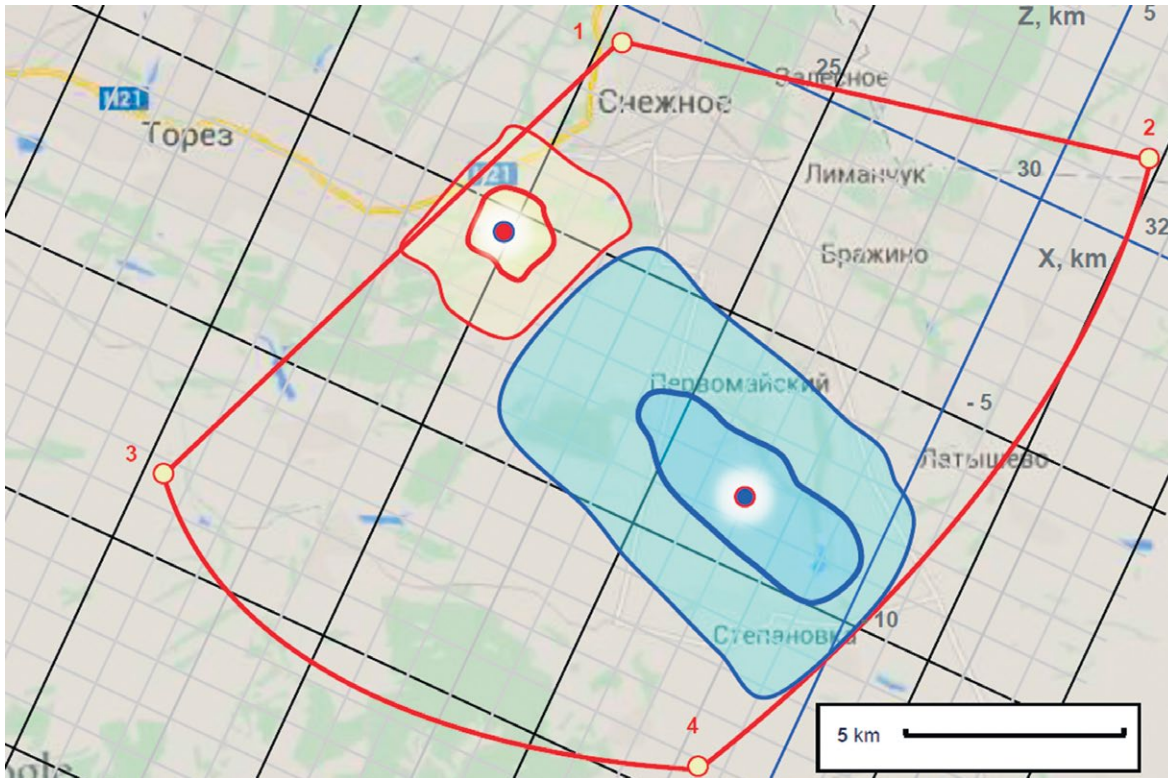
Results for sets of similar calculations were supplied; one for a warhead launched by a 9M38 missile and one for the same warhead launched by a 9M38M1 missile. These calculations produced two areas, respectively, approximately 20 and 63 square kilometres. The areas calculated by JSC Concern Almaz-Antey (see Figure 64) are consistent with the results of the NLR and Kyiv Research Institute for Forensic Expertise calculations.

Figure 64: Visualisation of JSC Concern Almaz-Antey fly out simulation results. Note: The red line, numbered 1 to 4, marks the initial area identified by the NLR fly out simulation; an area since updated. (Source: JSC Concern Almaz-Antey)

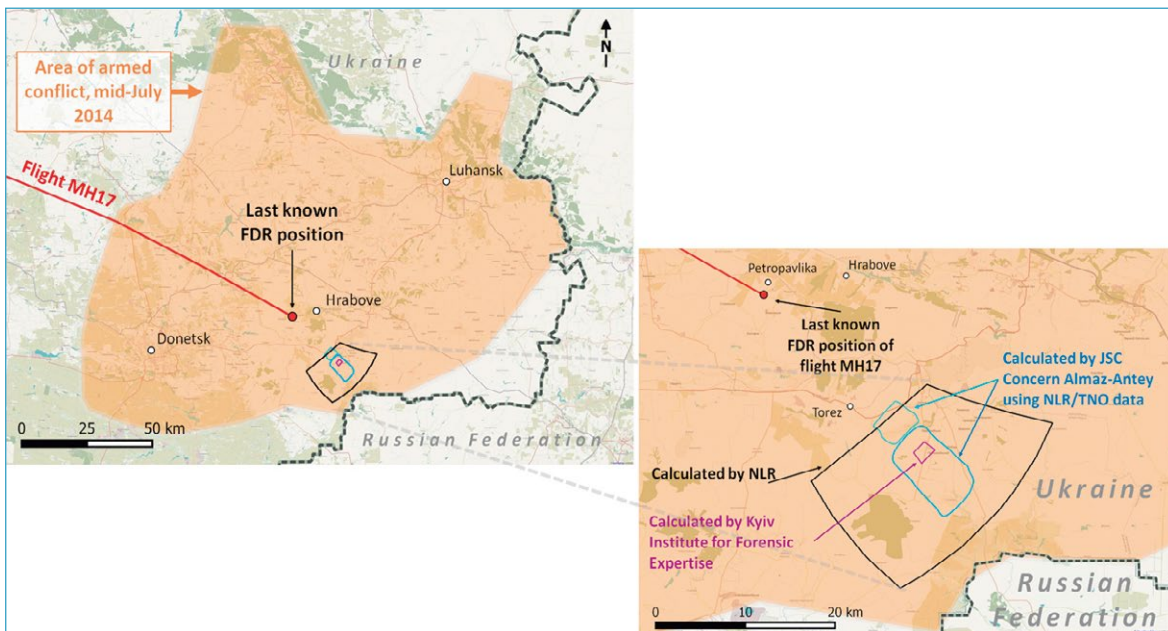
The results of the three sets of simulations are shown in a combination sketch (see Figure 65) of the calculated areas from which a 9N314M warhead carried on a 9M38-series missile as installed on the Buk surface-to-air missile system could have reached the warhead's detonation location in the volume of space near to flight MH17 and could have created the damage observed.

Figure 65: Combination sketch of the calculated areas. (Source: Dutch Safety Board)

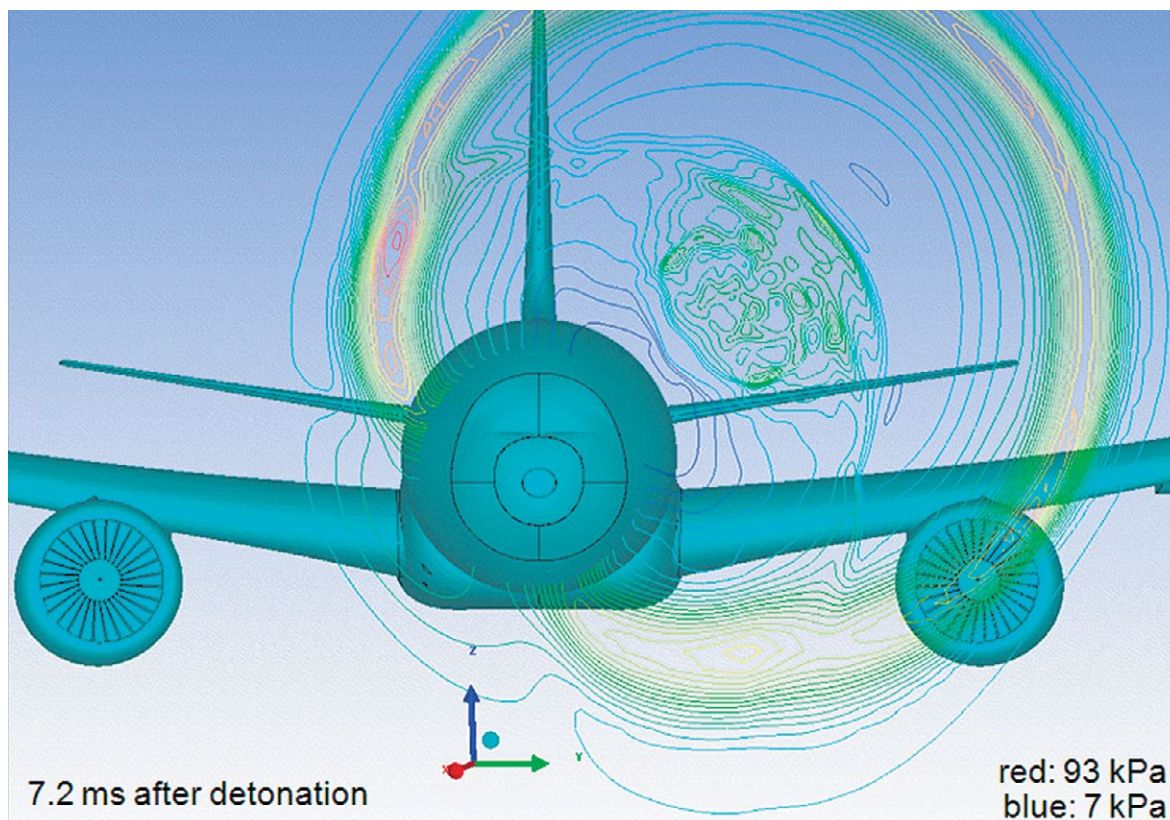
Figure 66: Sample image of blast simulation showing blast wave around fuselage, 7.2 milliseconds after detonation. (Source: TNO)

Calculations show how peak pressure decreases with increasing distance. The blast following the detonation of the warhead created an area of very high pressure near the cockpit with a maximum value of about 5,000 kilopascals. 75 kilopascals was taken to be

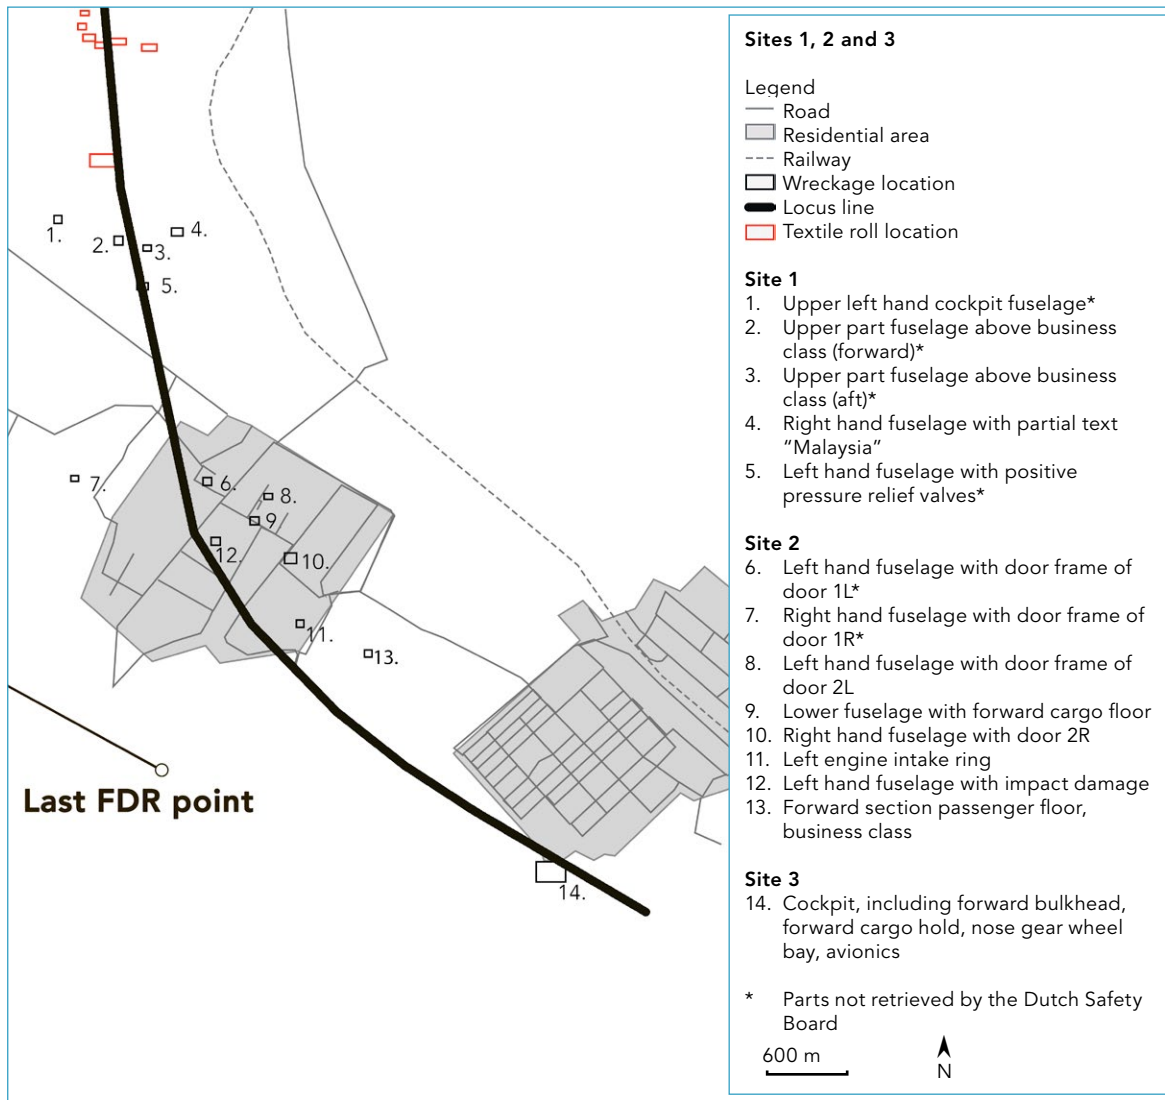
By running the ballistic trajectory analysis for multiple ballistic coefficients, a so-called locus line was obtained. The locus line represents the possible ground positions of wreckage parts after break-up, assuming that they all separated at the same initial position, altitude and speed and assuming a ballistic trajectory taking into account the wind, see Figure 74.

Figure 74: Calculated locus line (black) from ballistic trajectory analysis with identified wreckage and cargo parts in sites 1, 2 and 3. (Source: Dutch Safety Board)

The combination of the cockpit with the lower fuselage part has a very high ballistic coefficient. This means it would likely be found near the lower end of the locus line if it separated from the aircraft at the point of initial break-up, and that is where it was found (site 3).

All parts from the fuselage part in front of STA888/909 that were recovered, were found in the sites 1, 2 and 3, at or very close to the locus line.

All aeroplane parts of the fuselage aft of STA888/909, wings and empennage were found in sites 4, 5 and 6. These sites are located relatively far beyond the locus line. From this it can be concluded that these parts separated from the aeroplane much later than those of the forward fuselage.

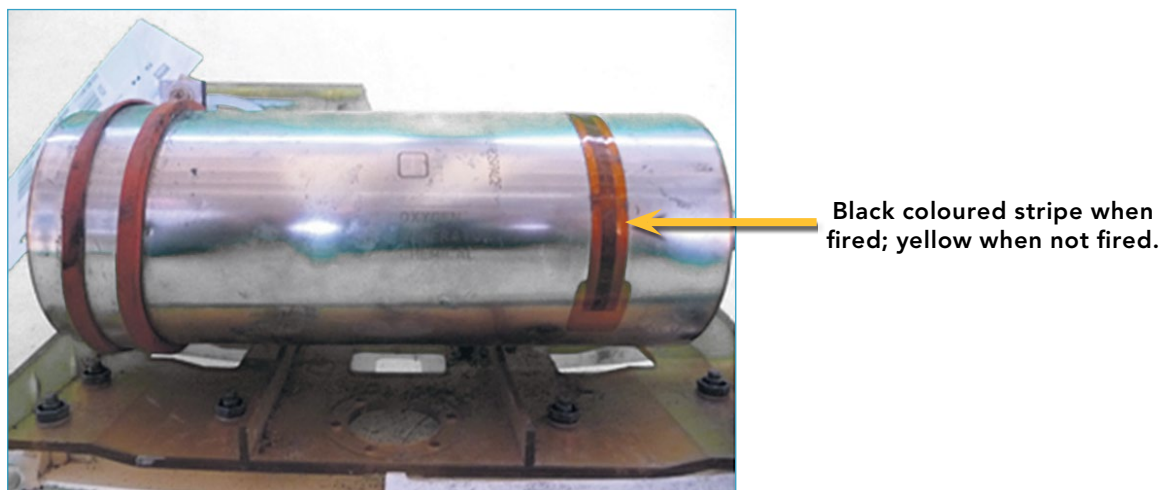
On the oxygen generators recovered from sites 4 and 5, some solenoid switches were deformed and the latches had separated from all of the recovered containers. It is therefore considered likely that oxygen masks dropped out of the passenger service unit containers due to torsion or other forces upon these containers. This would then result in the unlocking or separation of the latches. This could have been the result of either the blast of the warhead explosion, the effects of the in-flight break-up or the impact with the ground.

It requires a force of only a few Newton²⁰ to remove the firing pin from the oxygen generator. Therefore, it is conceivable that the oxygen generators were fired as a result of the blast, the dynamic forces during the in-flight break-up or the impact with the ground. The oxygen generator which had not been fired, originated from the crew rest area. It is considered possible that the rest area, a closed container, may have been better protected against the dynamic forces during the in-flight break-up or from the impact with the ground.

Figure 75: One of the recovered passenger oxygen generators. (Source: Dutch Safety Board)
