PART 1.4 – FINDINGS

Executive Summary of Findings

1.4.1 The incident involving Voyager KC Mk 3 (ZZ333) on 9 Feb 14 occurred when the aircraft suddenly pitched down while in the cruise at FL330 (33,000 ft). The pitch-down command persisted for a total of 33 seconds, during which time the aircraft lost 4,400 ft in height. The aircraft's self-protection measures initiated a recovery from the dive.

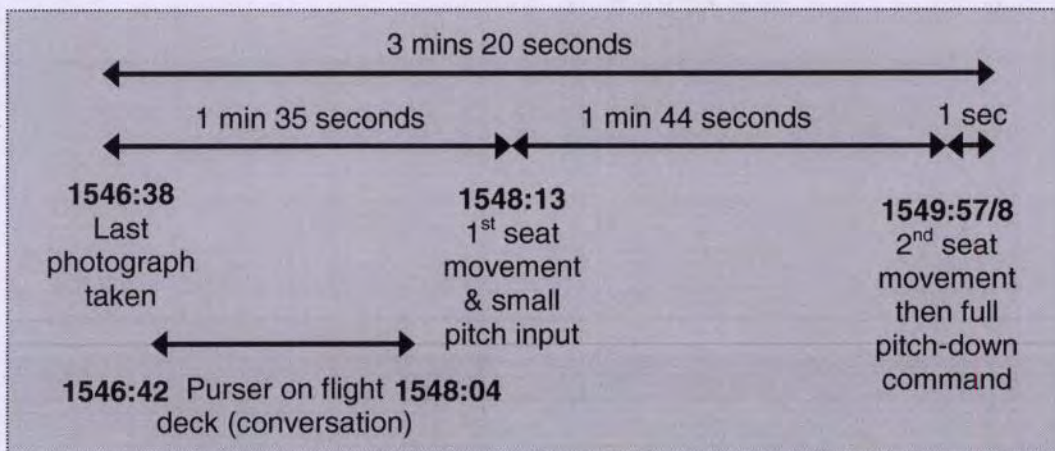
1.4.26 As such, the Panel established that the last photograph taken with the camera was at 15:46:38 UTC; one minute 35 seconds before the initial pitch event, and three minutes and 20 seconds before the full pitch-down event. Analysis of the CVR indicated that approximately four seconds after the last photograph was taken, the Purser came onto the flight deck to have a short conversation with the Captain, before returning to the passenger cabin (Figure 5).

Figure 5: Timeline immediately prior to incident (all times UTC).

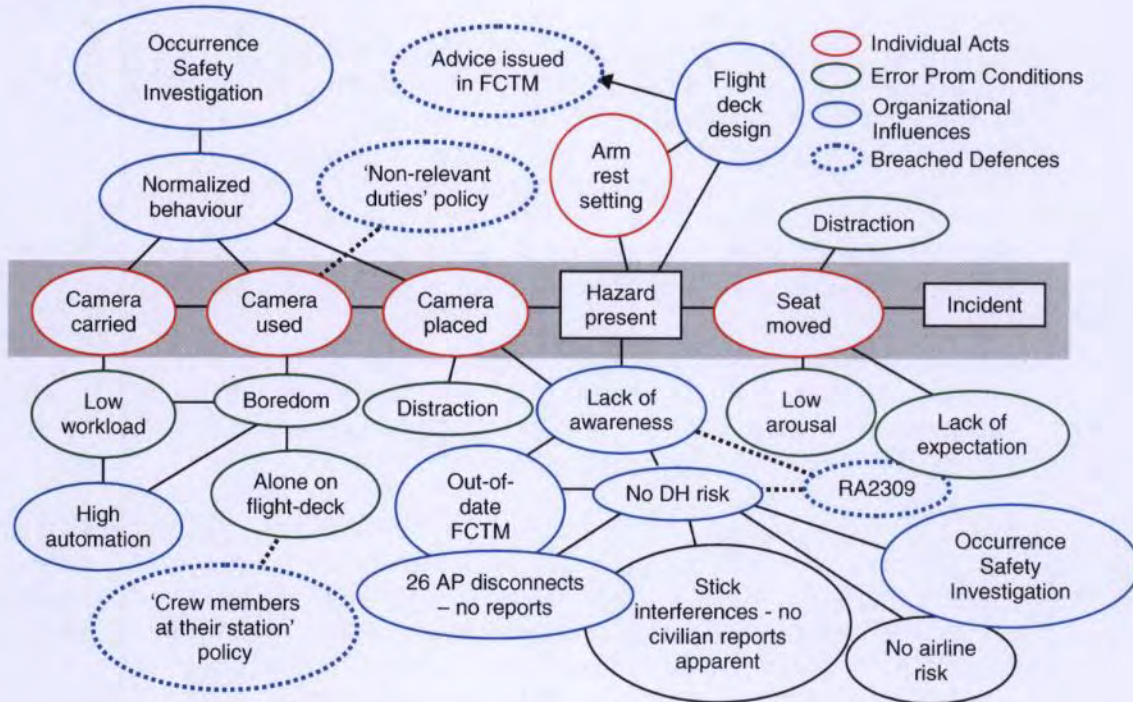
1.4.34 A series of individual acts took place in the moments before the pitch-down command which were assessed as having contributed to the incident itself. The individual acts however, were influenced by a combination of error promoting conditions, organizational influences and breached defences. The following paragraphs are drawn principally from Human Factors analysis conducted by RAFCAM. Figure 10 illustrates the key factors which were considered in determining how the pitch-down command happened, and forms the structure for the analysis in these paragraphs.

Figure 10: Diagram of key factors leading to pitch-down command.

1.4.35 **Carriage of the camera.** The carriage of the camera had a direct bearing on the incident, in as much as it was the object responsible for the side-stick interference. As such, the Panel concluded that **the carriage of the camera on the flight deck was a contributory factor**. This however, was influenced by a number of associated factors.

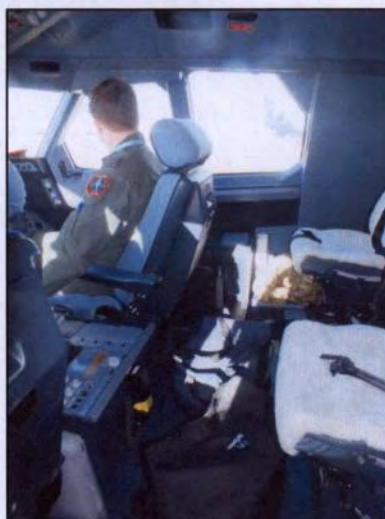
(3) The Panel saw and heard evidence that the issue of loose articles was not, in fact, limited to the C-130 fleet. The C-130 was the only aircraft type at RAF Brize Norton whose engineers were constituted separately (and geographically remotely) from its flying squadrons. As such, some Air Safety staff believed that the issue of loose articles was simply being dealt with more directly on other squadrons where the engineers were embedded, rather than reported officially. Similarly to C-130 crews, Voyager aircrew were required to take a large number of items of equipment on board the aircraft for operational flights. These items included two sets of body armour for each crew member, combat survival waistcoats, crew weapons, aircraft documentation, two route bags, a set of worldwide navigation kit and charts and a bag of classified material. Only some of these items had designated storage, with the rest usually found space around the flight deck; for example, on the floor behind the pilots' seats (Figure 11 and Figure 12). This volume of items was a result of the nature of the tasking and the associated volume of paperwork necessary to support the mission. It is likely that the number of required items on the flight deck promoted an attitude that it was generally acceptable to have a large volume of items on the flight deck, such that the carriage of a small number of personal effects would not have seemed unreasonable. Accordingly, all pilots interviewed on 10 Squadron by RAFCAM reported having a personally acquired tablet computer that they would take with them on the flight to enable access to the large amount of aircraft documentation. It was also considered normal to carry a personal

navigation bag in which items such as clipboards, their tablet computer and additional paperwork would be carried.

Figure 11: Carriage of in-flight publications.
