PART 1.4 – FINDINGS

Executive Summary of Findings

1.4.1 The incident involving Voyager KC Mk 3 (ZZ333) on 9 Feb 14 occurred when the aircraft suddenly pitched down while in the cruise at FL330 (33,000 ft). The pitch-down command persisted for a total of 33 seconds, during which time the aircraft lost 4,400 ft in height. The aircraft's self-protection measures initiated a recovery from the dive.

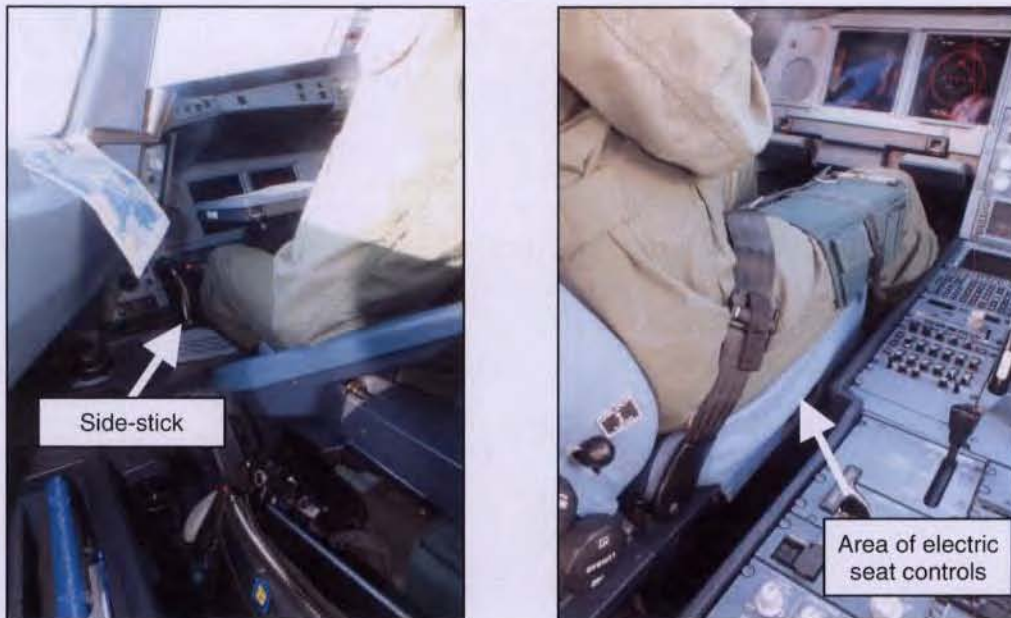
Figure 2: Captain's seat position.

1.4.21 Early analysis of the CVR identified a distinctive noise on the flight deck at one minute and 44 seconds prior to the event, and at the onset of the event itself. Spectral analysis of the noise identified it as the electrical motor used to adjust the flight deck crew seats (identified by its frequency of 1900-2000 Hz). The seats are adjustable by means of a switch which is located on the base of the seat itself. The Captain's seat is on the left-hand side of the flight deck and his adjustment switch is on the bottom right-hand side of the seat (Figure 2). In the two minutes leading up to the event the Captain was the only person present on the flight deck, indicating that the motor noise came from the Captain's seat. There was no evidence that the seat had malfunctioned in flight and functional tests carried out after the event showed that the seat was fully serviceable. It was quite normal for the seat to be adjusted several times during the flight, either for reasons of comfort or for the performing of a specific task. The Captain confirmed that his seat may have moved forward at this time, although he could not specifically recall it.

1.4.22 There was an obvious and strong temporal and directional correlation between the seat motor movement and the side-stick movement. The Panel examined the possibility that the movement of the Captain's seat and the Captain's side-stick were connected. For there to have been a direct relationship, the seat and the stick would have to be physically connected, either by the occupant of the seat or by an object (other methods of interference are dealt with in a separate

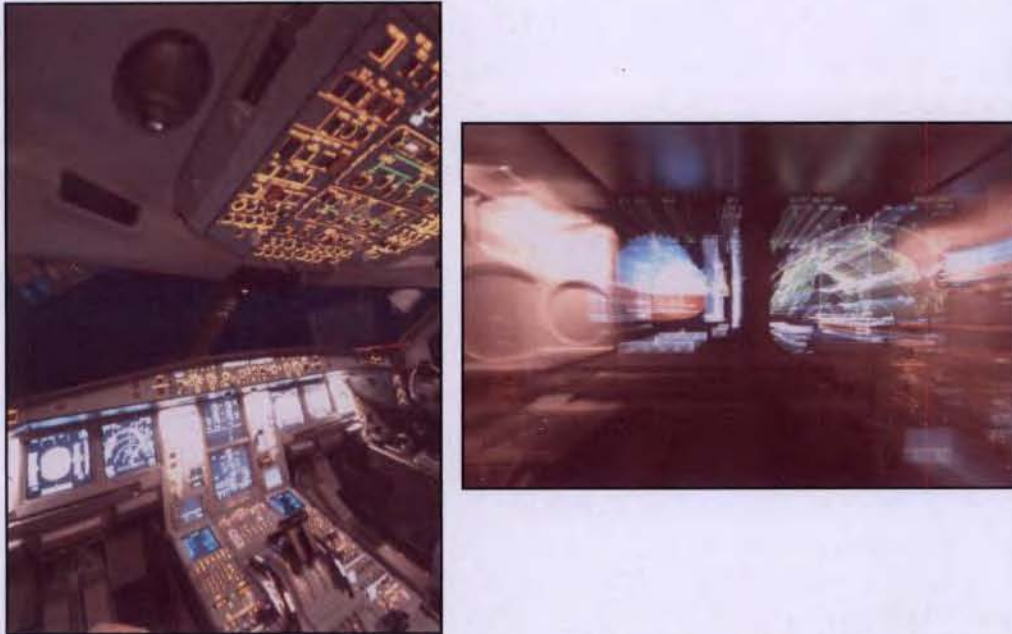
Figure 4: Sample of 28 photographs taken on flight deck shortly before incident.

Analysis of [redacted] photographs submitted subsequently by the Captain indicated that 28 photographs were taken during a period of darkness between around eight minutes and three minutes prior to the incident (Figure 4). It was established that, in all, 77 photographs were taken during the flight. In one photograph, the GPS digital clock on the flight deck could be seen, allowing a comparison to be made between the aircraft's internal time measurement and that of the camera.

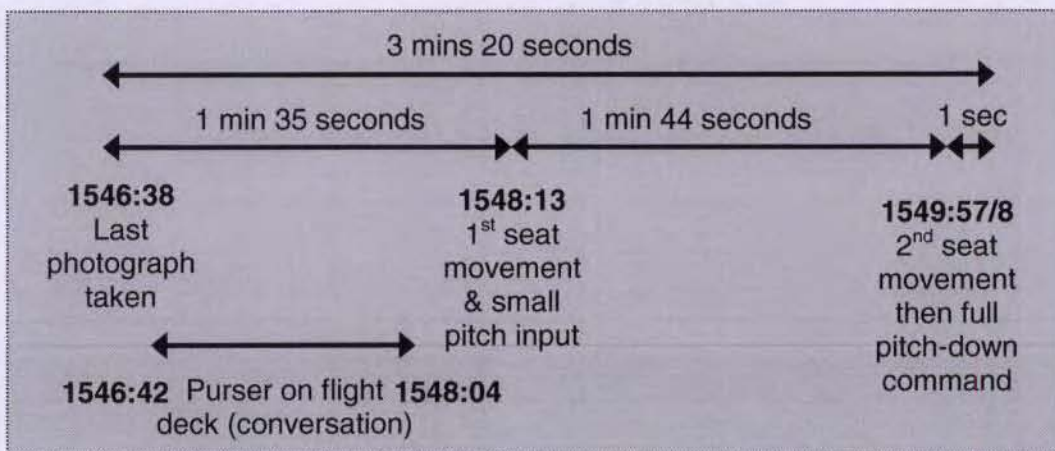
Figure 5: Timeline immediately prior to incident (all times UTC).

1.4.26 As such, the Panel established that the last photograph taken with the camera was at 15:46:38 UTC; one minute 35 seconds before the initial pitch event, and three minutes and 20 seconds before the full pitch-down event. Analysis of the CVR indicated that approximately four seconds after the last photograph was taken, the Purser came onto the flight deck to have a short conversation with the Captain, before returning to the passenger cabin (Figure 5).

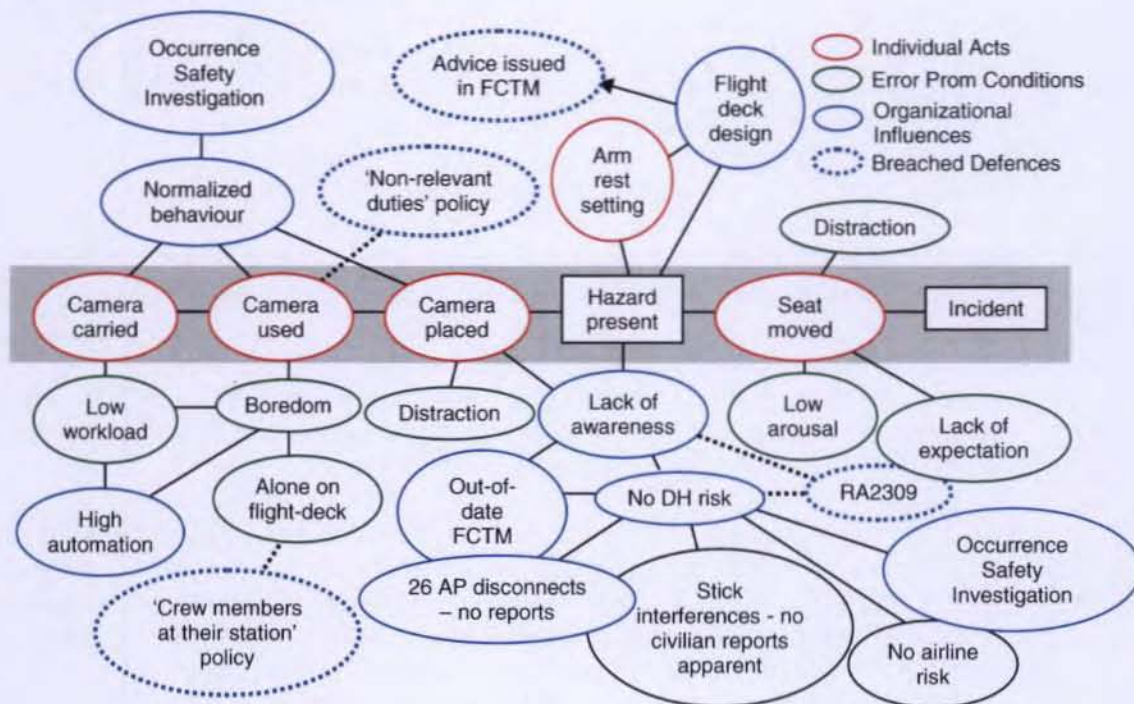
Figure 10: Diagram of key factors leading to pitch-down command.

1.4.34 A series of individual acts took place in the moments before the pitch-down command which were assessed as having contributed to the incident itself. The individual acts however, were influenced by a combination of error promoting conditions, organizational influences and breached defences. The following paragraphs are drawn principally from Human Factors analysis conducted by RAFCAM. Figure 10 illustrates the key factors which were considered in determining how the pitch-down command happened, and forms the structure for the analysis in these paragraphs.

1.4.35 **Carriage of the camera.** The carriage of the camera had a direct bearing on the incident, in as much as it was the object responsible for the side-stick interference. As such, the Panel concluded that **the carriage of the camera on the flight deck was a contributory factor**. This however, was influenced by a number of associated factors.
